Prepared by:
**The Watershed Projects Office,
California State University, Chico**

Prepared for:
United States Fish & Wildlife Service
July 2000

**Upper Butte Creek
Watershed
Road-Related Sediment Survey:
Scotts John, Bull
and Varey Creeks**

FINAL DRAFT

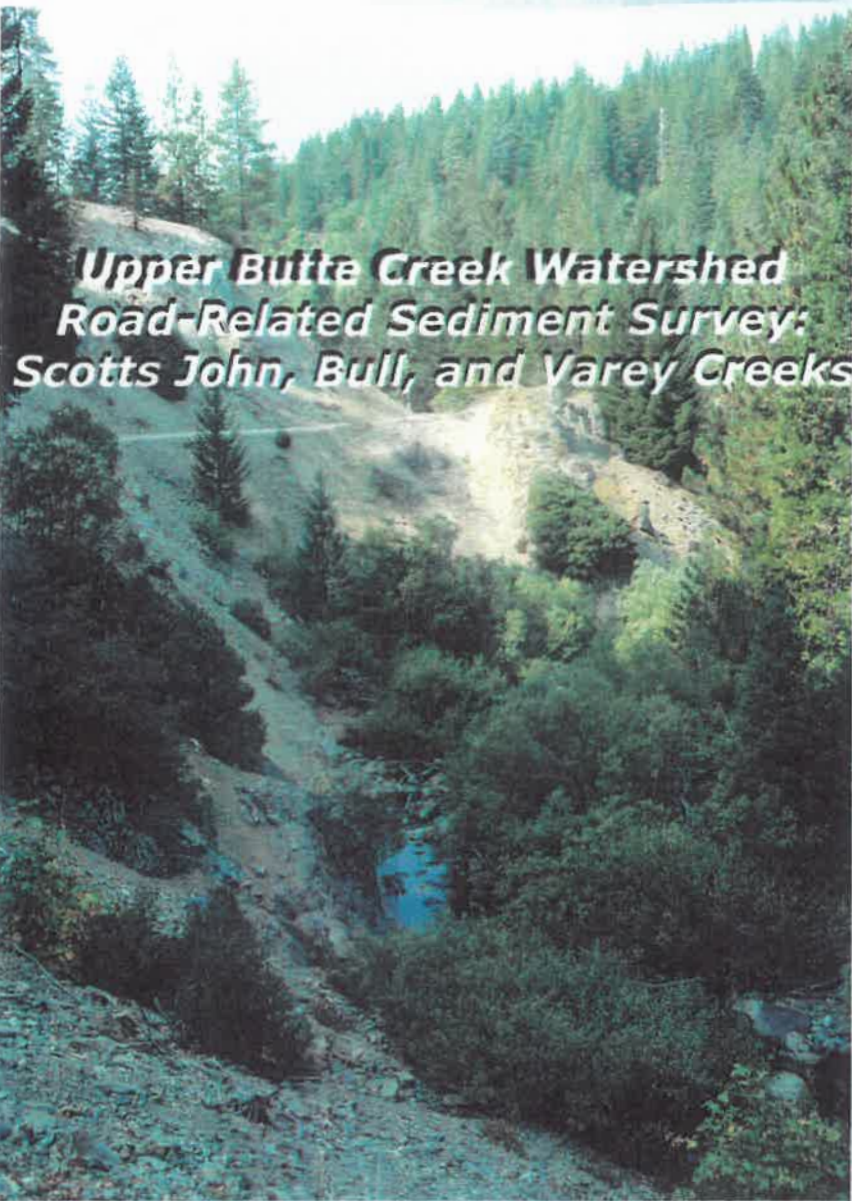
Front Cover: Photograph of the A-line road, just downstream of its crossing of Bull Creek. Fillslope erosion at this location was inventoried as site A-R3, with direct delivery of sediment to Bull Creek.

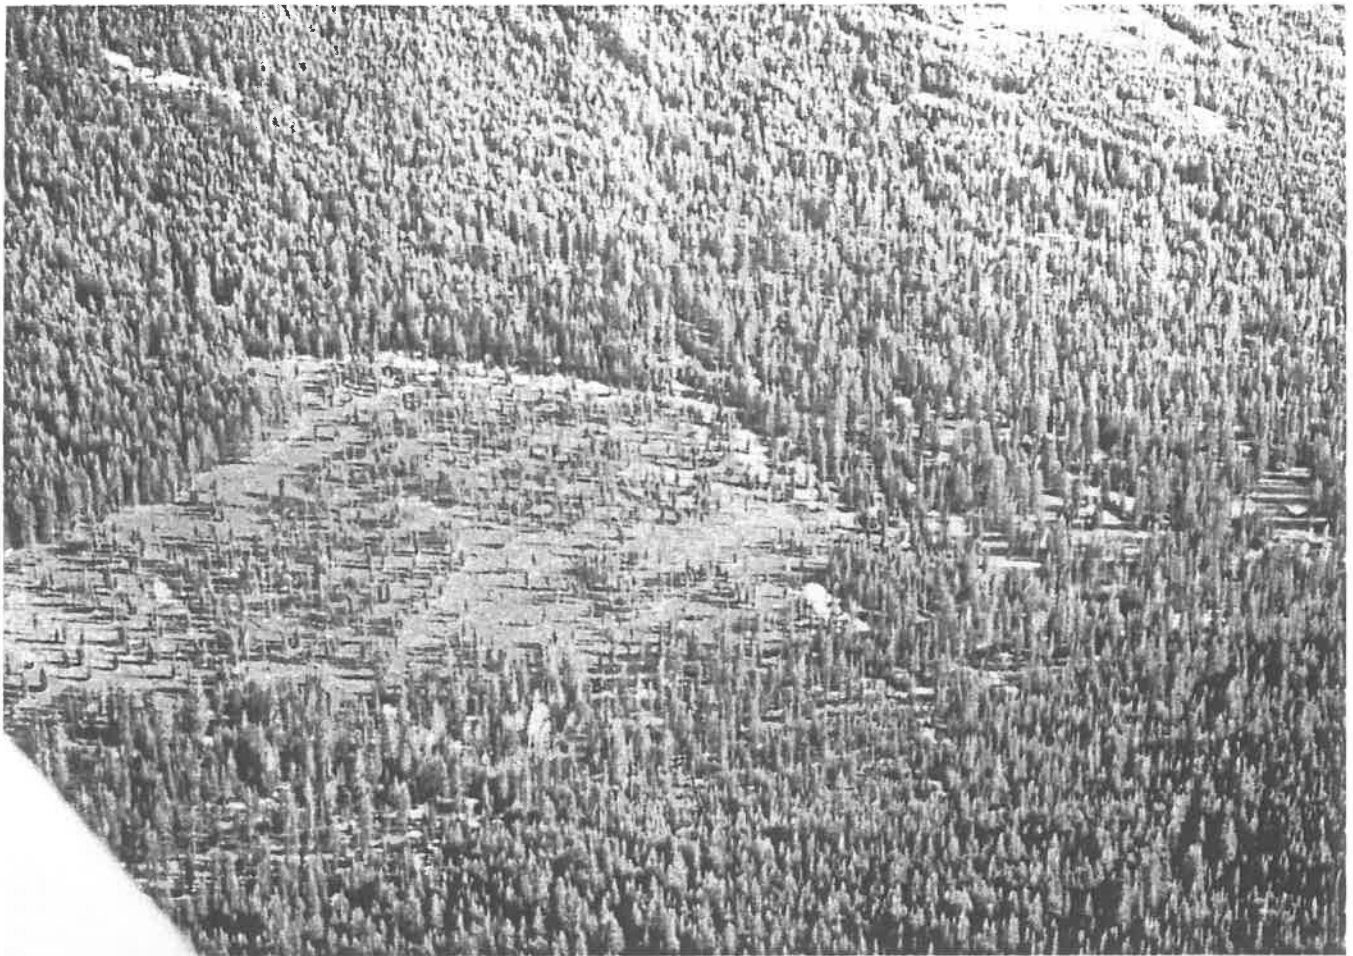
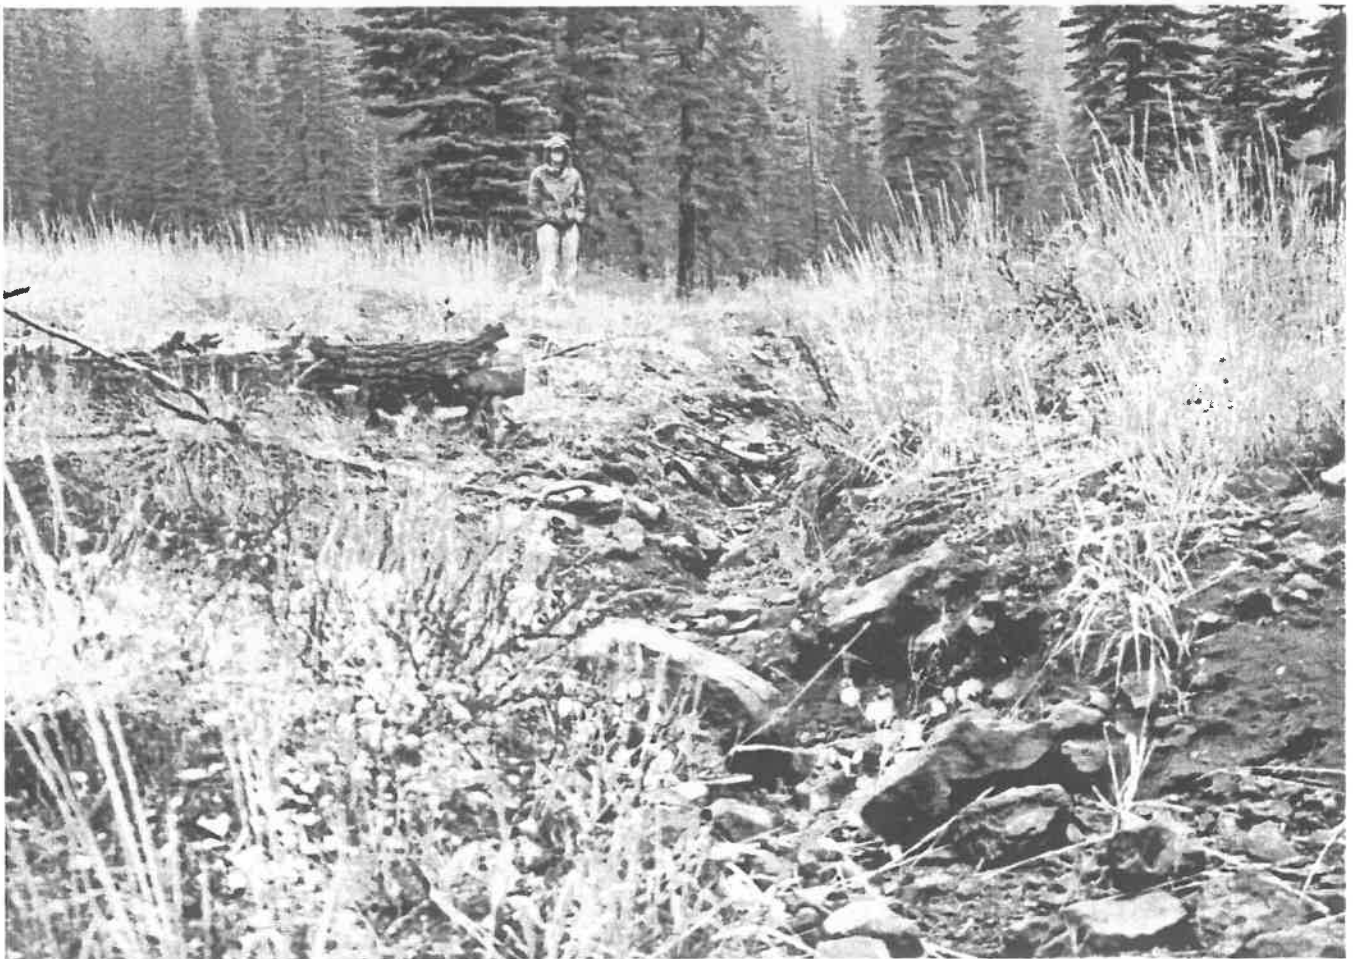
Photo A

Erosion at sites 26N11B-R2.1 and R3 was from the incision of new channels through forest stands that were heavily logged by the Forest Service in the 1980s. Sites 26N11B-R2.1 and R3 are two of the larger road-erosion sites found in the Scotts John Creek watershed and were measured as gullies that flowed through the harvested area between the 26N11 and 26N11B roads. Above both of these sites, old skid-trails concentrate surface and subsurface flow into swales that are bolstered by 360 feet of contributing ditch. These new channels are about 1,500 feet long, and have an average cross-sectional area ranging from 1 to 1 ½ feet² (see Photo A).

Concentrated flow from the inboard ditch on the upslope road (top edge of harvested area in above photograph) has scoured new channels in the harvested area below the road (lower photo).

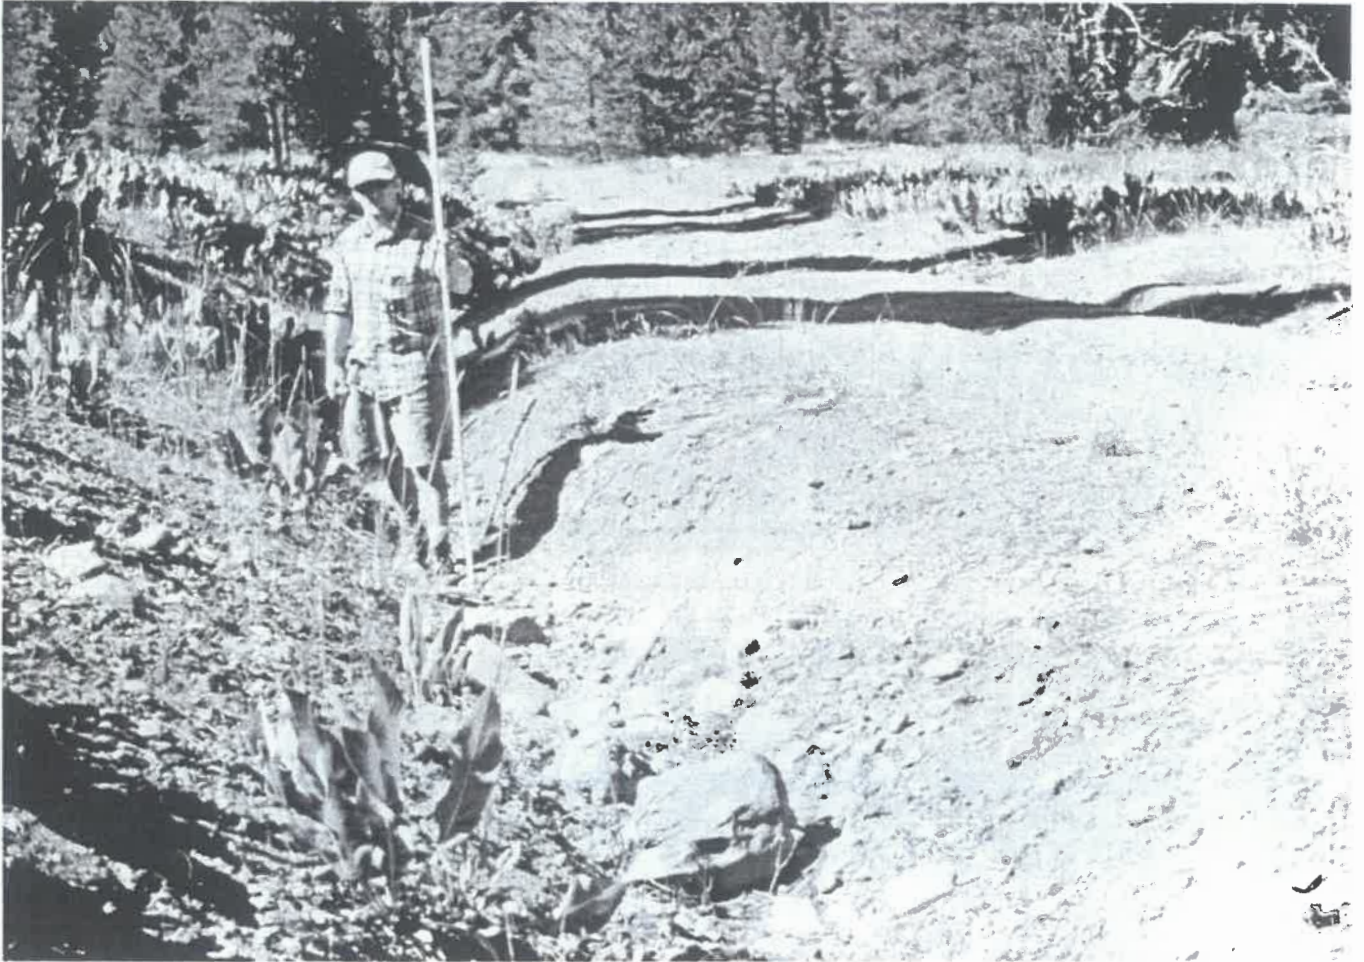
Many of the inboard ditches in the Scotts John Creek watershed are contributing fine sediments directly to streams.

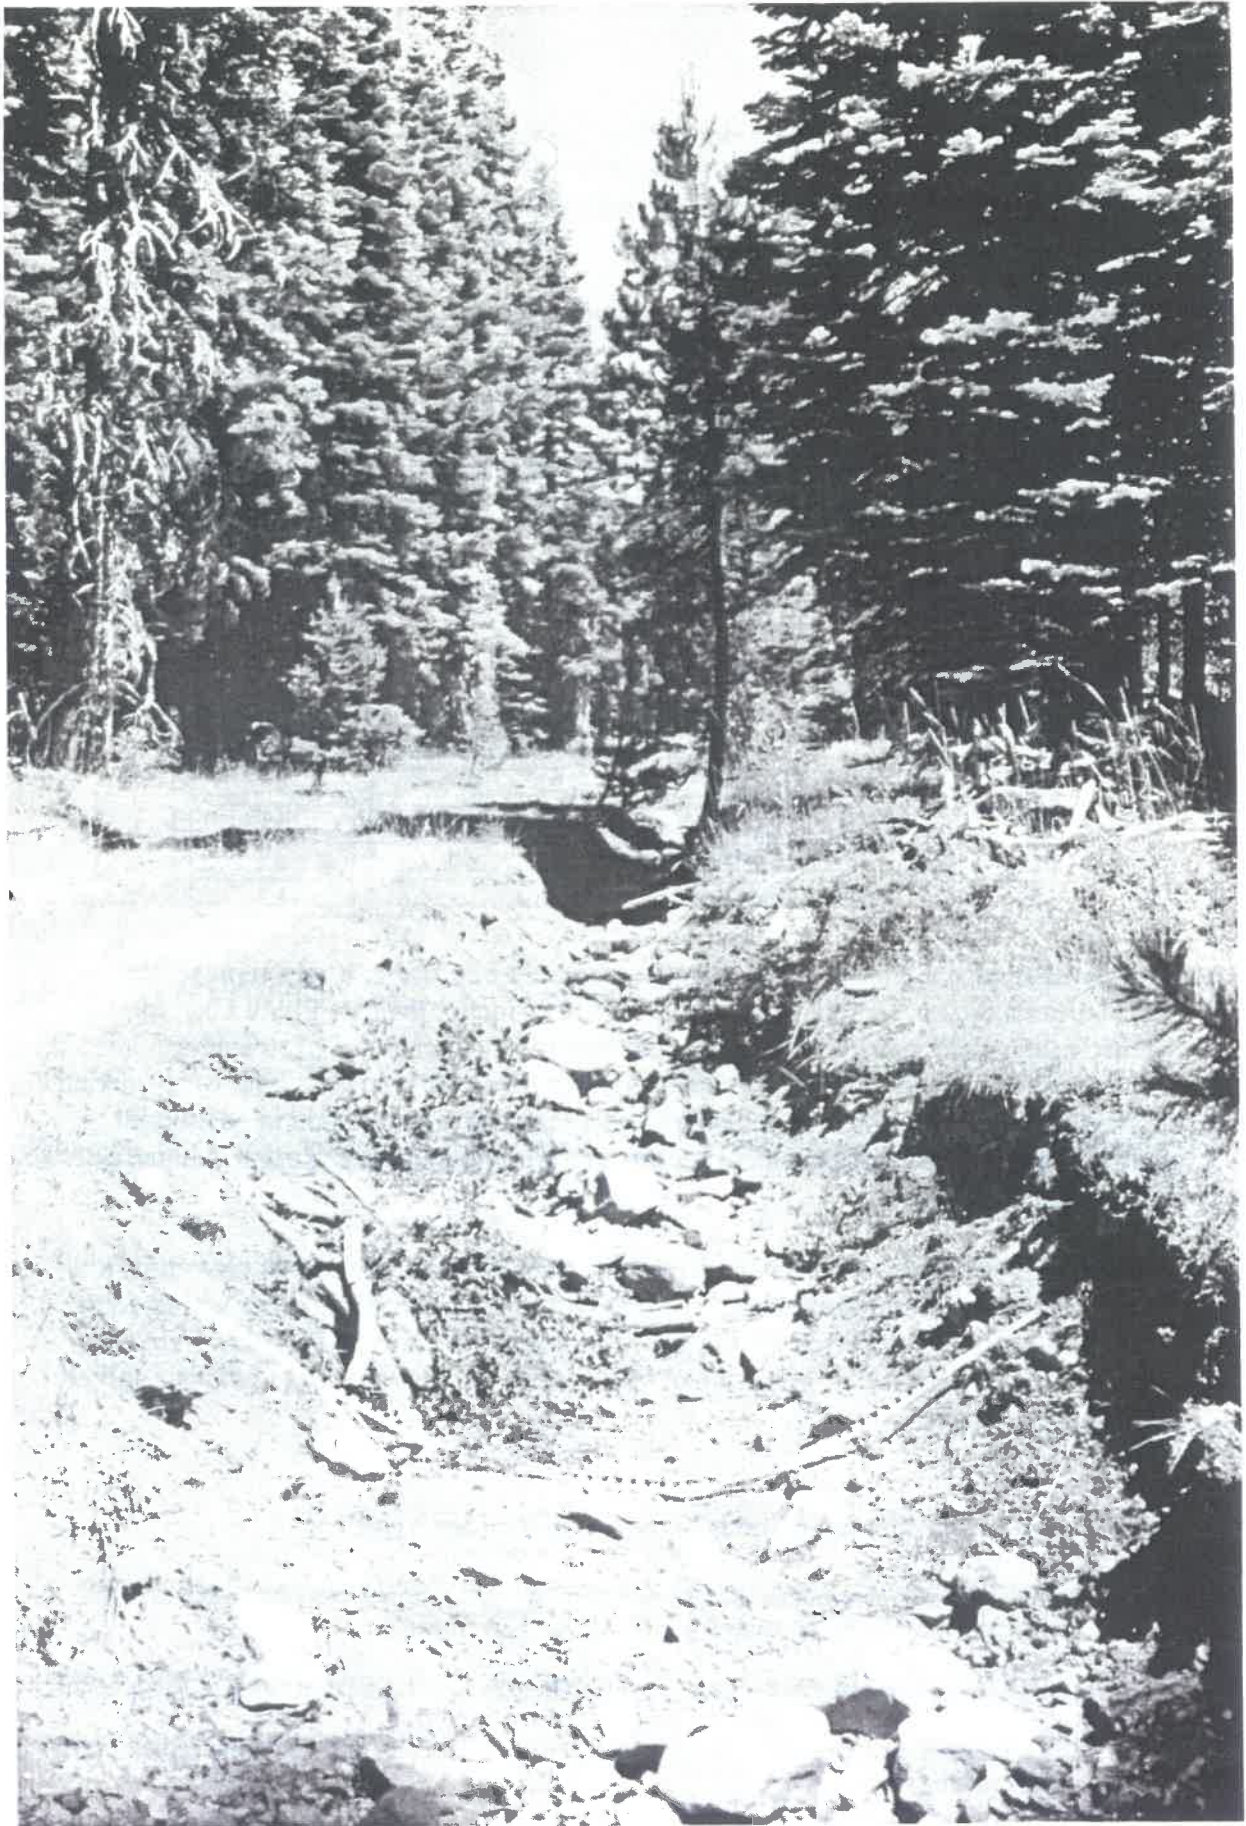
Photo C

While overtopping can be (and frequently is) a *cause* of erosion, it also represents a hazard or an indicator that the crossing is not fully functioning (see Photo C). No specific in-the-field investigation was conducted to assess cause of overtopping. Instead, the site attributes related to the physical processes involved in overtopping were queried to investigate causal mechanisms. Below are a series of queries made in an attempt to identify site attributes that may have caused overtopping of stream crossings in the Scotts John Creek watershed.

Diverted stream crossings (such as this one, on the 26N-27A road) have contributed much of the road-related sediment surveyed within the Scotts John Creek watershed.

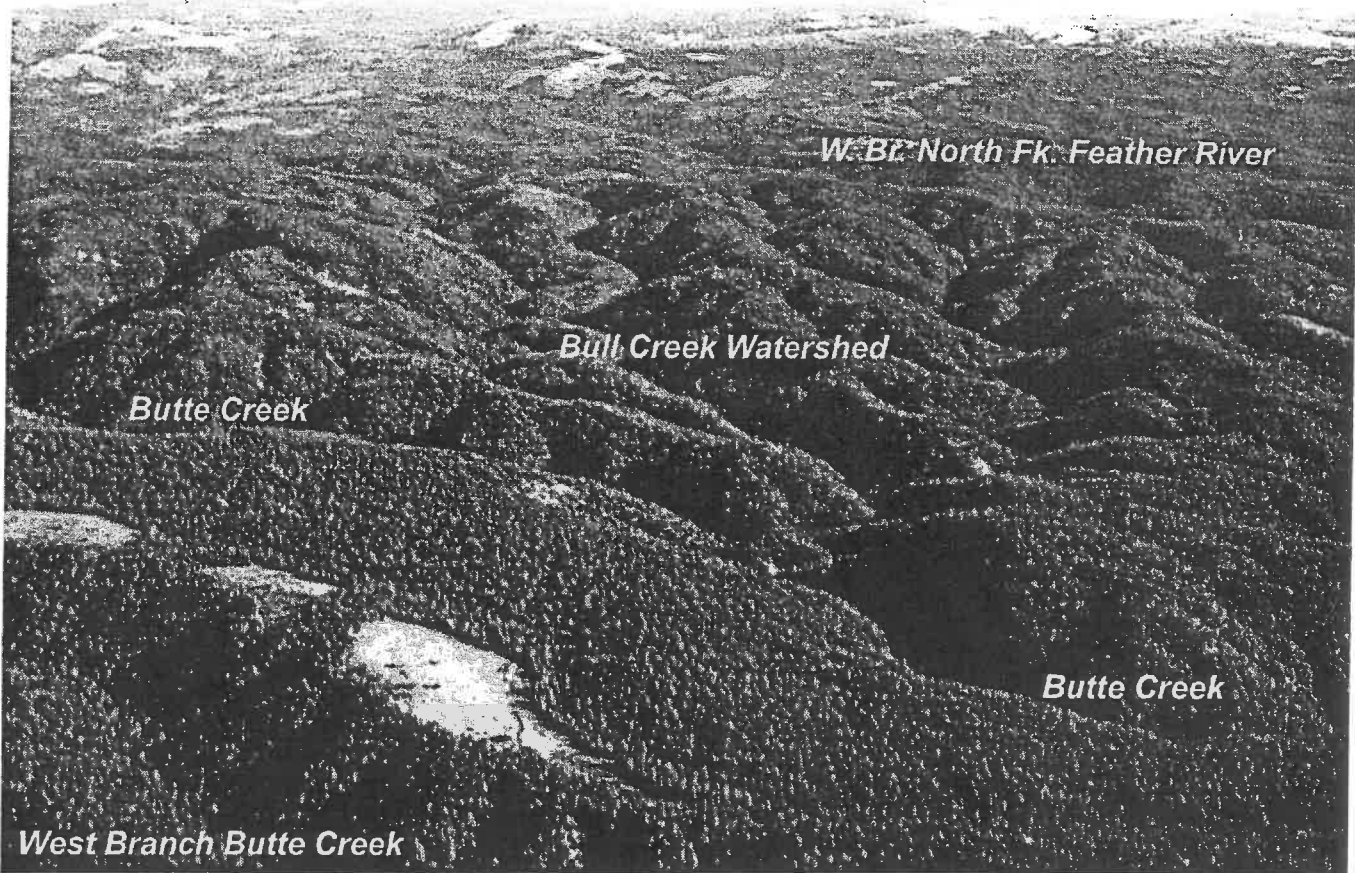
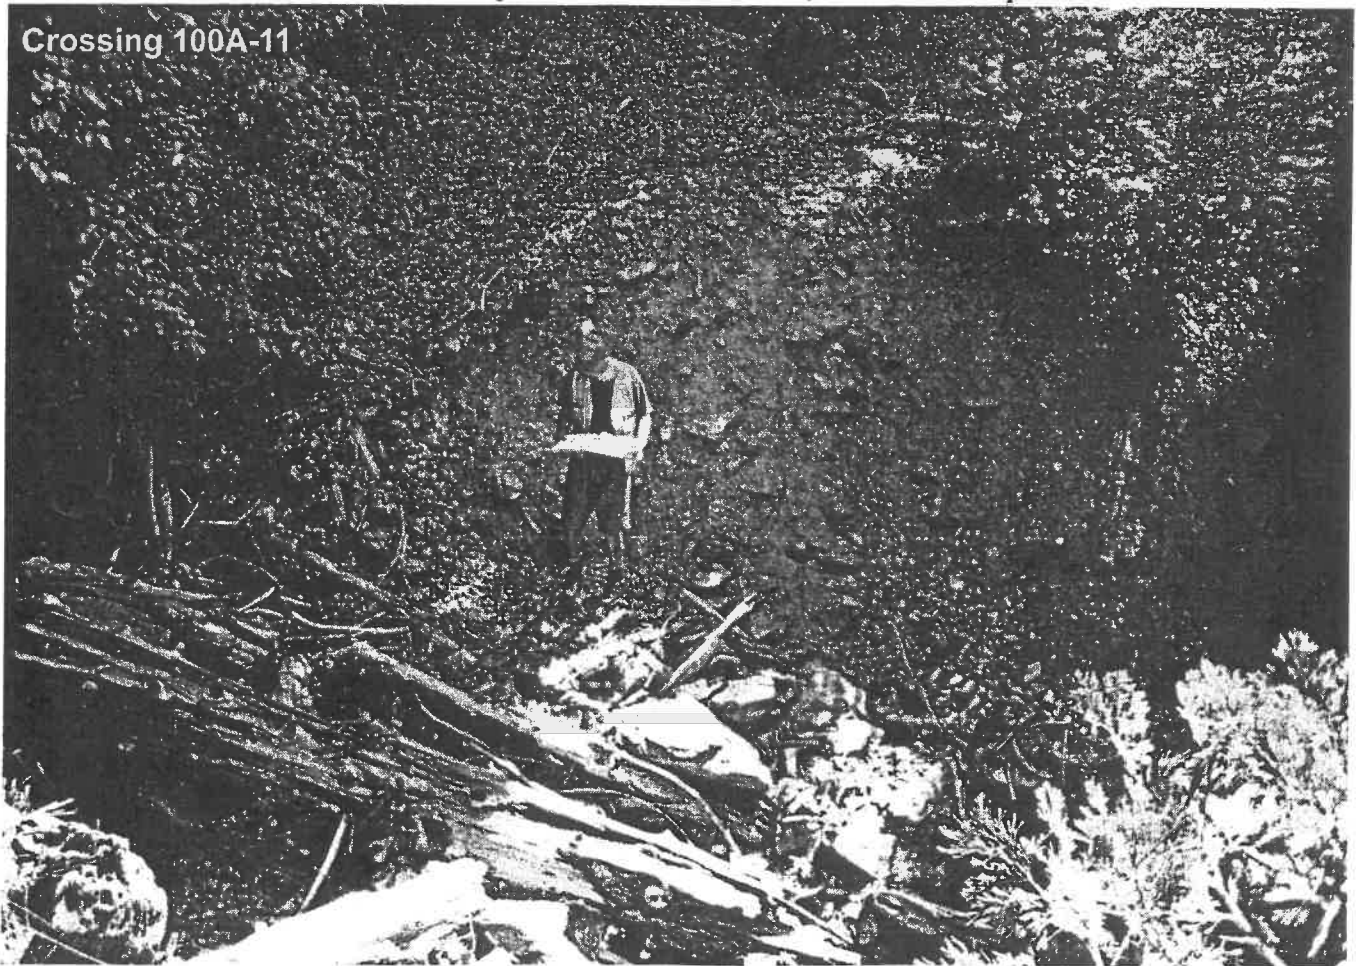
Photo D

In the Bull Creek watershed (shown above), many of the stream crossing sites located on abandoned midslope roads have blown out, as in the example below.

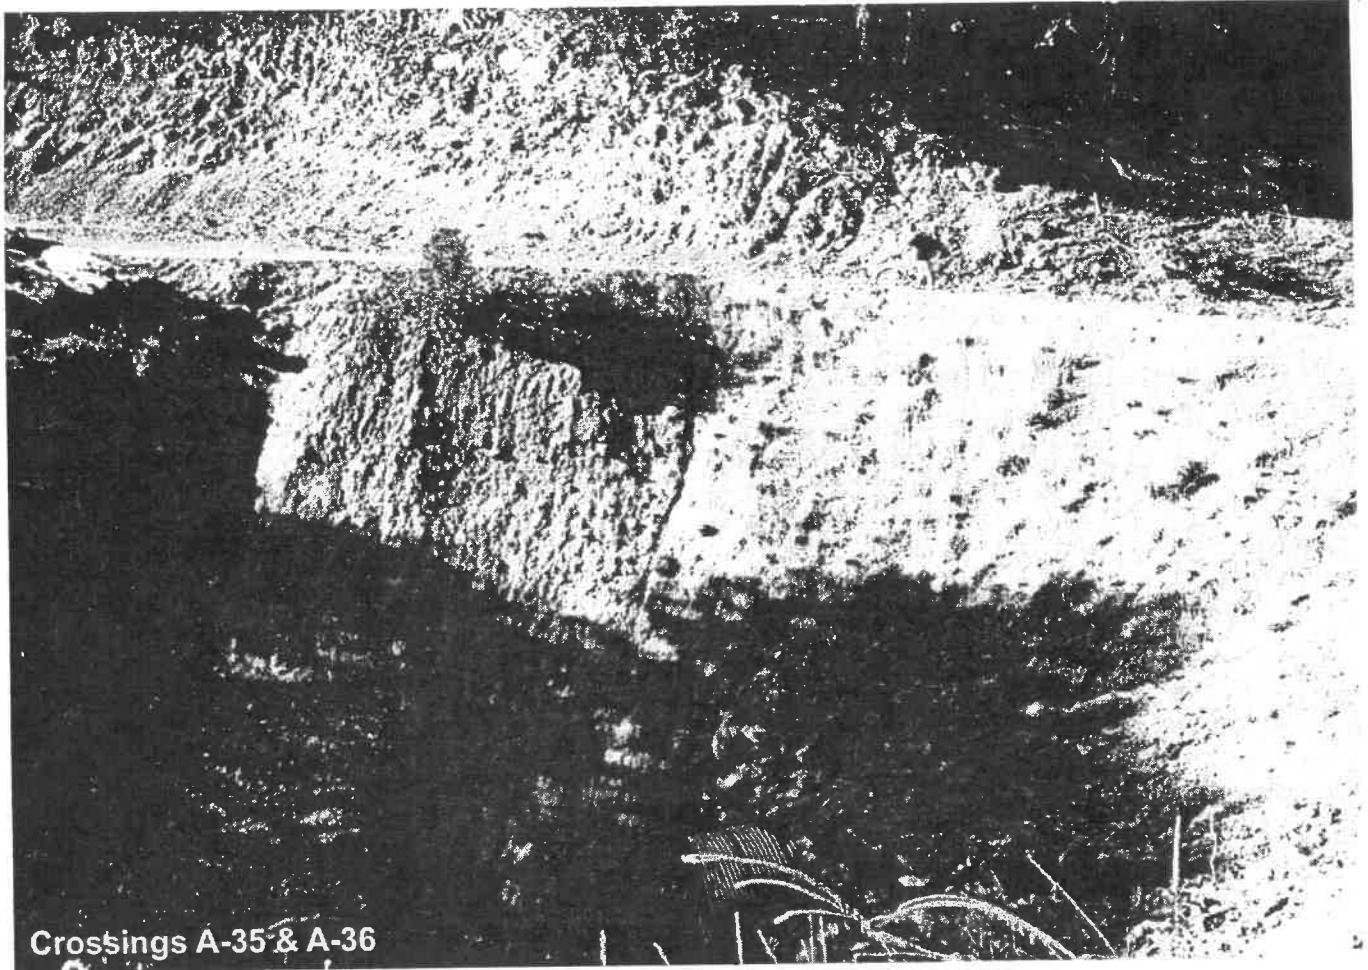
Crossings A-35 & A-36

Two examples of fillslope erosion on the A-Line road in the Secret Creek Basin of the Bull Creek Watershed

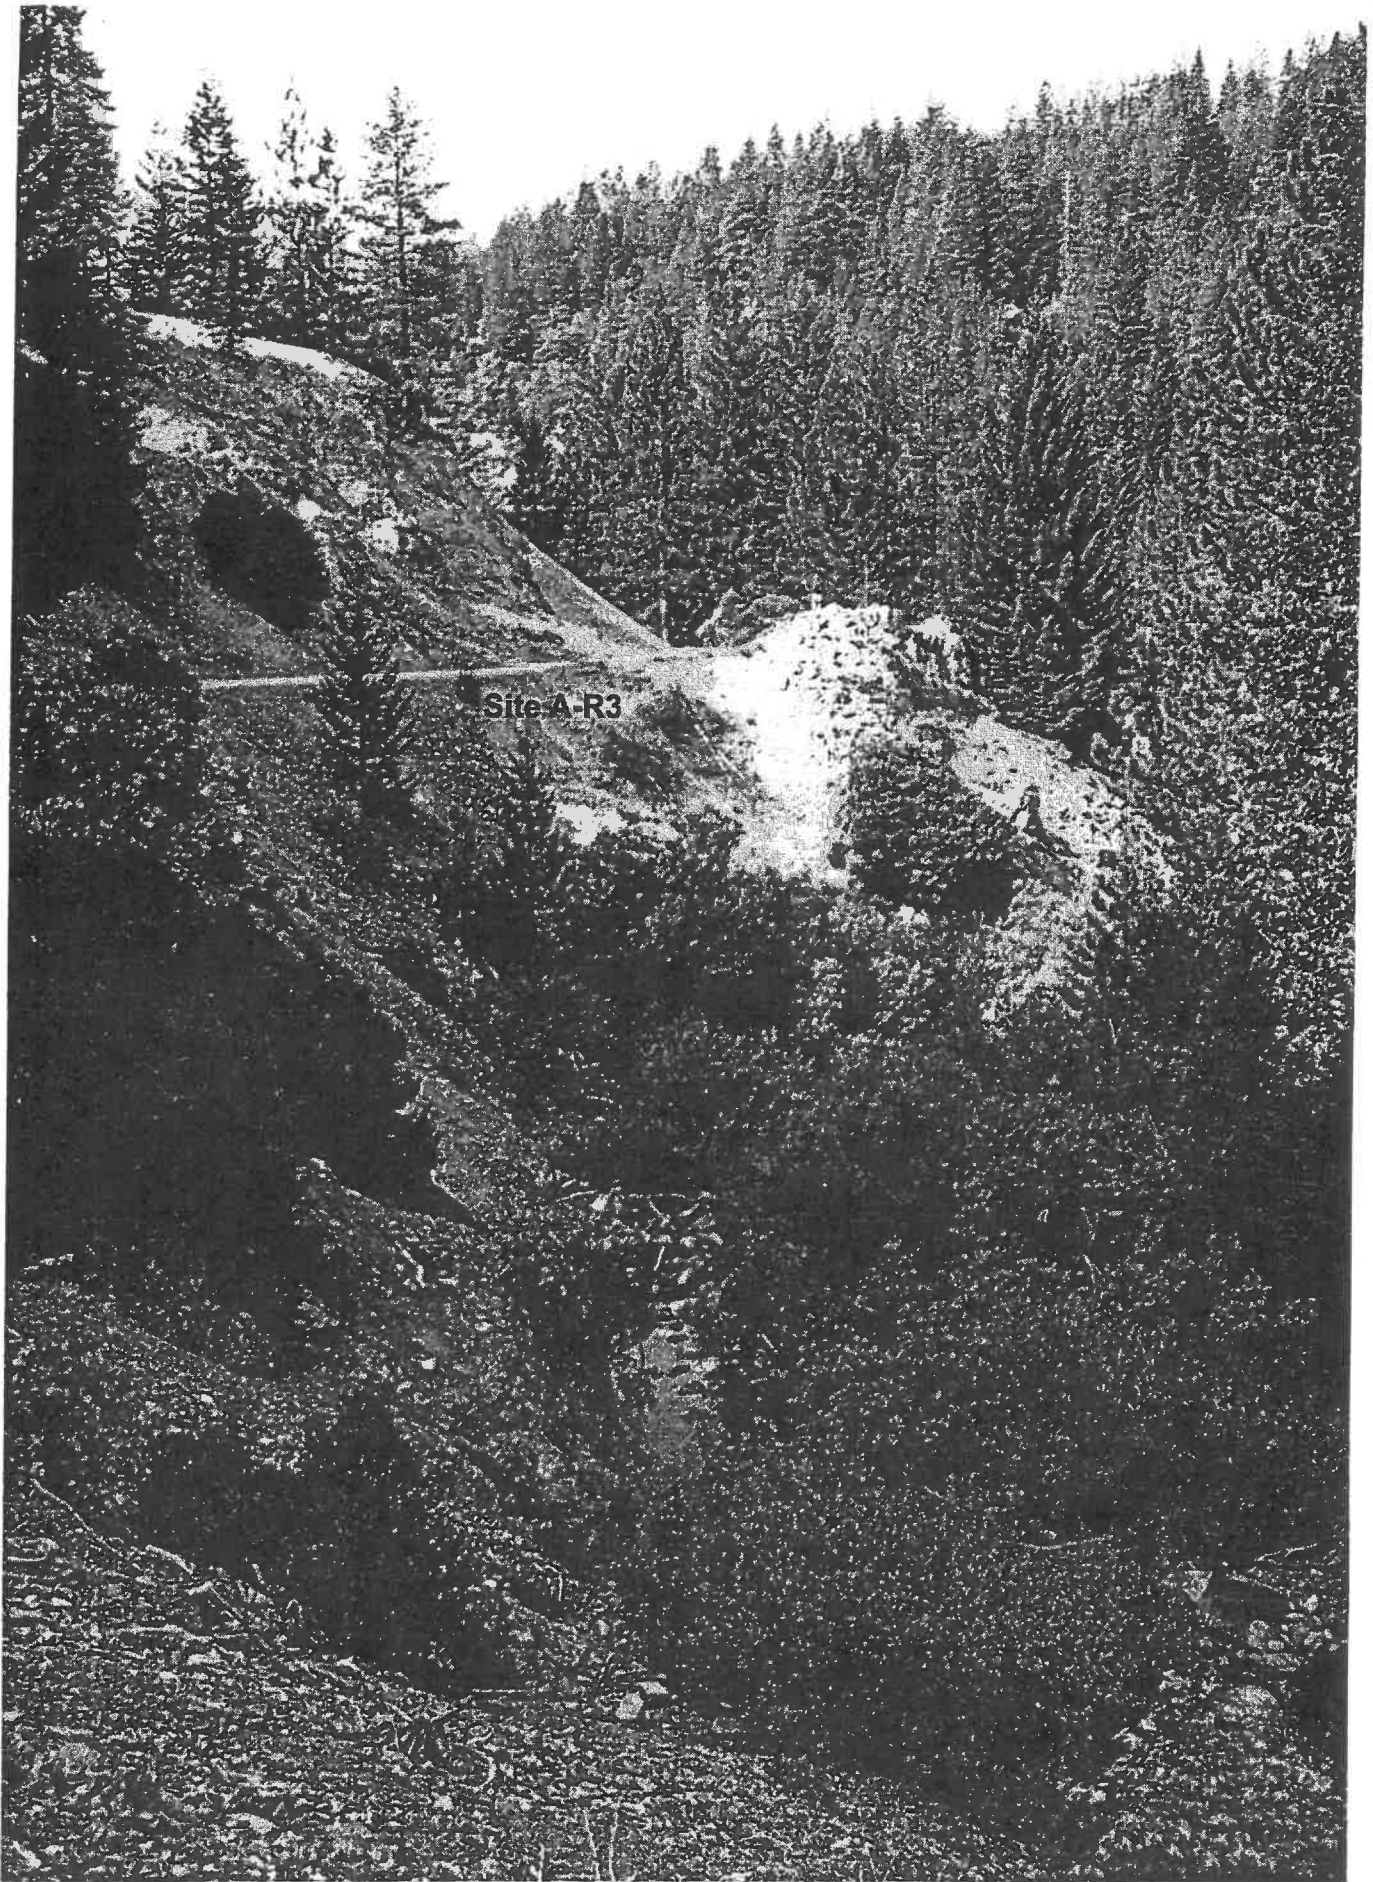
Photo F

Fillslope erosion from the A-Line road in the inner-gorge area
just downstream of the Bull Creek crossing.

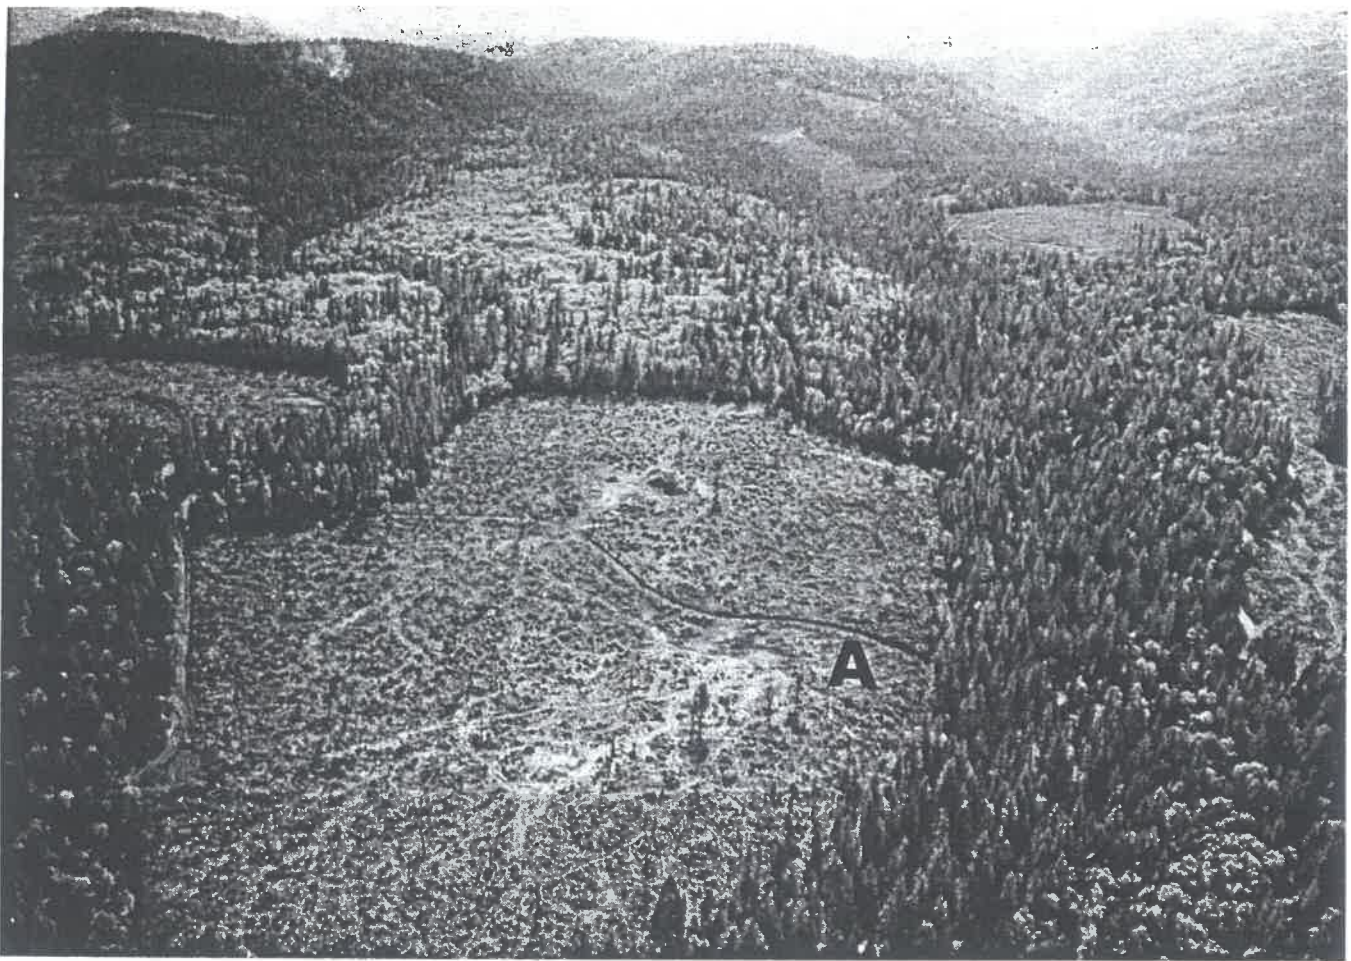
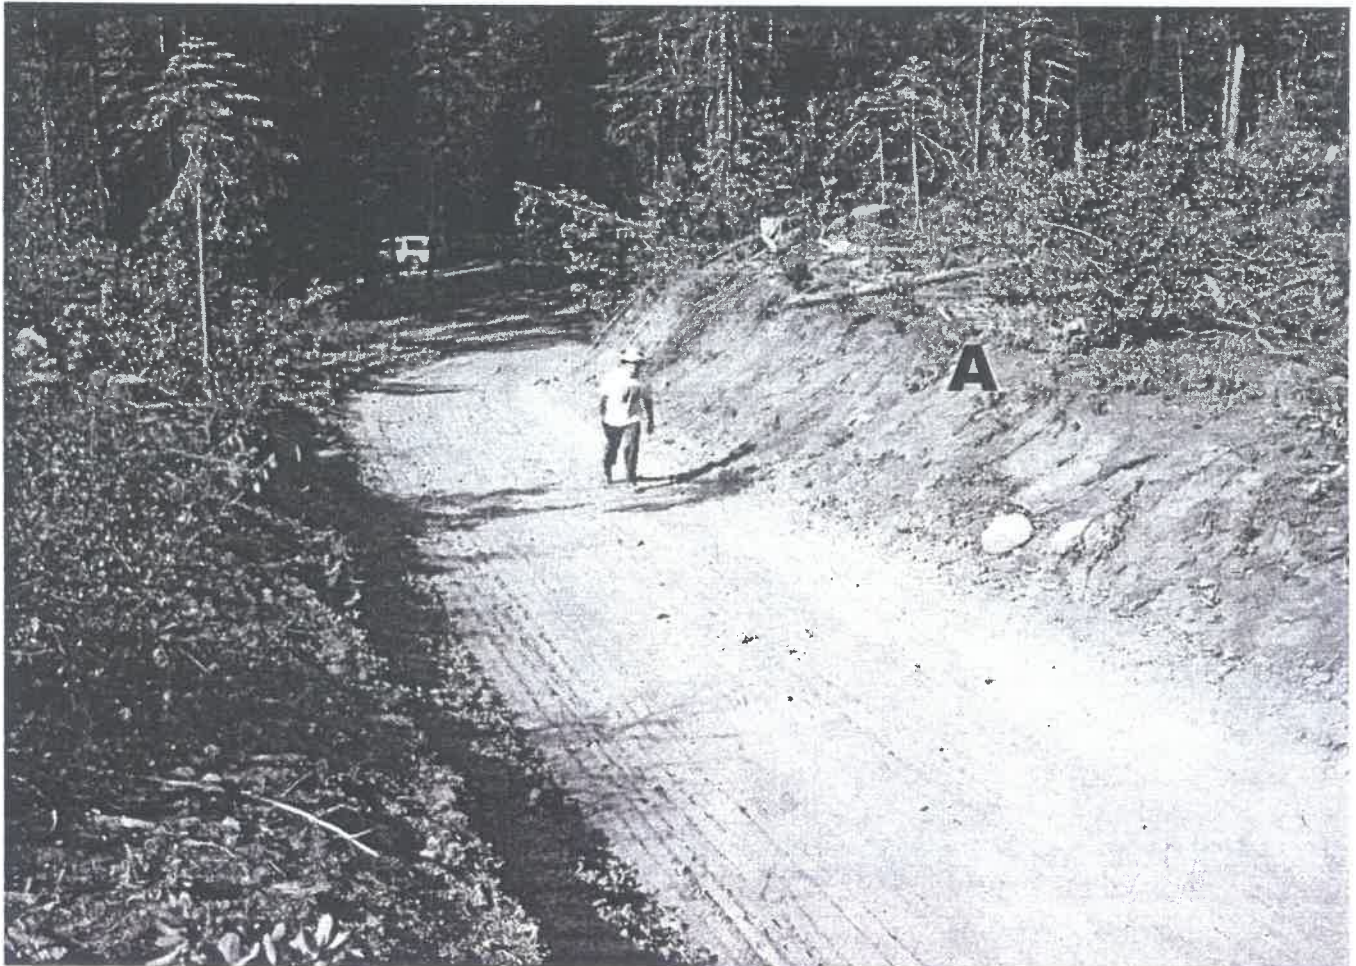
Photo G

The main stream crossing site (80F-1) in Varey Creek's ridgetop area receives fine sediments from approximately 1,100 feet of entrenched roadway. "A" marks same location on the two different photos.

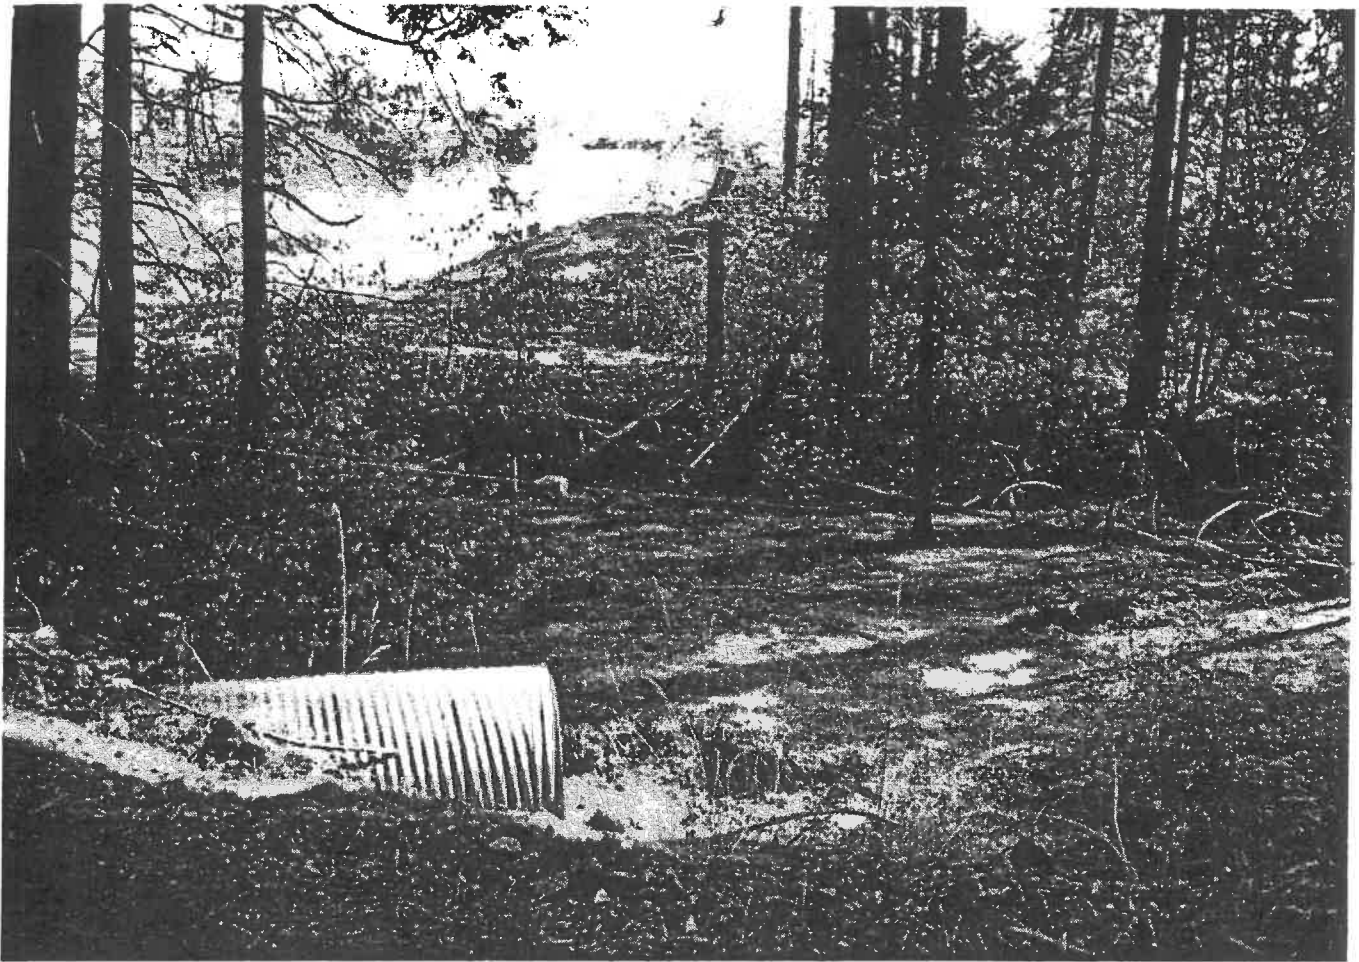
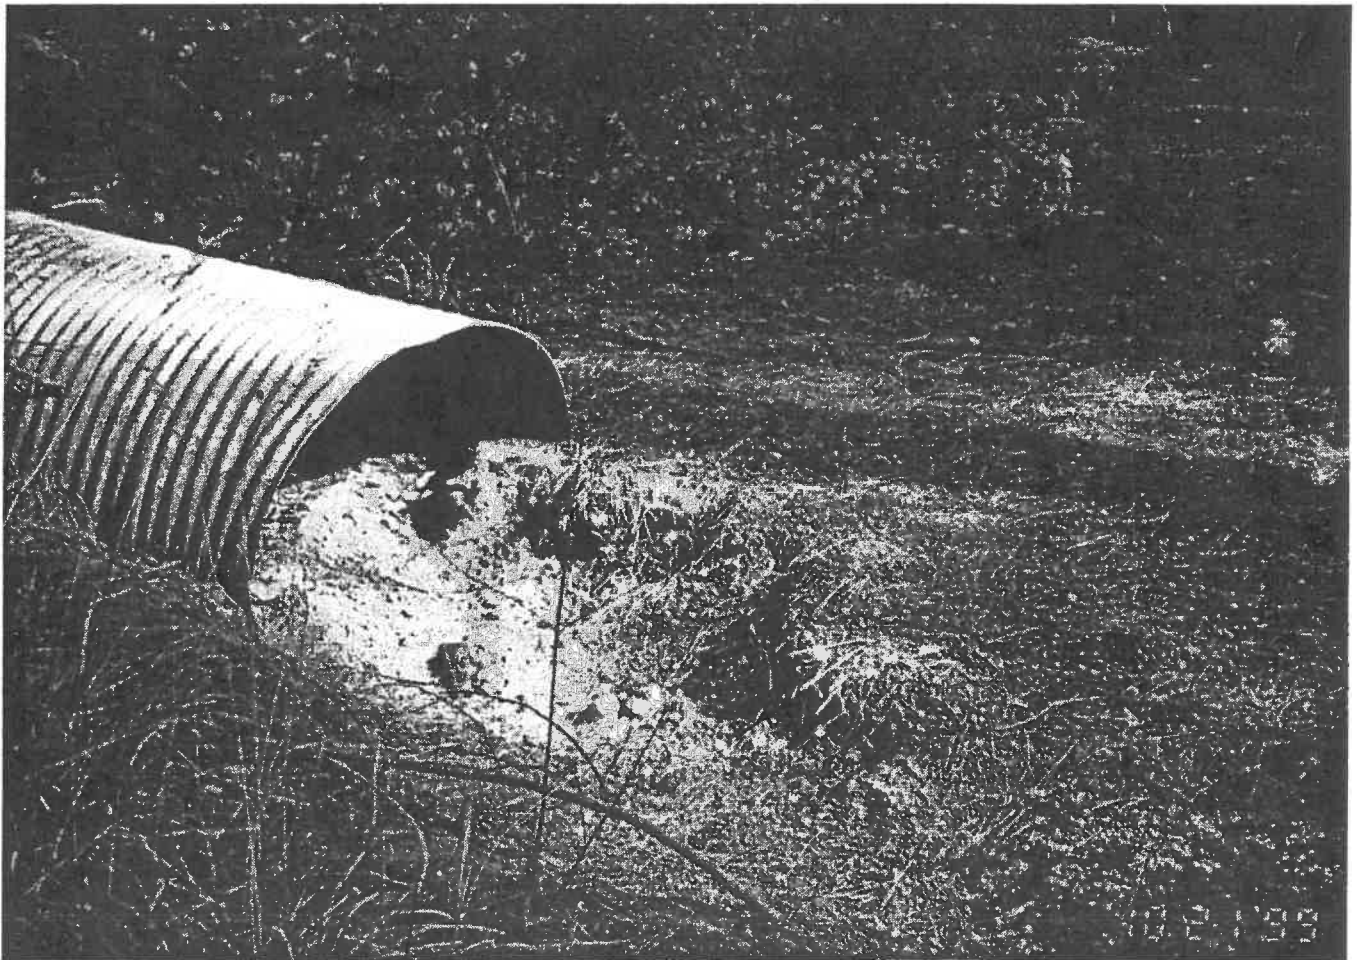
Photo H

The culvert at site 80F-1 suffers from considerable accumulations of fine sediment delivered from over 1000' of entrenched roadway.
