# Geomorphic Assessment of Butte Creek, Butte County, California

Prepared for the Chico State University Research Foundation  
Subcontract S99-024, Fluvial geomorphic study of Butte Creek

February, 2002

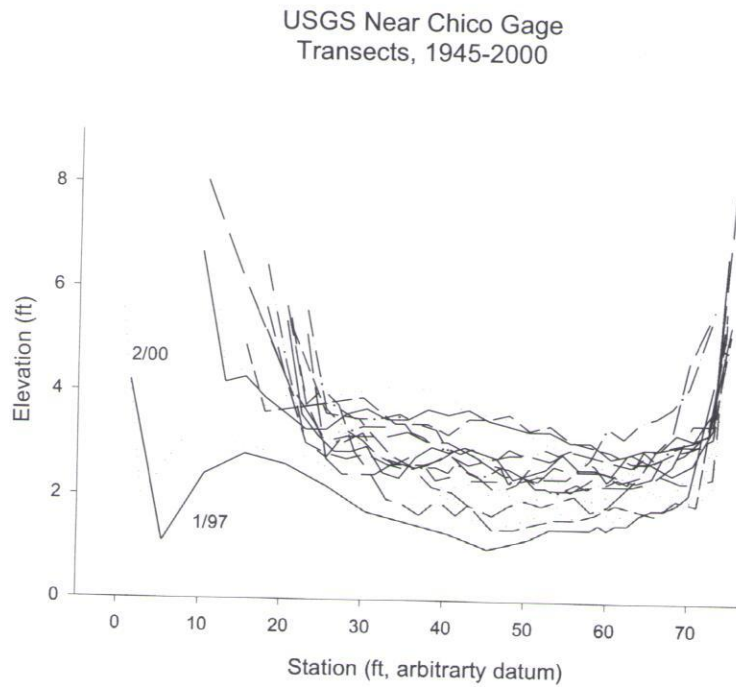
Figure 3-7: Measured transects for the USGS Near Chico gage, for 1945-2000. Note the widening and incision following the January 1997 high water.

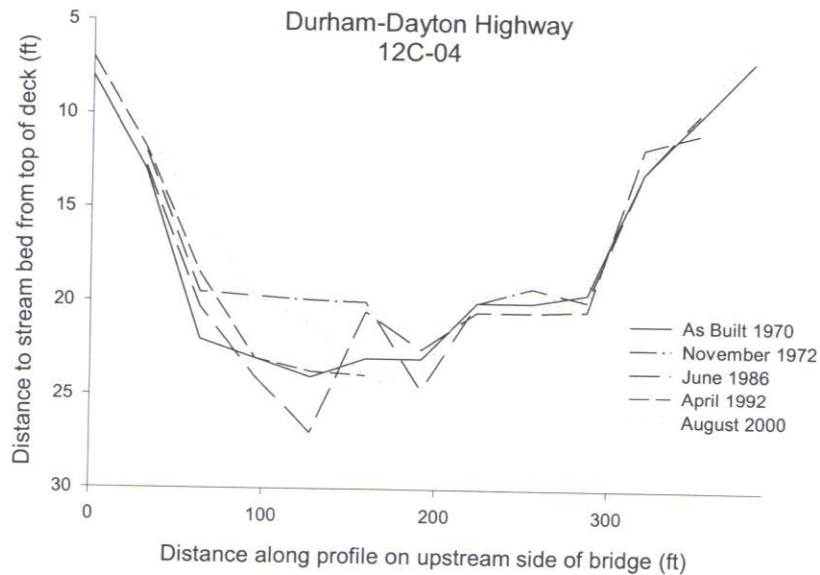
The earliest available profile for the Durham-Dayton Highway Bridge is drawn on the "as built" plans for the bridge, dated January 26, 1970. A profile was measured on November 28, 1972, and shows substantial aggradation on the left side of the channel. A report in 1974 noted that one to three feet of the pile shells were exposed on bents 5 through 11. A flow of 12,600 cfs at the USGS gage occurred in 1974. There was a higher flow (22,000 cfs at the gage) before the next profile was measured in June 1986, and the thalweg moved about 80 feet to the left and incised over two feet. Some aggradation of the thalweg occurred by April 24, 1992, when the next profile was measured, presumably because a check dam was installed just downstream of the bridge after 1986. This profile did not extend over the full width of the channel, so it seems likely that there was not evidence of additional incision or aggradation along the western side of the profile at the time. Our measurements show that the thalweg had moved back toward the center of the channel by 2000, but with little change in bed elevation.

This bridge was damaged in 1986, when one of the columns along the upstream edge was broken off by floating debris, and was further compromised by channel incision. The problem was not undermining the support of the piers, but rather increasing their slenderness ratio (exposed length divided by radius) up to 30%. A report in the CalTrans file by Carlton Brown attributed the incision to removal of a gravel bar downstream from the bridge, and recommended installation a check dam, which was completed in 1988. Another report in 1998 noted that some of the boulders in the check dam were displaced in the 1997 high water, and also noted incision at some piers and aggradation at others.

Figure 3-12: Channel cross section at the Durham-Dayton Highway Bridge from measurements between 1970 and 2000.

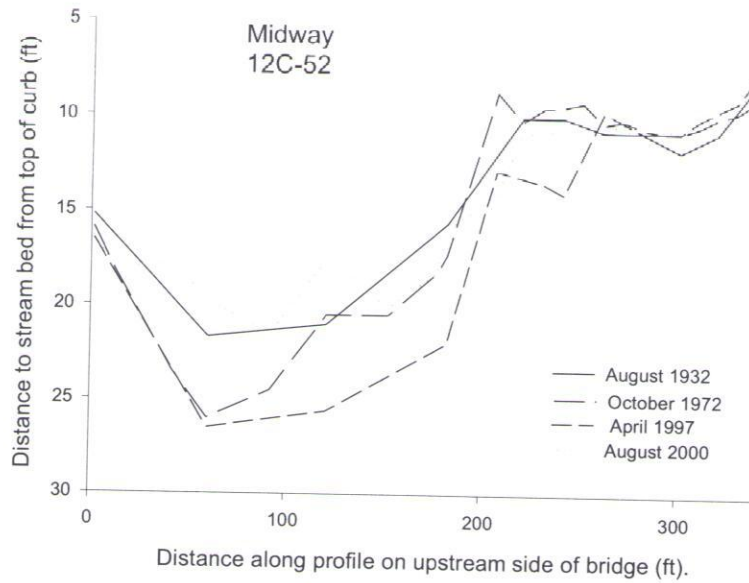
The Midway Bridge was built in 1915. We found measured profiles for August 1932, October 12, 1972, and April 1, 1997, and measured a profile in August 2000. The 1972, 1997, and 2000 profiles were measured along the upstream edge of the bridge, but the 1932 profile was along the bridge centerline and so is not strictly comparable, but is nevertheless revealing given the magnitude of subsequent incision and aggradation.

The general condition of the bridge was described as poor in a 1936 bridge inspection report. A supplemental bent was installed in 1937, but the bridge was nevertheless described as "weak and overstressed throughout." Additional bents were installed in 1940, and load restrictions previously in effect were relaxed. The bridge was transferred to Butte County in 1955, but evidently it was necessary to install temporary bents in the 1970's, presumably in response to the approximately five feet of incision indicated by measurements in 1972. The additional bents must have contributed to the tendency of the bridge to catch floating debris during high flows, as it did in 1986; according to a 1986 report "Recent stream debris has accumulated beneath span 1 and spans 4 through 10, with much scour and erosion present." There was also erosion along the left abutment. More erosion occurred subsequently, on the right side of the channel, probably much of it during the 1997 flood. Concrete blocks or boulders were placed around the piers at various times to protect them from scour, particularly after the high water in 1986 and 1997. According to a 1998 report, "Scour mitigation of Piers 2, 3, and 4 has been completed with the placement of large boulders around the piers and throughout the channel on the upstream side of the bridge." Our measurements in August 2000 show about five feet of aggradation since 1997, presumably because of the boulders. However, these data give only a generalized depiction of the current channel. Murky water was backed up from Gorrill Dam in August, so the channel bottom was not visible. We visited the bridge in January 2001, and could see that there are scattered boulders all across the channel (Figure 3-14), as well as boulders piled around the piers (at ~ 60, 120, and 180 ft on the profile). Our data point at ~ 90 feet probably fell between boulders. Accordingly, the true profile is much more jagged than that shown in the figure, but the loss of channel cross-section and flood conveyance capacity indicated by the figure for the 1997-2000 period probably is reasonably accurate. Under the railroad bridge, which is just upstream from the highway bridge, the thalweg appeared to be about four feet deeper.

Figure 3-13: Channel cross sections at the Midway Bridge from measurements between 1932 and 2000.

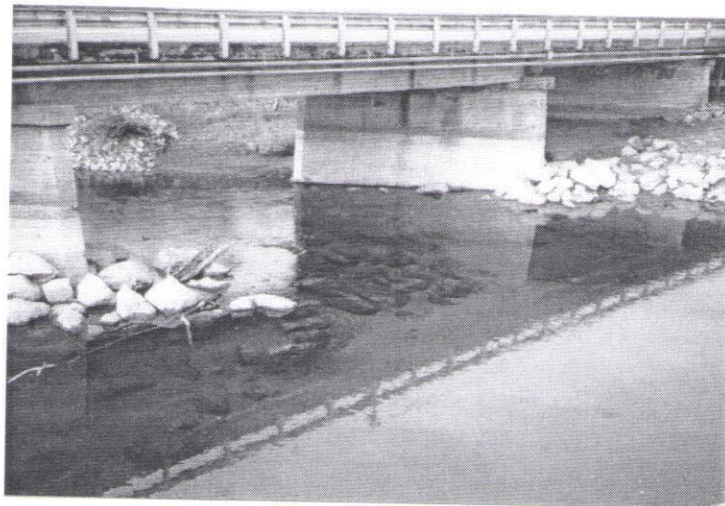
Figure 3-14: Large rip-rap placed around piers under the Midway Bridge after the January 1997 high flow to control scour. (The light surface in the lower right corner is the reflection of the sky.)

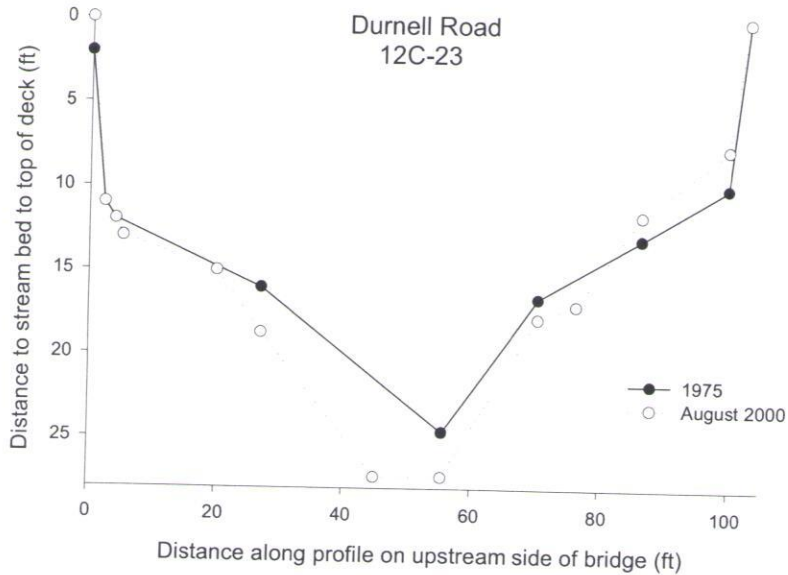
We found one useful profile, dated January 3, 1975, for the Durnell Road Bridge. Our resurvey in 2000 showed over 2.5 feet of incision since 1975..

Figure 3-15: Channel cross section at the Durnell Road Bridge from measurements in 1975 and 2000.

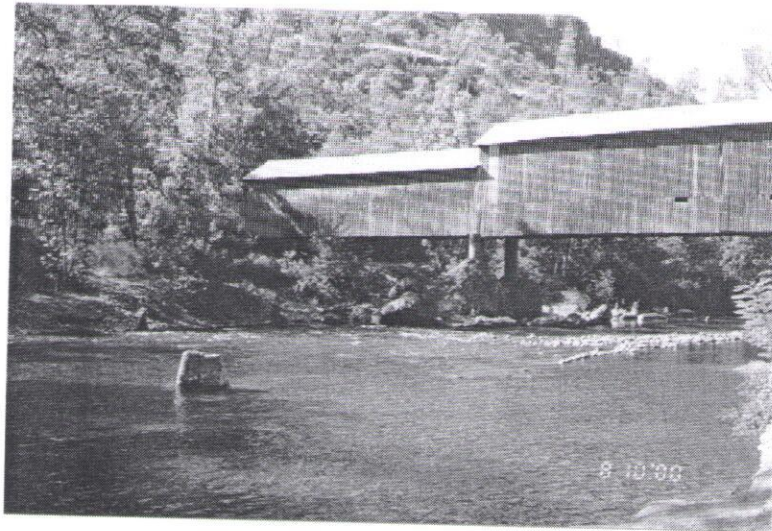
Figure 3-17: Stumps in growth position in the channel of Butte Creek downstream from the Covered Bridge show that the channel has aggraded in this reach. The stream must have been below the elevation of the stumps when the trees were growing.

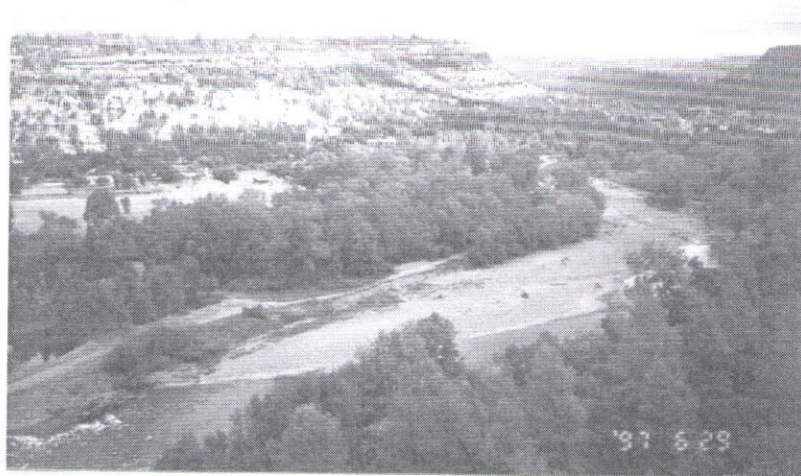
Figure 4-15: View upstream in the lower Butte Creek Canyon. Much of the canyon floor has been dredged for gold and mined for gravel, obliterating any natural terraces or remnant channels. Note the mining pond in the lower left, separated from the creek by the eroding remains of a gravel haul-road (look for the patch of reflected sky just above the road at the edge of the figure).

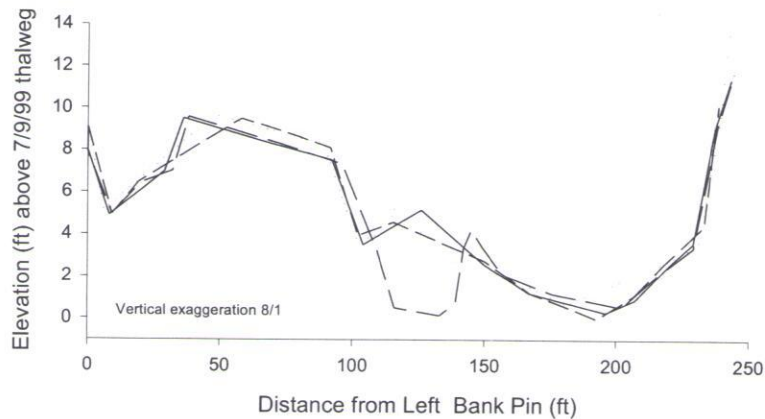
Figure 4-17: Repeated surveys of a transect upstream from the Parrott-Phelan Dam showing rapid re-growth of a gravel bar after material was removed to increase channel capacity: the view is downstream. The lines are: solid 11/98, dotted 7/99, dashed 7/99, dash-dotted 7/00.

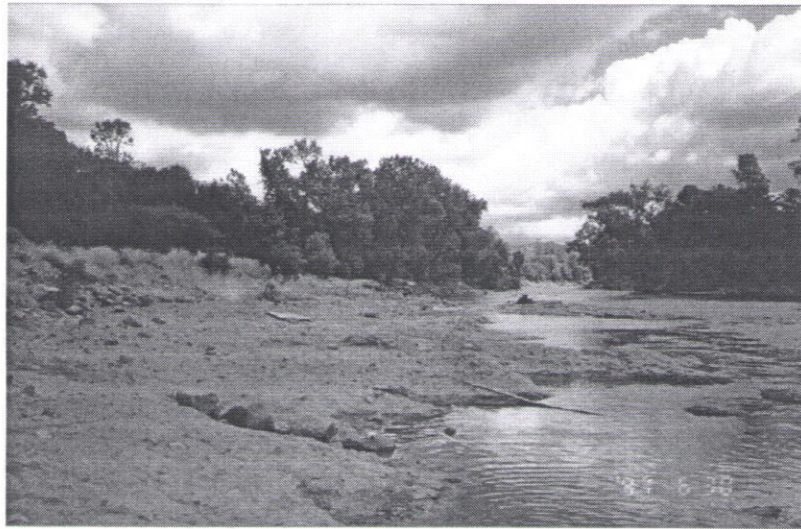
Figure 4-19: Resistant material in the bed limits channel incision in a number of places along Butte Creek, exemplified by this exposure of the Tuscan Formation at Sta. 9,600, about 2,300 feet downstream from the Skyway Bridge. The outcrop is visible near the left edge of Figure 4-18 above.

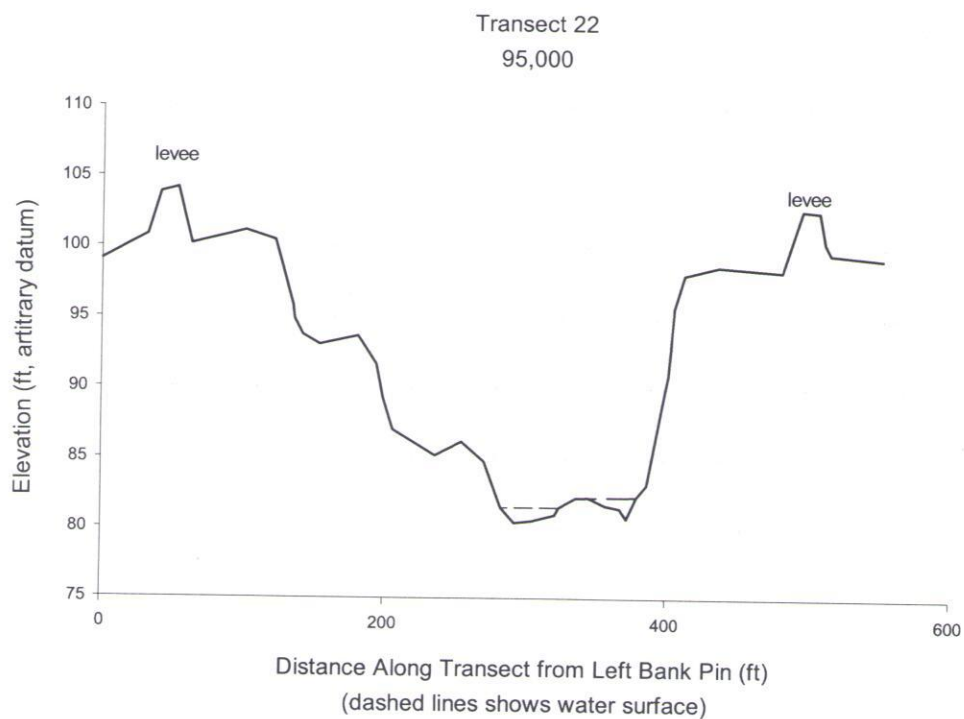
Figure 4-20. Transect across Butte Creek at Sta. 95,000, 1,900 feet downstream from Highway 99; view is downstream. Butte Creek is incised over 15 feet into the Red Bluff Formation at this location, where the low flow at the time of the survey (10/2/99) was spilling across a mid-channel bar.

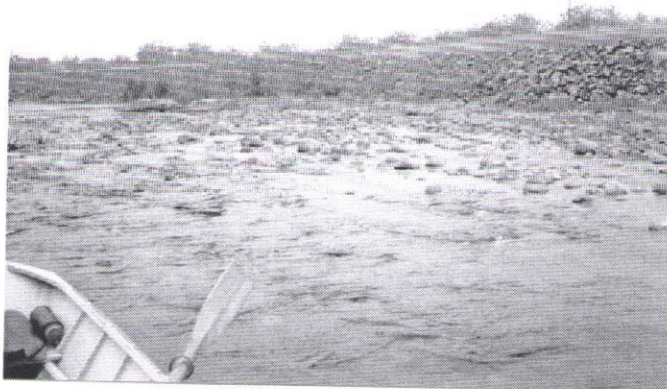
Figure 4-21. Boulders on this bar downstream from Highway 99 indicate the high shear stresses that occur during high flows in this incised and leveed reach.

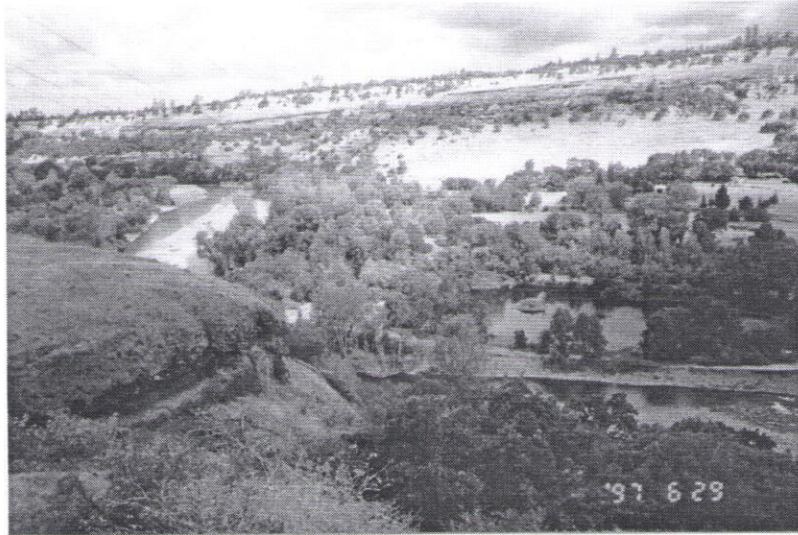
Figure 5-3: The mining pond along the right bank of Butte Creek in the Canyon Reach, in the right-center of the photograph, is now separated from the creek only by a narrow berm that shows clear signs of erosion.
