Cursory Assessment of the Butte Creek Ecological Preserve

January 2007

Butte Creek Ecological Preserve Assessment

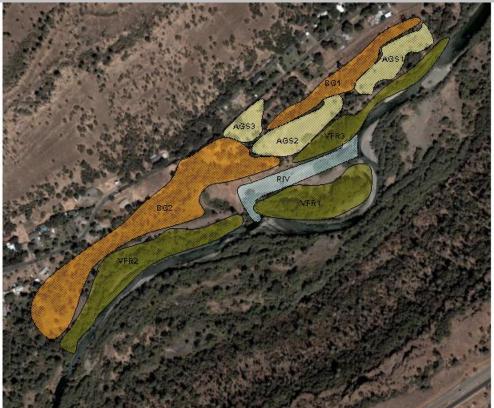
As stated previously, the vegetation communities at the BCER include valley foothill riparian, blue oak-gray pine, annual grassland and riverine habitats. Figure 3 below provides a general reference to the extent of these communities within the areas of the preserve visited for this assessment.

Figure 3. Shaded areas represent major vegetation communities and areas discussed in this assessment. BG = Blue Oak-Grey Pine, VFR = Valley Foothill Riparian, RIV = Riverine, AGS = Annual Grassland.

During one visit to the preserve, mountain lion (*Felis concolor*) scat and tracks were located between areas AGS1 and AGS2 identified in figure 3. Also, within AGS1 an older pile of black bear scat (*Ursus americanus*) was observed. The mountain lion scat

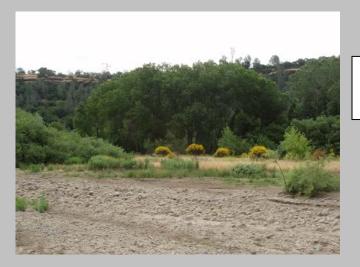
Often, the vegetation that has become established in disturbed or embedded soils is dominated by non-native species such as Spanish broom (*Spartium junceum*), yellow star thistle (*Centaurea solstitialis*) and Himalayan blackberry (*Rubus discolor*). Invasive species including Himalaya blackberry (*Rubus discolor*), vinca (*Vinca sp.*), cocklebur (*Xanthium spinosum*), yellow star thistle (*Centauria solstitialis*) and Spanish broom are present throughout the preserve. In many locations monotypic stands of these plants dominate the understory of the riparian forest. Patches of native species including Santa Barbara sedge (*Carex barbarae*), mugwort (*Artemesia douglasiana*) and others, which persist in isolated patches among the invasive plants.

Figure 4. Spanish Broom growing along the floodplain of Butte Creek

The existing weed management practices do not appear focused. Piles of pulled weeds were observed along the overflow channel. The primary vegetation within these weed piles was grasses and forbs. It appears that there are some threats existent from major invasive species such as Spanish broom, which are being overlooked. Many of the grasses and forbs within the observed weed piles are nearly naturalized into the annual grassland ecosystem. Development of a weed management program with specific management plans and direction would greatly increase the success of invasive species eradication. Some of the management tools could include hand pulling, the use of goats or other livestock, mechanical, chemical, or prescribed fire treatments. In addition to eradication of invasive species, proactive measures to ensure invasive seed introduction does not occur. Some measures to minimize introductions might include interpretive signage for visitors to make them aware of invasive species identification and impacts, and the development of a protocol to request shoes and clothing be cleaned of seeds prior to entering the preserve.

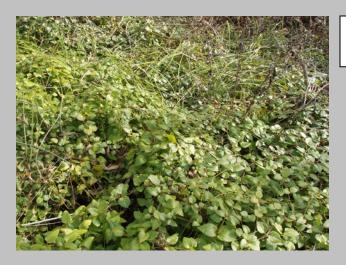
Figure 5. Vinca competing with Santa Barbara sedge.

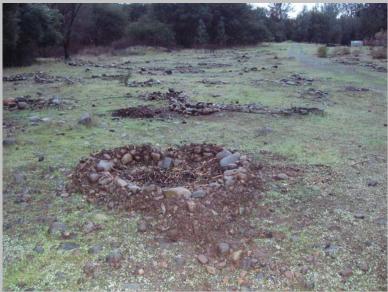
Figure 6. Mounding of rocks around plantings in annual grasslands.

The upland restoration activities occurring within the areas dominated by annual grasslands east of the "native plant garden" (see AGS2 in figure 2) could include more plantings of naturally occurring and successful species within these areas such as yerba santa (*Eriodictyon californicum*), gum plant (*Grindelia robusta*) and buckwheat (*Eriogonum* sp.). The plantings within this area include native bunchgrasses (primarily deer grass [*Muhlenbergia rigens*]), Juncus (*Juncus* sp.), blue oak (*Quercus douglasii*) and valley oak (*Q. lobata*) seedlings, Mexican elderberry, California poppy (*Eschscholzia californica*), and Penstemon (*Penstemon* sp.). The mounding of rocks around the planted vegetation gives an appearance of a horticultural landscape (see figure 6). Restoration activities should be ecologically appropriate and should facilitate the natural processes (such as fire and flooding), which support the existence of vegetation communities within the preserve.
