# Geomorphic Assessment of Butte Creek, Butte County, California

Prepared for the Chico State University Research Foundation  
Subcontract S99-024, Fluvial geomorphic study of Butte Creek

February, 2002

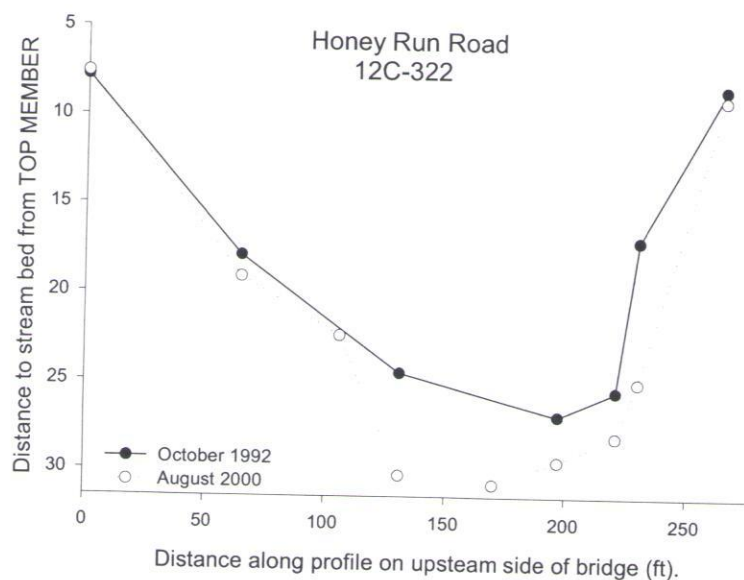
The Honey Run Road Bridge (12C-322) was built 1965 and has three 65 ft spans. A report from 1986 notes erosion on right abutment, but notes accompanying measurements in 1992 indicate no scour. Significant scour was reported in an April 1997 report, which is consistent with the scour reported at the gaging station a short distance downstream. Our measurements in 2000 show up to seven feet of incision since 1992.

Figure 3-10: Channel cross section at the Honey Run Road Bridge from measurements in 1992 and 2000.

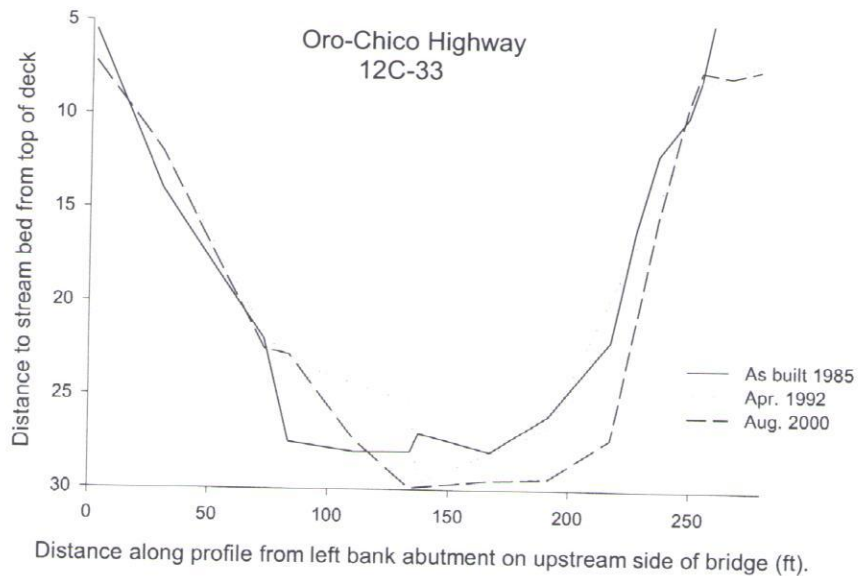
The existing bridge for the Oro-Chico Highway was constructed in 1986, and data on the previous bridge have been lost. Profiles are available from the "as built" plans and from measurements in 1992 and 2000, and indicate several feet of incision on the right side of the channel, mostly occurring between 1992 and 2000. The bridge has two piers, each 85 feet from the abutments, and 108 feet apart, so the bridge is well designed in terms of passing woody debris. The Butte Creek channel is confined within resistant banks of the Redbluff Formation in this area.

Figure 3-11: Channel cross section at the Oro-Chico Highway Bridge from measurements in 1985, 1992 and 2000.

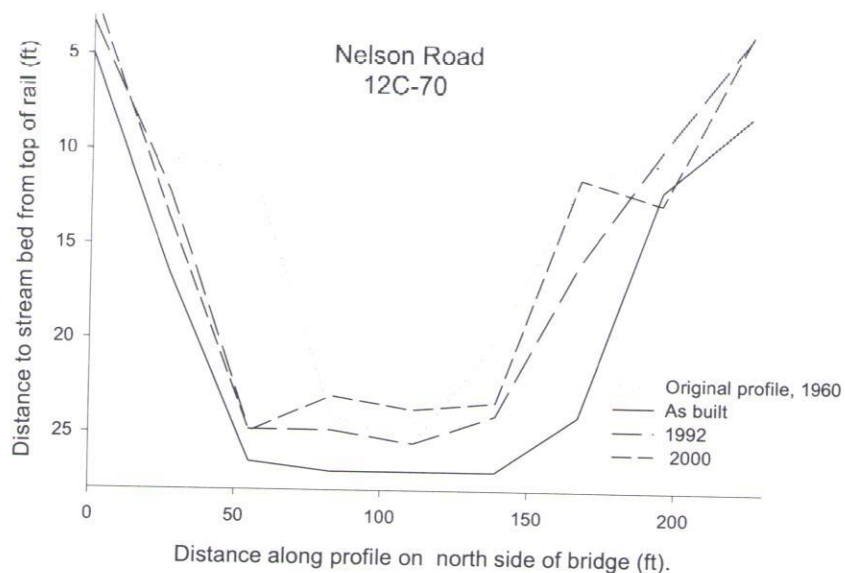
The Nelson Road Bridge was constructed in 1960. The as-built plan shows an "original ground" profile, as well the finished profile, showing that the channel was significantly enlarged and deepened during bridge construction. The 1992 profile shows about two feet of aggradation of the thalweg and considerable narrowing of the channel. Our resurvey in 2000 showed additional narrowing and about two additional feet of aggradation across most of the bed, although the thalweg aggraded only 0.6 feet. The dominant change appears to be adjustment back toward the 1960 channel, especially along the right bank.

Figure 3-16: Channel cross section at the Nelson Road Bridge from measurements between 1960 and 2000.

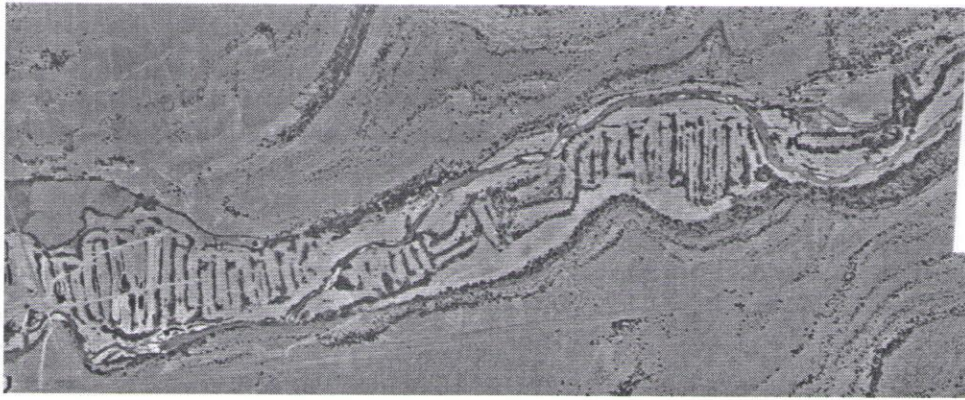
This reach of stream has been the most influenced by gold dredging and gravel mining, as shown by the extensive areas of dredger tailings shown in historical Aerial photography and on the USGS topographic maps (Chico and Hamlin Canyon quadrangles). Dredges move across the landscape on a pond of their own creation. As the head of the dredge chews into the floodplain, the tail end of the dredge discharges the larger cobbles and gravel into piles of "tailings" at the other end of the pond. In this way, the dredge works the pond across the floodplain, leaving the characteristic series of elongated piles seen in Figure 4-14. The finer sediments are sluiced for gold within the dredge and discharged into the pond, where they settle to the bottom, to be covered later by the tailing piles as the dredge moves along. As a result, the alluvium is inverted; the soil and fine-grained sediments normally at the surface and interspersed through the alluvial sediments are buried, leaving barren piles of relatively uniform cobble across the landscape.

Figure 4-14: The floodplain of the Lower Canyon Reach was extensively mined by dredges, as shown by this 1952 aerial photograph. Flow is from right to left.

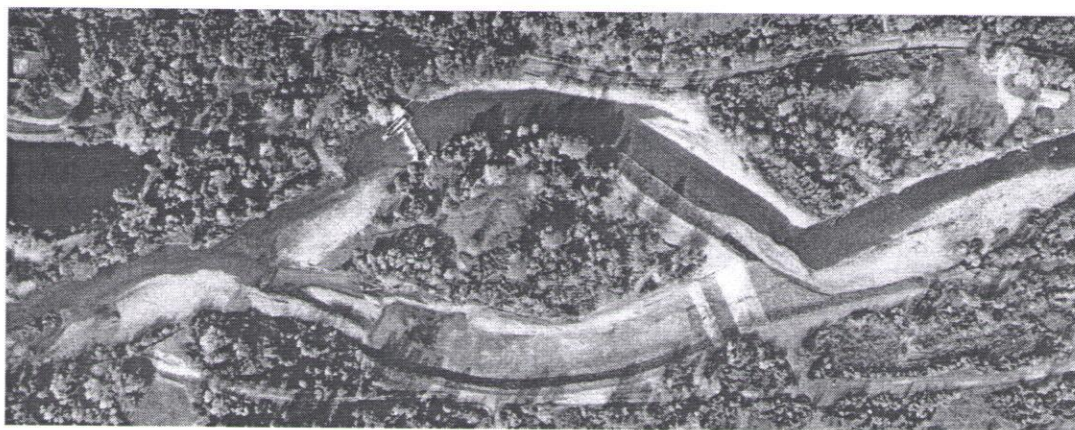
Figure 4-16: Aerial view of the Parrot-Phelan Dam and high-flow by-pass channel. Flow is from right to left. A sill keeps low flows from entering the by-pass. Note the mining pond on the right bank near the left edge of the figure.

creek back to abandoned channel as the first phase. This allowed diversions at the dam to resume. The second phase, still under emergency status and with no environmental review, was intended to keep the stream flowing past the diversion through a massive application of rip-rap along the left bank of the stream and on both sides of the newly created channel, which was turned into a high-flow by-pass channel (Figure 4-16).

Rip-rap now extends along more than 3,000 feet of the left bank of the creek from this project alone, and based on experience elsewhere there will be a tendency to extend the rip-rap if channel migration upstream seems to put the existing rip-rap at risk from erosion. This loss of active alluvial channel constitutes a significant degradation of habitat for listed salmon and steelhead, as well as for other aquatic and riparian species.

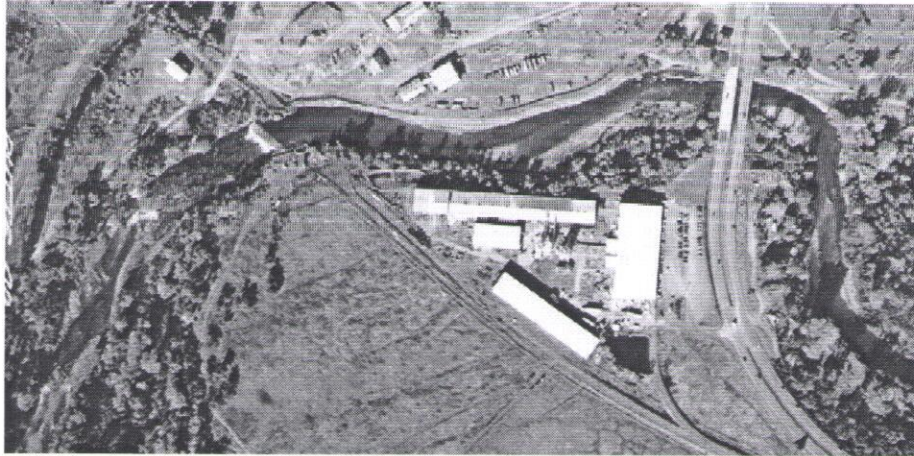
Figure 4-18. Butte Creek downstream from the Skyway (flow is toward the left). Industrial development is encroaching on the stream on the right bank, but there is good riparian habitat just downstream. The Durham Mutual headworks are just downstream from an old railroad alignment that is shown on early maps. The Tuscan Formation outcrops in the streambed downstream from the headworks.

Historically, the distributary Little Butte Creek left the channel on the right bank just below the area shown in the figure, as did a smaller distributary on the left bank (Figure 3-6).

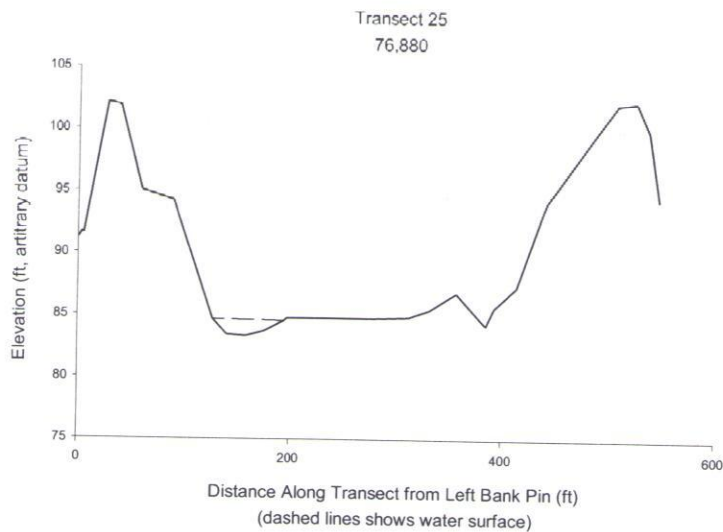
The stream continues across the Butte Fan in this reach, but the levees are farther apart and the channel is somewhat wider than above the Oro-Chico Highway (Figure 4-22). There is more alluvium in this reach, because of the greater width and decreased slope (0.0023), and a pattern of alternate bars is evident along the channel. These bars provide spawning habitat for fall-run chinook salmon. The Red Bluff Formation underlies the channel to about Sta. 85,000, but is much less prominent in the banks than it is upstream. Instead, the banks are primarily of the late-Pleistocene alluvium of the Modesto Formation, or recent alluvium. Below Sta. 85,000, the underlying material grades into a duripan that resembles saturated adobe, and may be part of the Riverbank Formation. This duripan underlies the channel for the rest of the study reach, with important consequences for sediment transport. Gravel transport is mainly in the "partial bed mobility" mode, in which clasts move individually rather than in mass.<sup>4</sup> At the lower end of the gravel reach, clasts typically move one by one onto the duripan. Once gravel clasts are on the bare duripan, they lose any protection from adjacent clasts, so that the entire upstream surface of the clast is exposed to the force of the flow. Clasts that are so exposed can be moved by flow at much lower velocity than clasts that form part of a gravel deposit, where they are partly shielded from the flow by adjacent clasts. In consequence, clasts tend to be swept through reaches with a duripan bottom, especially where the channel is narrow. This point is discussed in more detail below, in the paragraphs on the reach ending at Durnell Road.

Figure 4-22: Transect across Butte Creek just upstream from the Durham-Dayton Highway bridge, at Sta. 76,880, showing a longitudinal bar within the channel near the right bank. Surveyed 10/99.

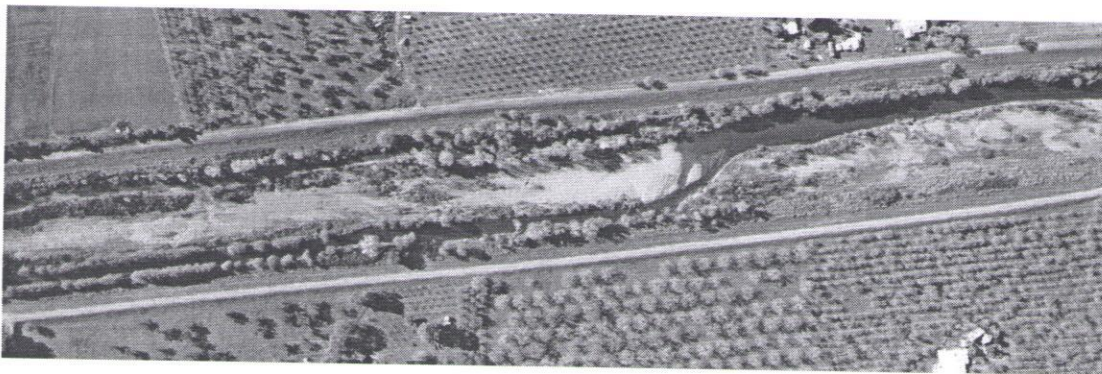
The channel was straightened in the reach before it was leveed, and a strongly developed pattern of alternate bars dominates the appearance of the stream at low and moderate flows. The stream flows along one levee, then cross the channel and flows along the other. The bed is mainly gravel near the upper end of this reach, but downstream the duripan is increasingly exposed in the low-flow channel, despite the gravel bars to either side. The slope flattens in this reach, with a break in slope evident on the long profile of the channel (Figure 4-4) at about Sta. 73,100. There is also a sharp drop at the top of the reach, resulting from the grade control structure just downstream from the Durham-Dayton Highway Bridge.

Figure 4-23: Large alternate bars in the channel downstream from Durham-Dayton Highway

Concern has been expressed regarding localized areas of aggradation in the channel, for example in the reach upstream from the "Big Bend." We recommend caution regarding removal of such deposits, which provide hyporheic habitat that is very limited in this reach. We suspect that the aggradation may be episodic, alternating with periods of incision. We suggest that a period of monitoring precede any removal of gravel, unless hydraulic modeling demonstrates a significant decrease in the flood conveyance capacity of the channel.

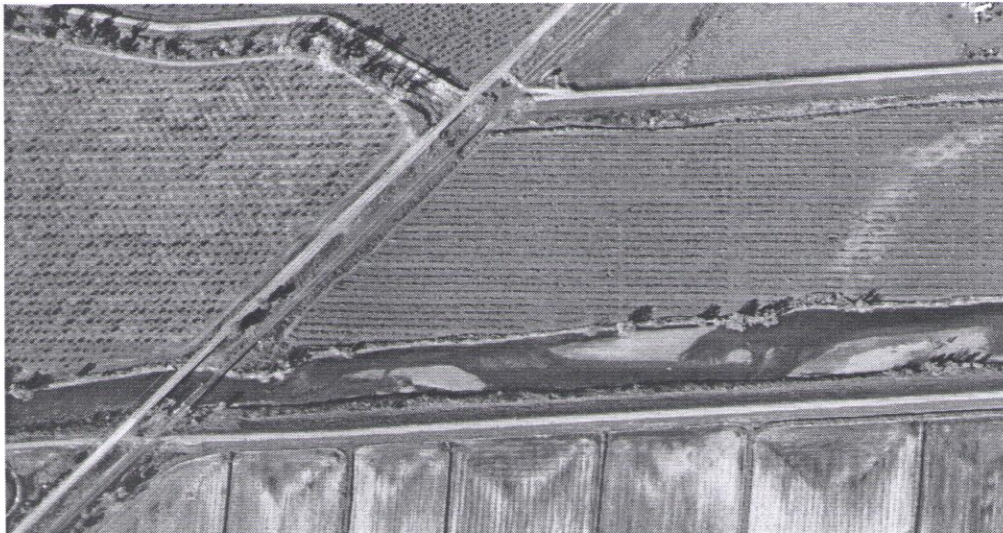
The stream continues along the edge of the fan in this reach, but the soils on the floodplain, and those to the west of the levee, are strongly influenced by fine-grained mining debris. The Adams Dam is near the top of the reach, at Sta. 66,800. The right-bank levee moves back from the channel in this reach, making room for an orchard and the Keeney Restoration Project on the floodplain along the right-bank, but there are rice fields outside the left bank levee. The channel stays close to the left bank levee, and the gradient continues to decline (Fig. 3-3). The channel is incised into the duripan through most of the reach, as shown by channel profiles at the Midway bridge (Figure 3-13). In consequence, a flow greater than the five-year event is need to inundate the floodplain; one of us (E. G.) witnessed a flow of over 9,000 cfs contained entirely within the channel. There are now alternate gravel bars forming upstream from the Midway and railroad bridges (Figure 4-24). The gravel bars may result from the backwater effect of the bridges and the riprap that was been placed around the piers of the Midway bridge after 1997 to control scour (Figure 4-18), from increased transport of gravel into the reach during and after January 1997, or, most likely, from a combination of the two.

Figure 4-24: Alternate bars in the channel upstream from the Midway Bridge. The light colored arc on the right overbank near the right of the picture is the remnant of a channel meander that shows clearly in 1952 aerial photography.

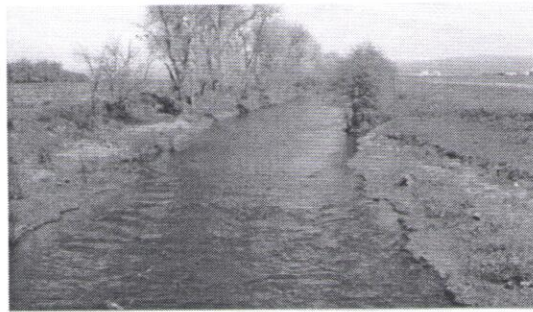
Figure 4-25: Butte Creek flowing through the Butte Basin; view upstream from the Durnell Road Bridge. The levee is well back from the stream on the western side in this area.

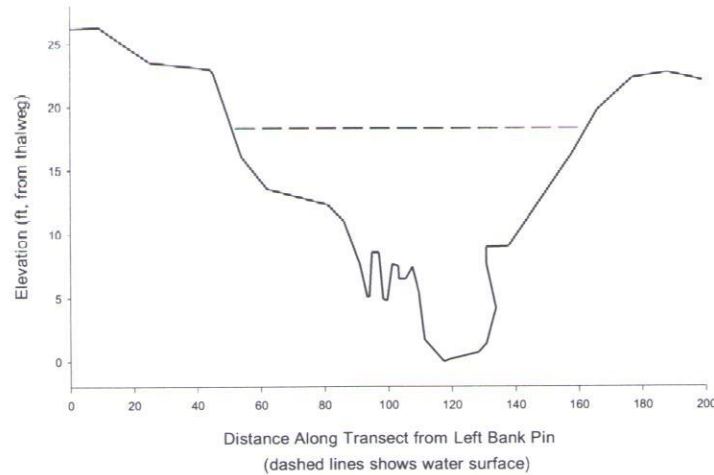
Channel roughness at Durnell Road is very low. Stage at Durnell Road peaked at 18.3 ft above the thalweg on 14 February 2000, when discharge at the USGS gage reached 7,300 cfs. We estimated that the average velocity at the peak flow was 7.9 feet per second, using a transect surveyed in the county right-of-way just upstream from the bridge, and assuming that upstream accretions balanced the tendency of channel storage to damp peak flows. Substituting this value into the Manning equation gives an estimate of Manning's  $n$  of  $\sim 0.018$ .<sup>5</sup> This is a very low value for  $n$ , so it may be that our assumption about the discharge or our estimate of slope is incorrect. For any reasonable values of slope and discharge, however, the data show that the channel in this reach is hydraulically very efficient. This probably results from the smooth duripan that makes up the channel bed here and in most of the basin reach.

<sup>5</sup>The precise value depends upon the extent to which the transect is smoothed in calculating the channel perimeter. Our calculations used 930 ft<sup>2</sup> for area, 140 ft for the wetted perimeter (substantially smoothed), and 0.0007 for the slope.

Figure 4-26: Transect across Butte Creek upstream from the Durnell Road Bridge, showing the high water observed on 14 February 2000. The left bank pin is on the levee. Vertical exaggeration is 4/1.

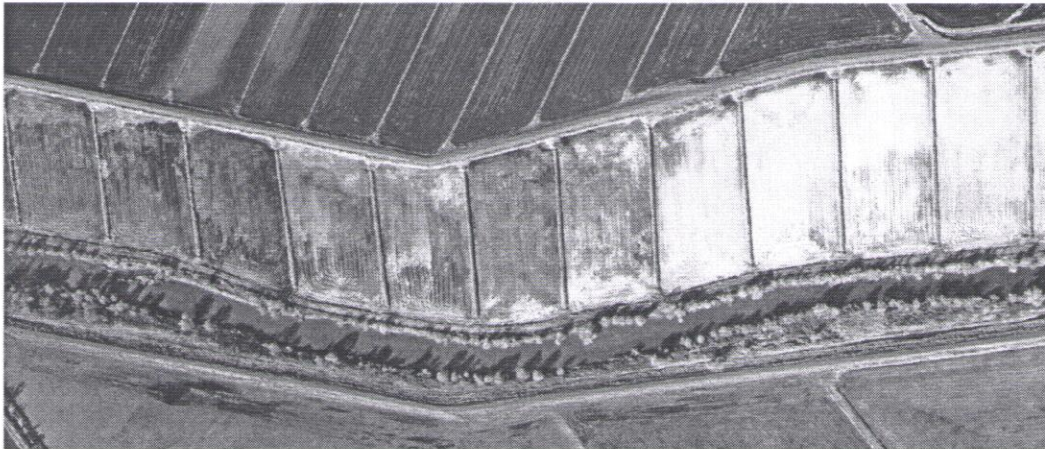
Except for a kink at Aguas Frias Road where the channel moves from next to right bank levee to next to the left bank levee, the channel is nearly straight through this long, low gradient (0.0005) reach. The duripan is exposed in most of the bed, but there are some small gravel deposits. The levees are 600 or more feet apart through this reach, and rice is grown on the overbank except for the lower 3,000 feet which belongs to DFG and has been left fallow. There is a thin fringe of riparian vegetation along the channel, perhaps a bit more than farther upstream.

Figure 4-28: Butte Creek near the end of the Corps of Engineers levees. Rice is grown on the right overbank between the levees. Flow is from right to left.

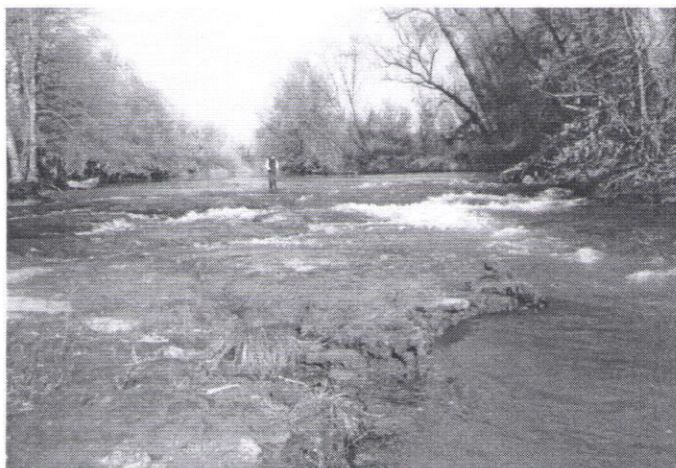
reach also increases. There is a sharp drop at the top of the reach where the stream passes over a particularly resistant outcrop of duripan (Figure 4-29), and several other smaller drops over outcrops in the next few thousand feet downstream.

Figure 4-29: Outcropping of particularly resistant duripan in the channel about 19,700 feet upstream from Highway 162.

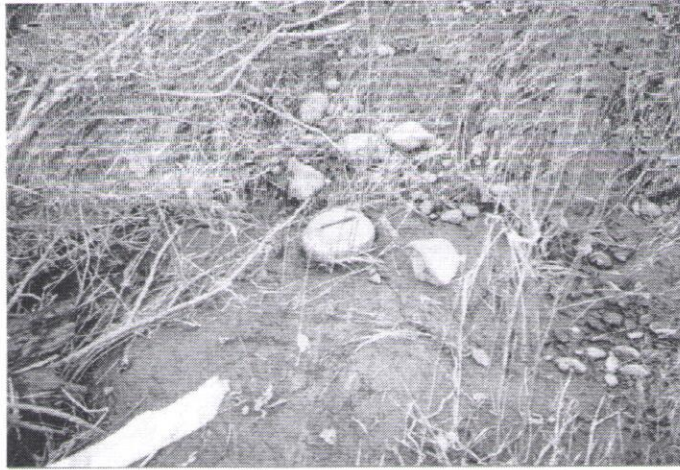
Surprisingly, there is a small gravel deposit with a median grain size of 25 mm at Sta. 13,700. This occurs where the gradient of the channel seems to flatten out again, although we are not certain of this since we did not survey a long profile in this part of the stream. We also found scattered gravel clasts on the duripan banks of the stream in the upper part of this reach (Figure 4-30), one of which had an intermediate axis measuring about 180 mm. There are also scattered deposits of sand on the bank, and the soil in the banks seems more silty than the clay soils outside the levees.

Figure 4-30: Gravel clasts next to the channel about 15,100 feet upstream from Highway 162; the intermediate diameter of the largest clast is over 180 mm (there is a pen on top of the clast for scale).

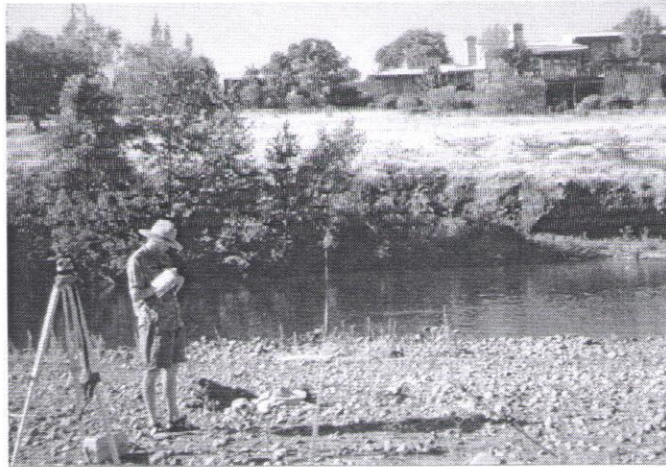
It is easier to identify areas where bank erosion will not occur, or will occur only slowly, because of highly resistant materials in the banks. Doing this comprehensively would have required better access to sites than we had, and in some cases subsurface sampling, so we have not tried to map such areas, although an obvious example is shown in Figure 5-1. Areas with resistant banks are better suited for homes and other infrastructure than alluvial sites, even if they are closer to the creek. Therefore, we recommend against using some arbitrary distance from the stream as a criterion for judging proposed developments.

Figure 5-1: Resistant banks protect these homes in the Canyon from channel migration.

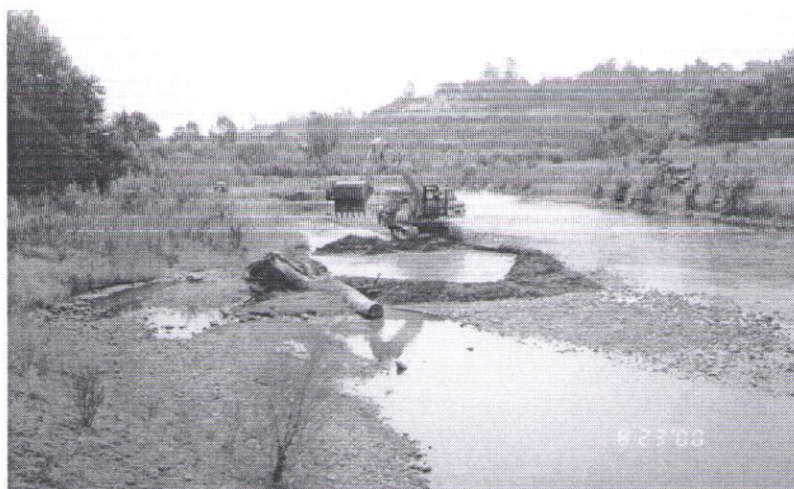
Figure 5-2: Equipment removing gravel from the channel upstream from the Parrott-Phelan Dam to maintain channel capacity.

At the least, the current situation creates a need to remove material from the bar periodically, using heavy equipment. This occurred in August, 1999, and again in August, 2000. Material excavated in 2000 was trucked to the right bank of the creek downstream of the Parrott-Phelan Diversion Dam, where it was placed at an elevation such that a very high flow will be required to mobilize it. Although we recognize the need to minimize releases of fine sediment during these summer low-flow operations, some method should be developed for returning the sediment to the stream. Pushing the sediment into the stream during periods of high flow seems one alternative, but it seems better to raise the sill at the entrance to the Parrot-Phelan Diversion By-Pass Channel to minimize the need for mechanically moving the sediment around the dam<sup>3</sup>

The sill at the entrance to the Parrot-Phelan Diversion By-Pass Channel should be raised. During flow events that move a significant amount of gravel, part of the flow passes over the sill on the left bank upstream from the Parrot-Phelan Diversion and passes the diversion in an armored artificial channel. This reduces the discharge in the main channel, and so reduces the competence of the stream to transport coarse sediment. In consequence, a bar forms opposite and downstream from the sill that increases the proportion of the flow going into the high-flow channel at a given discharge, and reducing the discharge at which water begins to flow into the by-pass (we have observed flow going into the high-flow channel at a discharge of about 1,500 cfs).<sup>2</sup> As the frequency of flow into the by-pass channel increases, so too does the problem of fish being stranded in the by-pass.
