Prepared by:
**The Watershed Projects Office,
California State University, Chico**

Prepared for:
United States Fish & Wildlife Service
July 2000

**Upper Butte Creek
Watershed
Road-Related Sediment Survey:
Scotts John, Bull
and Varey Creeks**

FINAL DRAFT

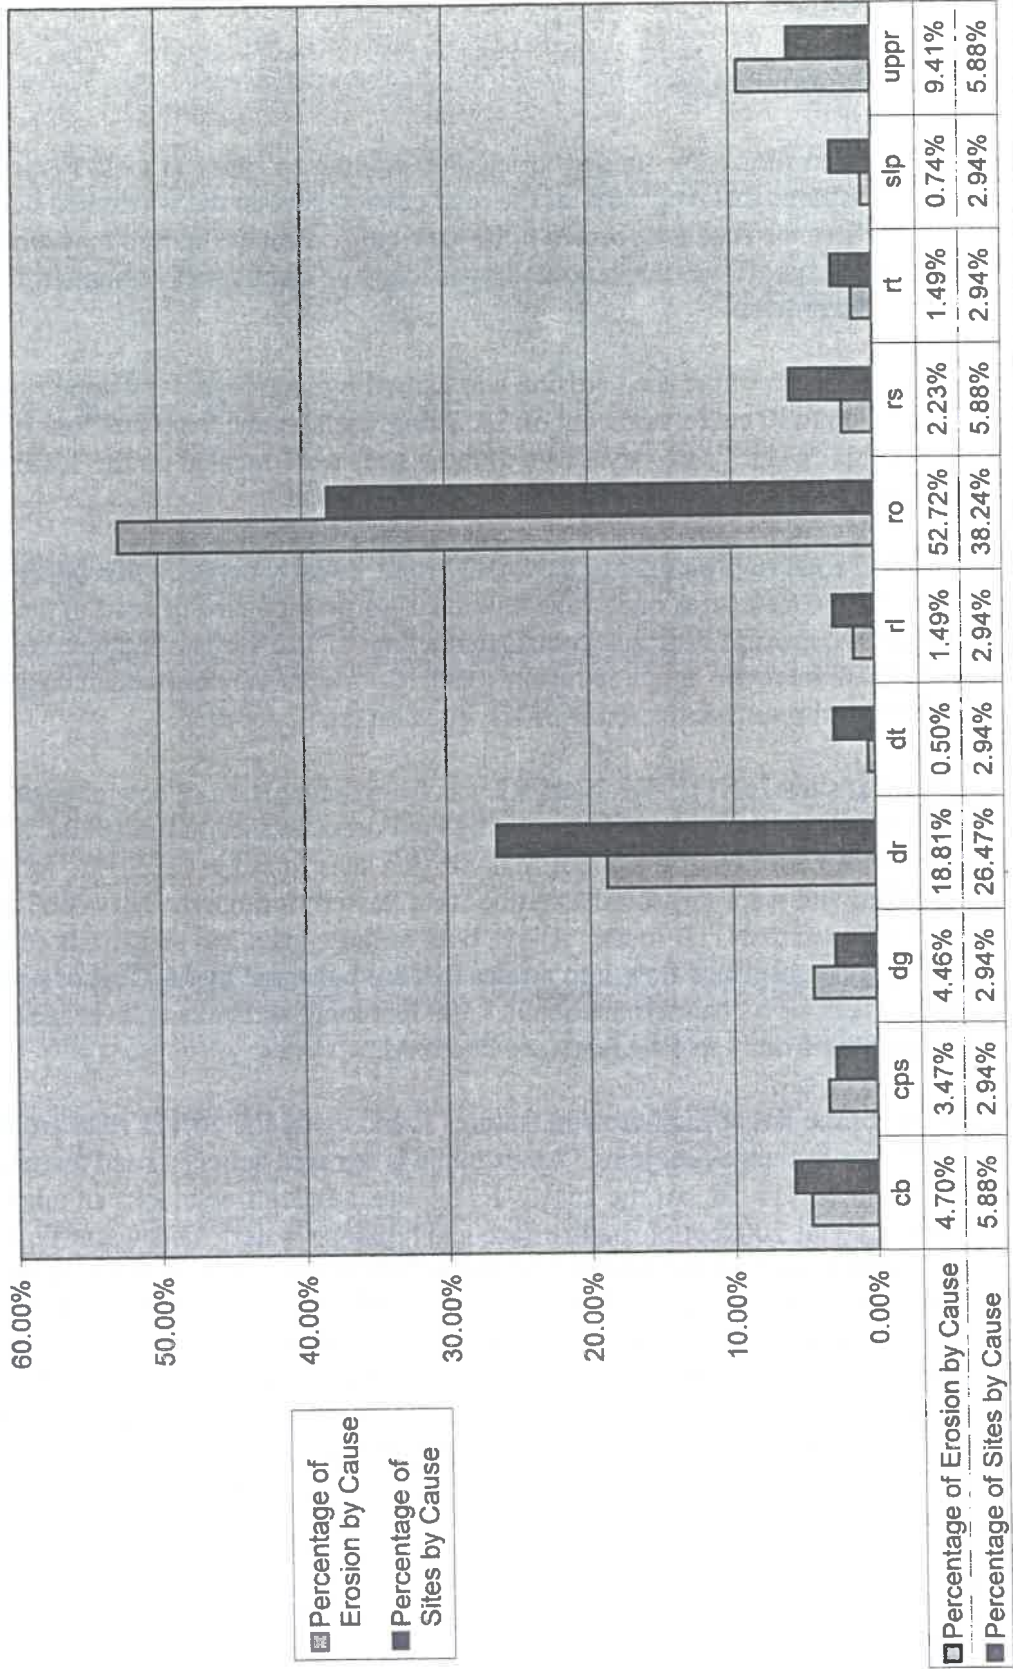
Figure 1

Road erosion sites were queried for erosion volume by cause to yield Figure 1. This graph illustrates that over 50% of the road erosion sites in the watershed occurred in places where the road intercepted hillslope runoff. Erosion caused by problems occurring where ditch runoff was concentrated by inadequate ditch relief accounted for another 19% of the erosion.

Scotts John Creek Road Erosion: Comparison of Sediment Volume by Cause with Percentage of Sites by Cause

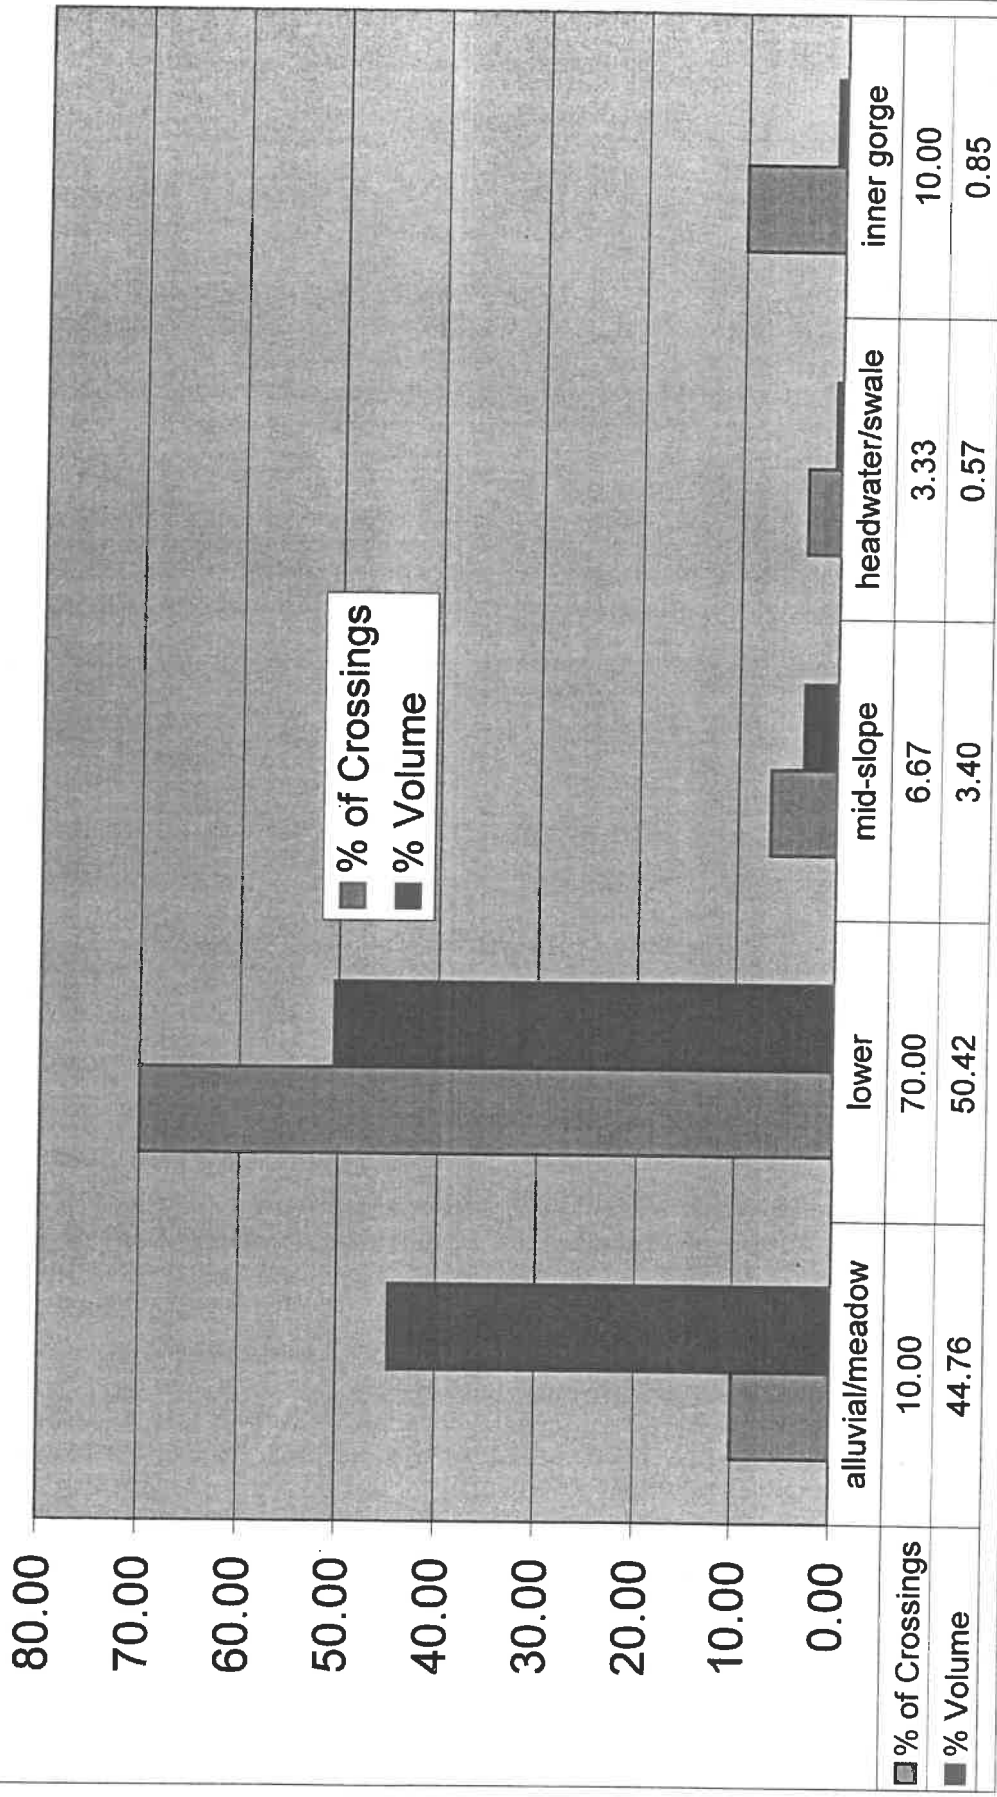
Figure 2

Stream crossing erosion accounted for 47% of the erosion in the watershed. While 46% of the volume eroded at stream crossings came from alluvial-meadow locations, these locations amounted to just 13% of the sites (see Figure 2). All of the alluvial-meadow erosion came from two of the three sites. While three alluvial-meadow sites represent only 10% of the total number of crossings they contributed 45% of the total erosion for all stream crossings.

Scotts John Creek Stream Crossings: Crossing Sites Related to Landform

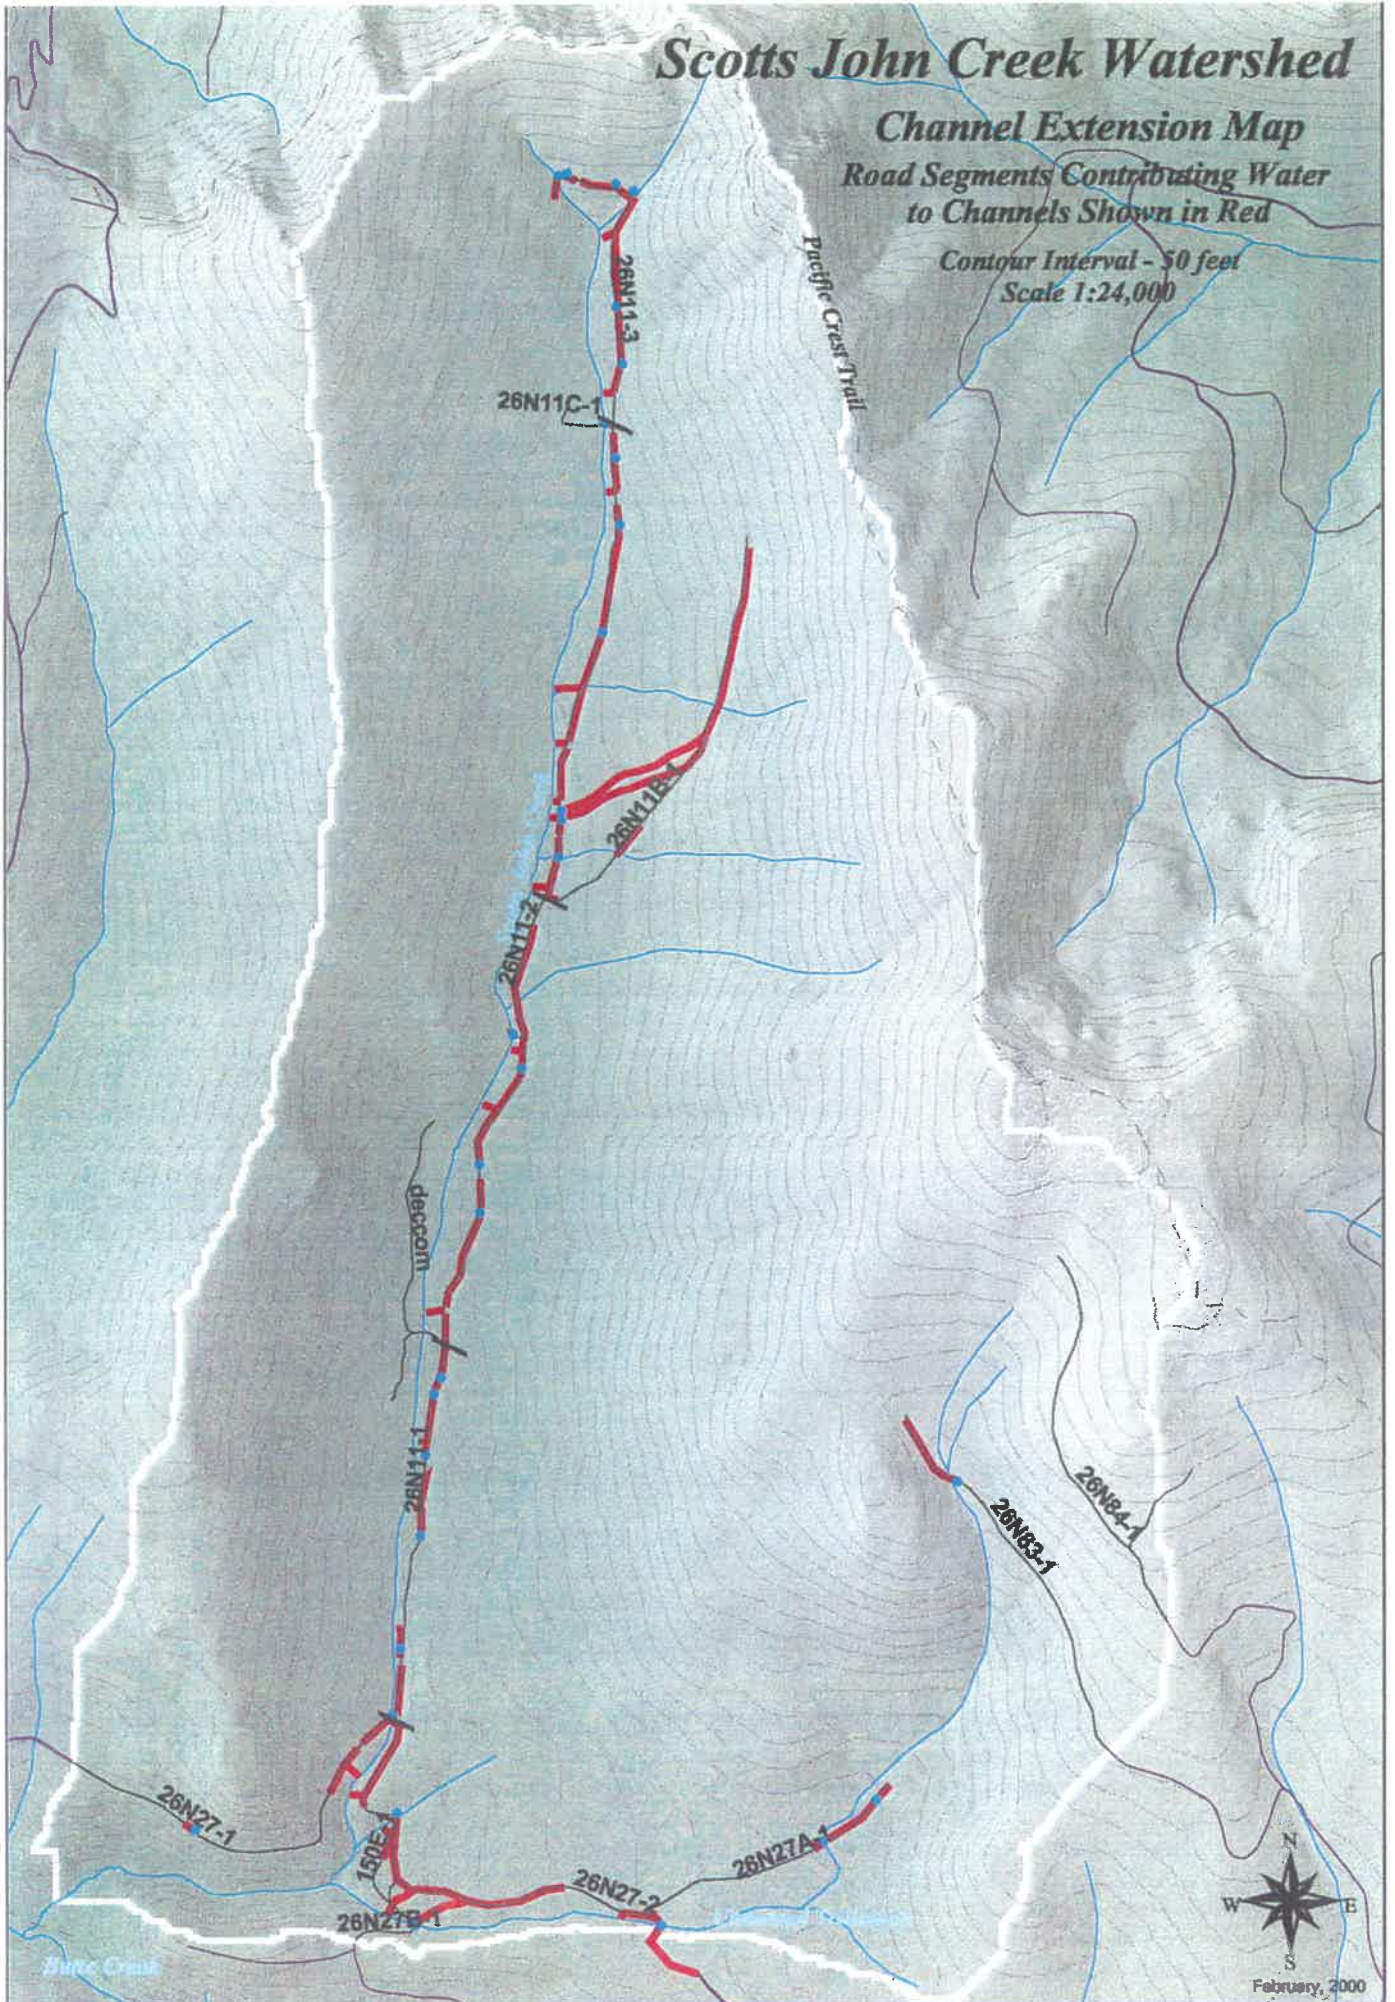
Map 4

A channel extension map was prepared for all three sub-watersheds (Map 4). These maps used the “Contributing Length” information from the field surveys to illustrate graphically the amount of ditch or road-surface feeding water directly to a near-stream erosion site or to the *inlet* of a drainage structure. The resulting maps portray the hydrologic connectivity between the transportation system and the stream channel network. In the Scotts John Creek watershed, 9.6 miles of road have created 6.1 miles of

new channel. This translates to about 65% of the total length of roads being directly connected to the channel network. Seventy-five percent of the road surface of the 26N11 and 26N11B roads is directly connected to the stream channel network.

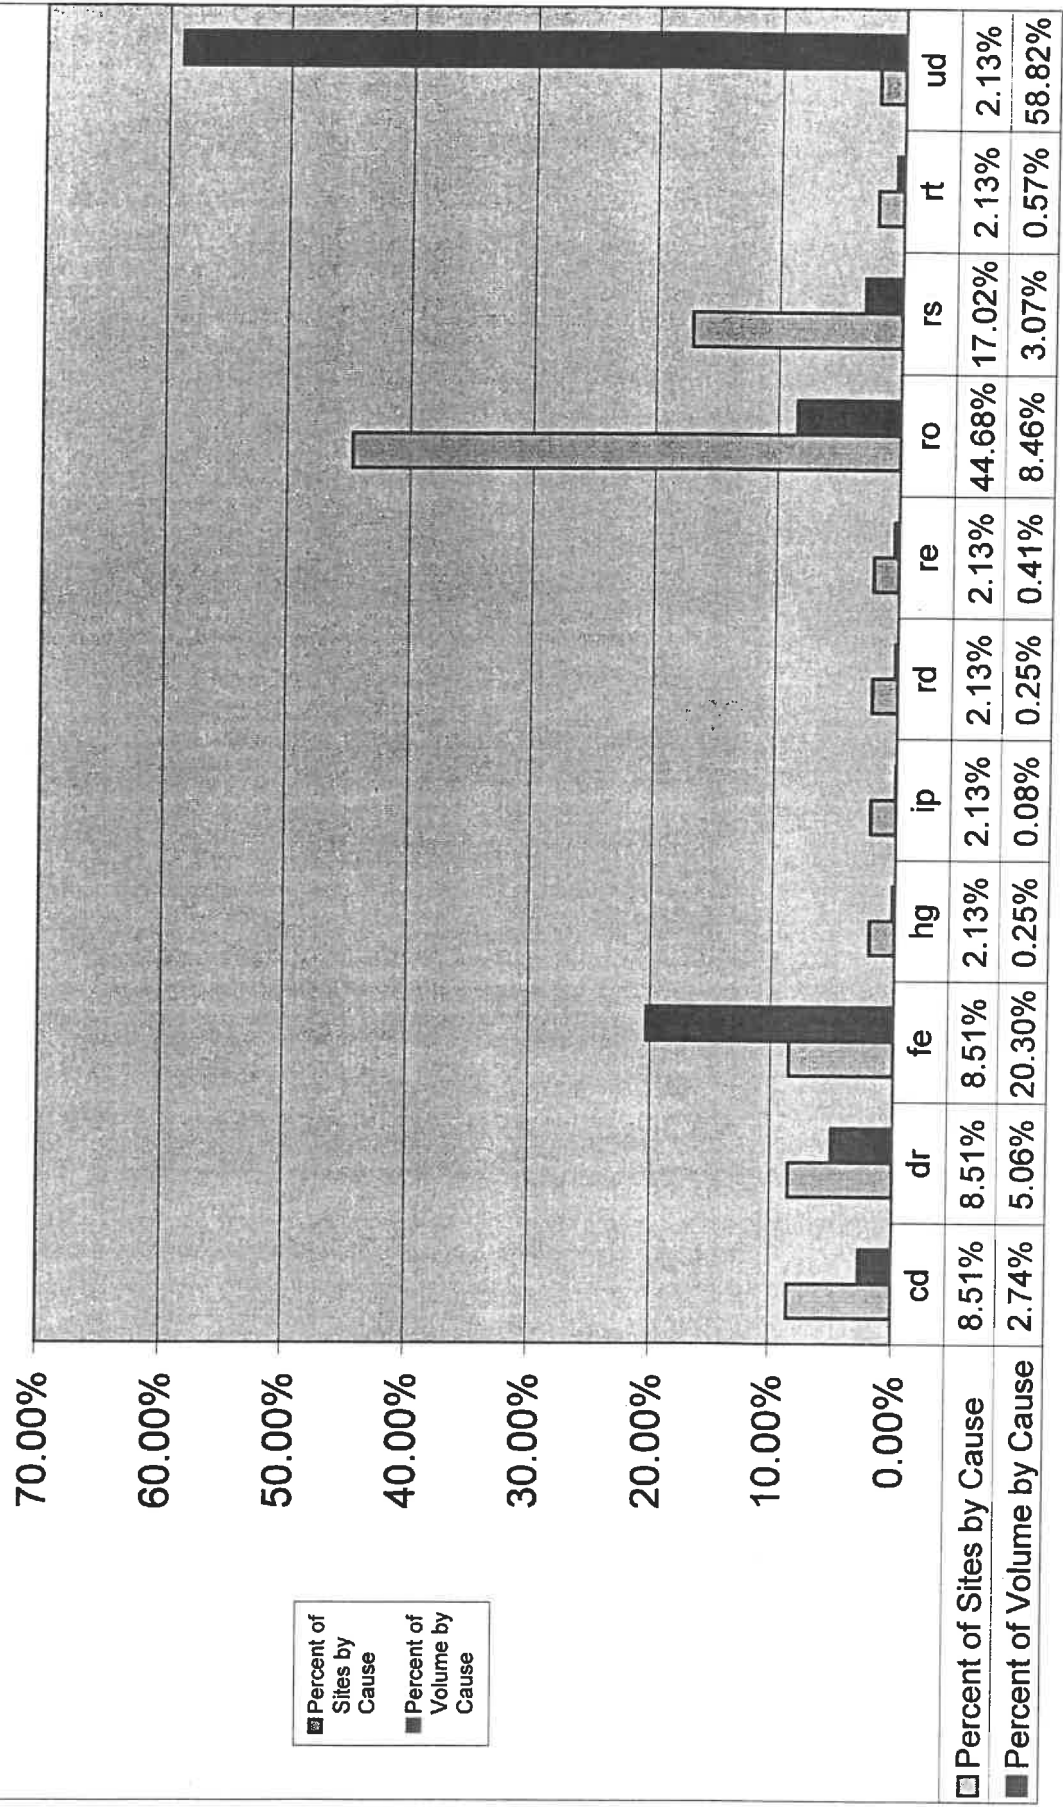
Figure 3

Road erosion sites in the Bull Creek watershed were queried by cause (see Figure 3). Of the 6,120 cubic yards of erosion from road sites in the watershed, 59% came from one site (the A-R5). This 3,600 cubic yard site is located along Bottle Creek, and although it was the only site surveyed at which an exact causal mechanism for failure could not be determined, the area has been heavily modified by historic railroad construction. 1952 aerial photographs show an old railroad fill crossing Bottle Creek downstream of the present A-line crossing, and the A-R5 site is located at the outlet of an old culvert through the old railroad fill. The old pipe is perched 20 vertical feet above the current creekbed, and appears to have passed water onto an unprotected fillslope.

Bull Creek Road Erosion Sites by Cause

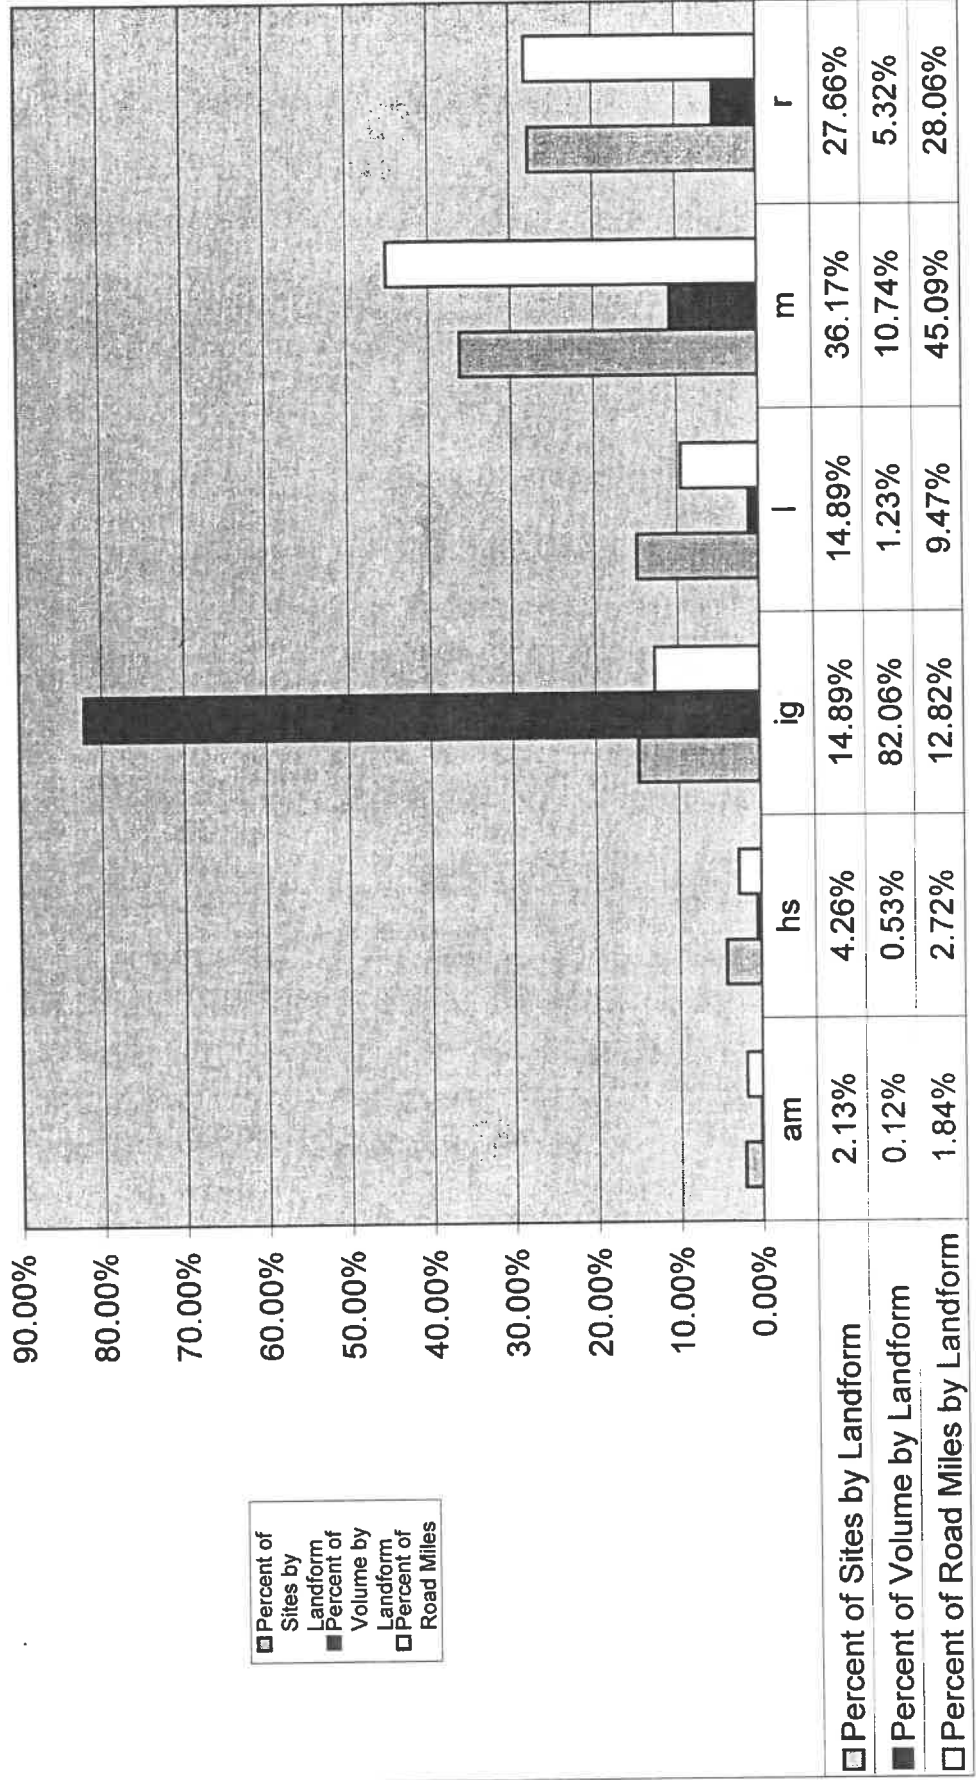
A query of road erosion sites by landform (Figures 4a and 4b) reveals that in the Bull Creek watershed, “inner-gorge” areas are a high-risk area for road erosion. Figure 4a shows that on the basis of the raw data, “inner-gorge” landform produced 82% of the non-stream-crossing erosion, yet comprised less than 15% of the sites. On the A-line road, four sites in the “inner-gorge” areas of Bull, Bottle, and Secret Creeks combined to produce a total of 4,975 cubic yards of erosion. These sites represent 82% of all of the sediment delivered from “inner-gorge” road sites, and comprise 81% of all road site erosion. When the A-R5 site (totaling 3,600 yards³) is removed, as displayed in Figure 4b, “inner-gorge” locations still contribute 56% of the erosion from road sites. Midslope roads are, however, significant in their role in contributing sediment (see Figure 4b), delivering 26% of the erosion for road sites.

Bull Creek Road Erosion Sites Related to Landform

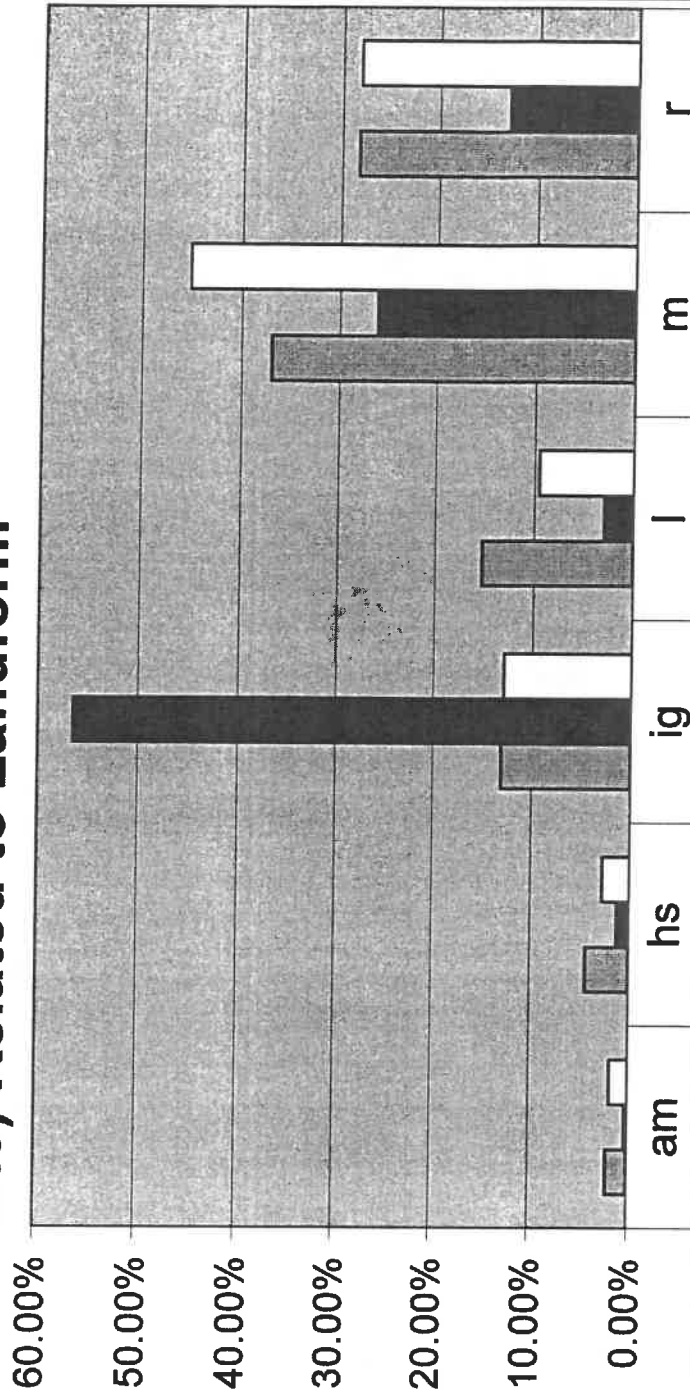
Figure 4b

Bull Creek Road Erosion Sites (WITHOUT A-R5 Site) Related to Landform

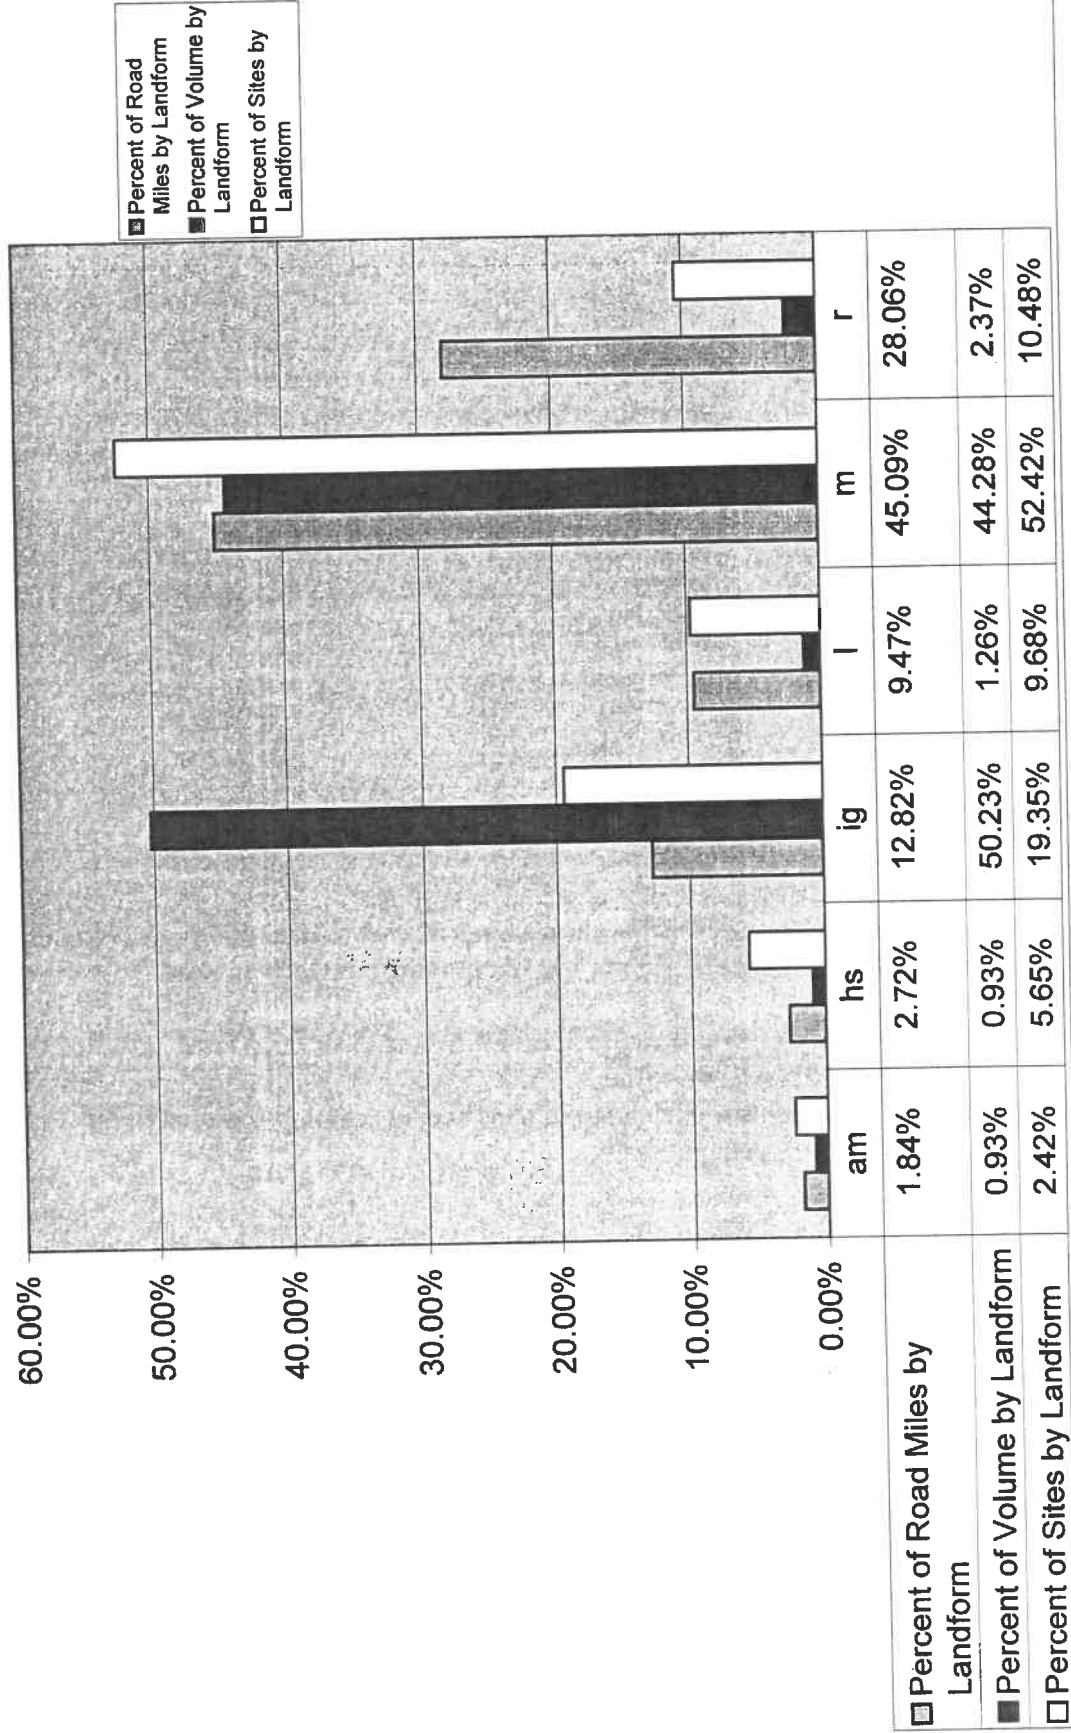
Figure 5

In the Bull Creek watershed, 55% of the all road-related sediment delivery was associated with stream crossings. The majority of this erosion (78%) came from crossings on mid-slope roads, which represented over 60% of the sites surveyed (see Figure 5). Again, this can be directly attributed to the large number of sites on the A-line. 5,257 yards³ (69.1%) of the erosion from all stream crossings came from the midslope A-line road. One such mid-slope site on the A-line was the A-8 site, where 3,000 yards³ of erosion occurred (details discussed below in "*Stream Crossing Erosion by Cause*").

**Bull Creek:
Road-Related Erosion (ALL sites) Related to Landform**

All road-related erosion sites (including road sites and stream crossing sites) were included in a query by landform to identify landform positions producing the greatest amounts of erosion (see Figure 5).

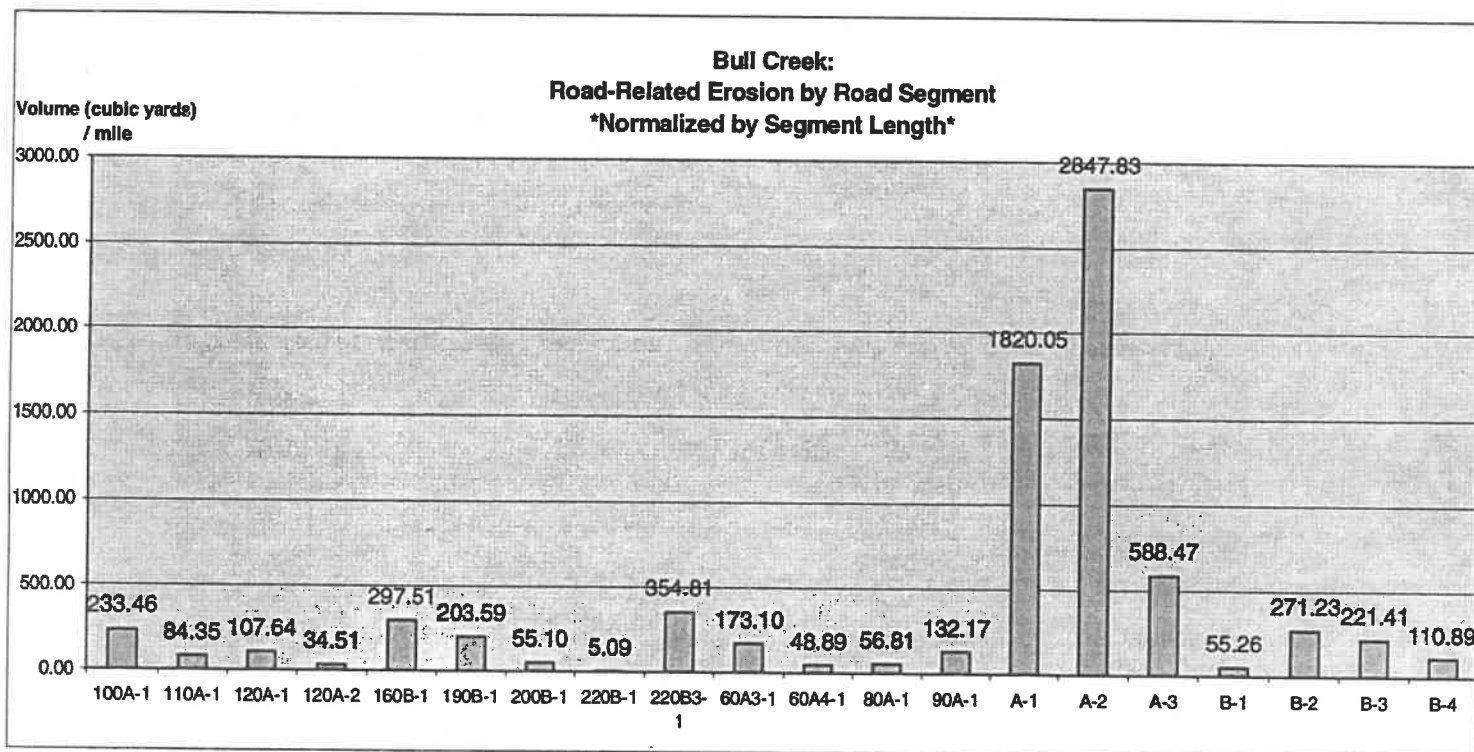
When queried by road segment, similar trends emerge. Of all the erosion in the watershed, 83% occurs on the three A-line road segments (A-1, A-2, and A-3). The major erosion sites in the inner-gorge and mid-slope areas (sites A-8, A-R5, and A-38) of the A-line road skew the data heavily. To account for this, the volumes were normalized by miles of road per segment (See Figure 6). Though the trends for the three "A-line sites" are similar, other road segments (such as 220B3-1, 160B-1, B-2, and 100A-1) appear as considerable contributors of sediment (over 200 yards³/mile) on a mile-for-mile basis.

Figure 6: Bull Creek: Road-Related Erosion by Road Segment, Normalized by Segment Length

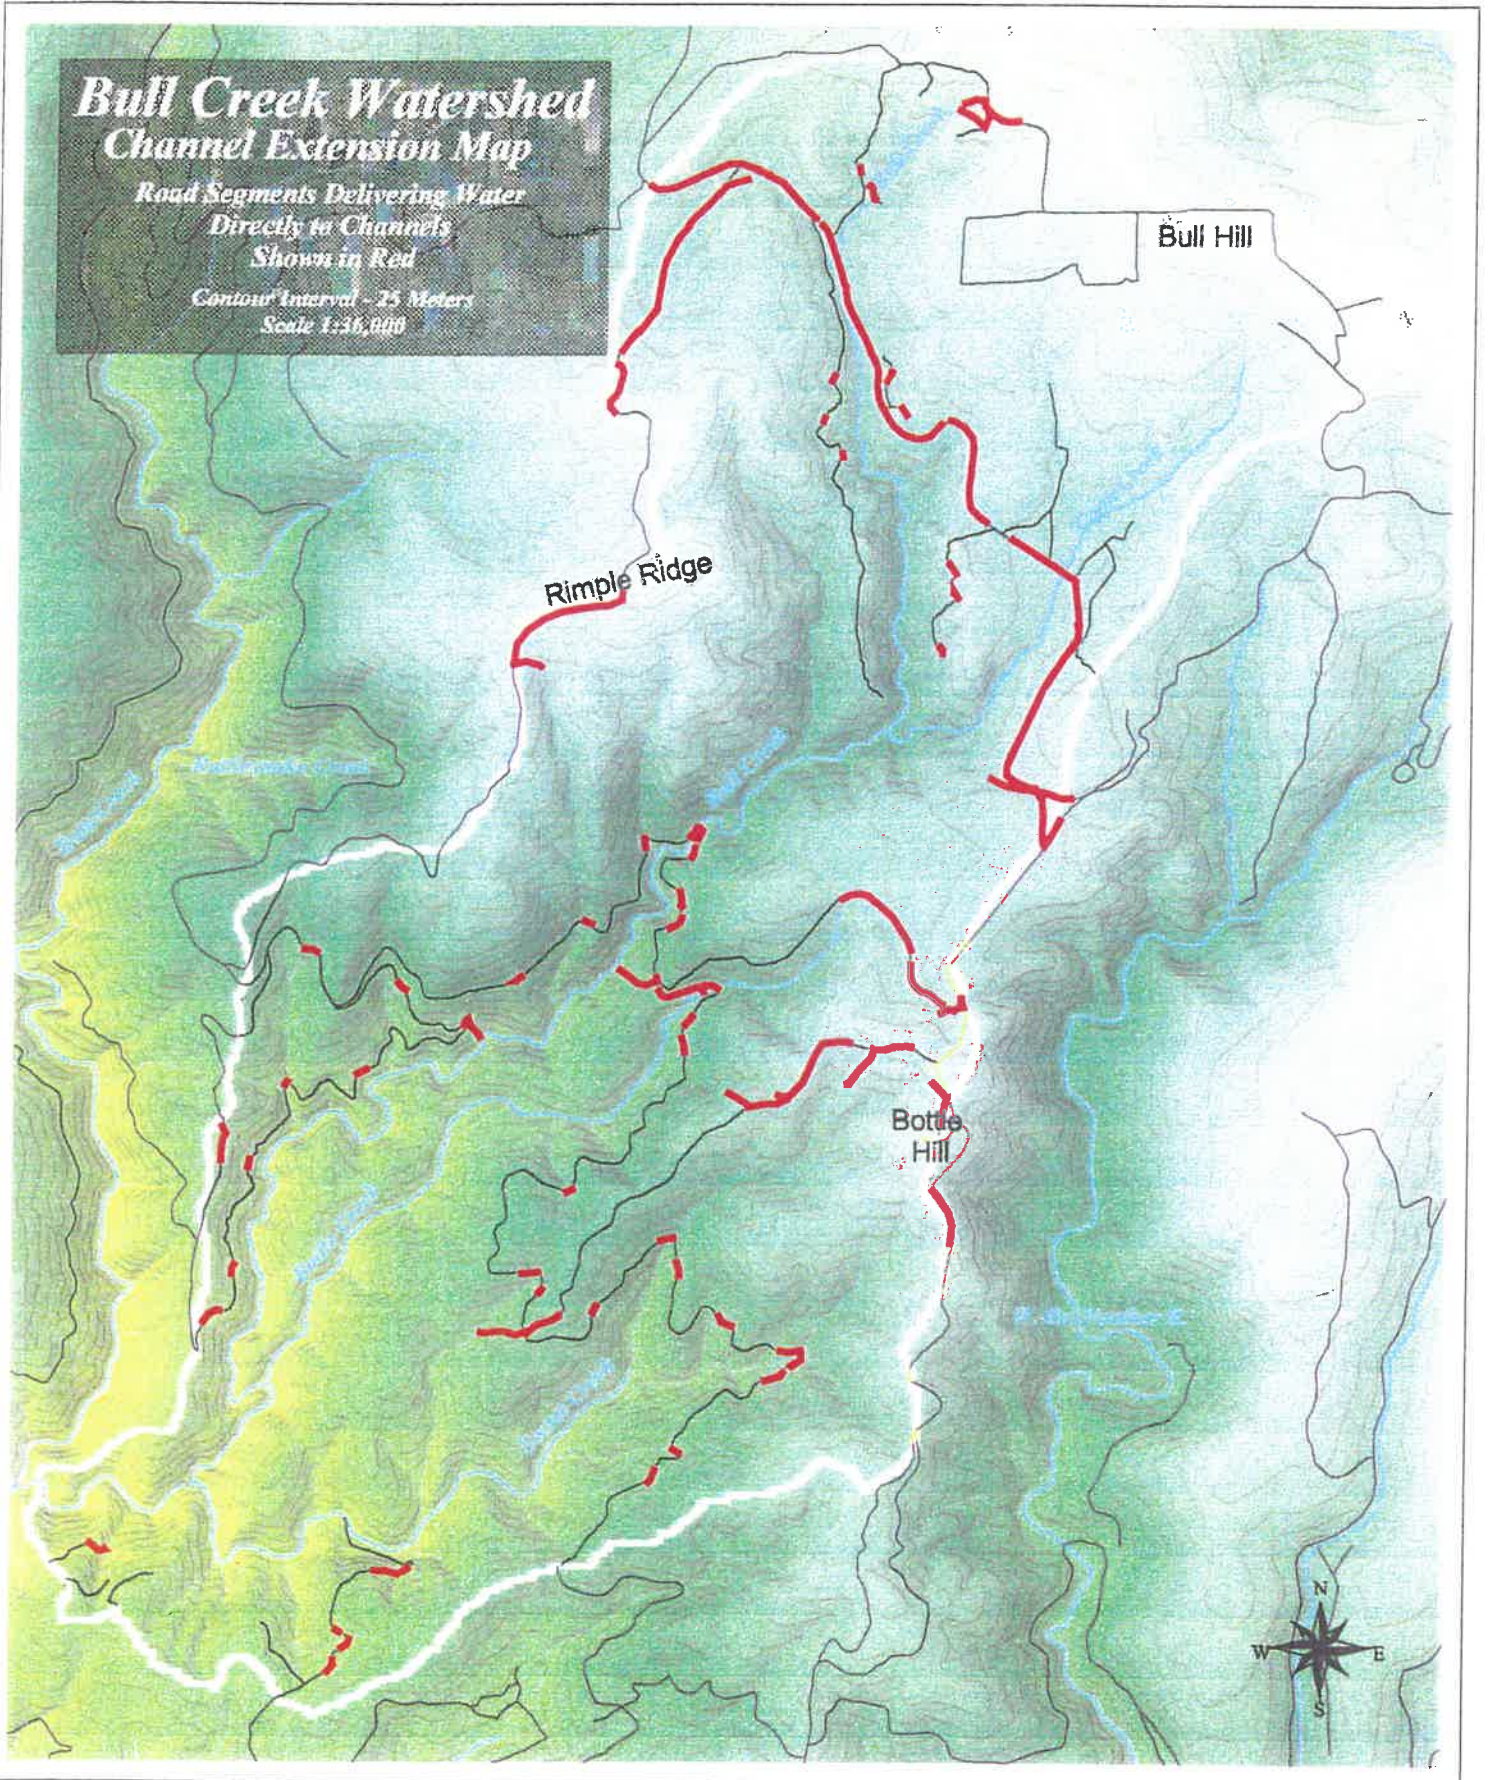
In Bull Creek 8.62 miles (about 30% of the total 29.12 miles) of the road-surface is connected to the stream system. Of this connected roadway, about 40% comes from the B-line (Skyway) - the only major road in the watershed which is drained by inboard ditches. Within the Bull Creek watershed, 95% of the length of the B-line delivers its drainage directly to a channel. Map 8 graphically illustrates the extent to which the road network is linked to the stream channel network.

Bull Creek Watershed Channel Extension Map

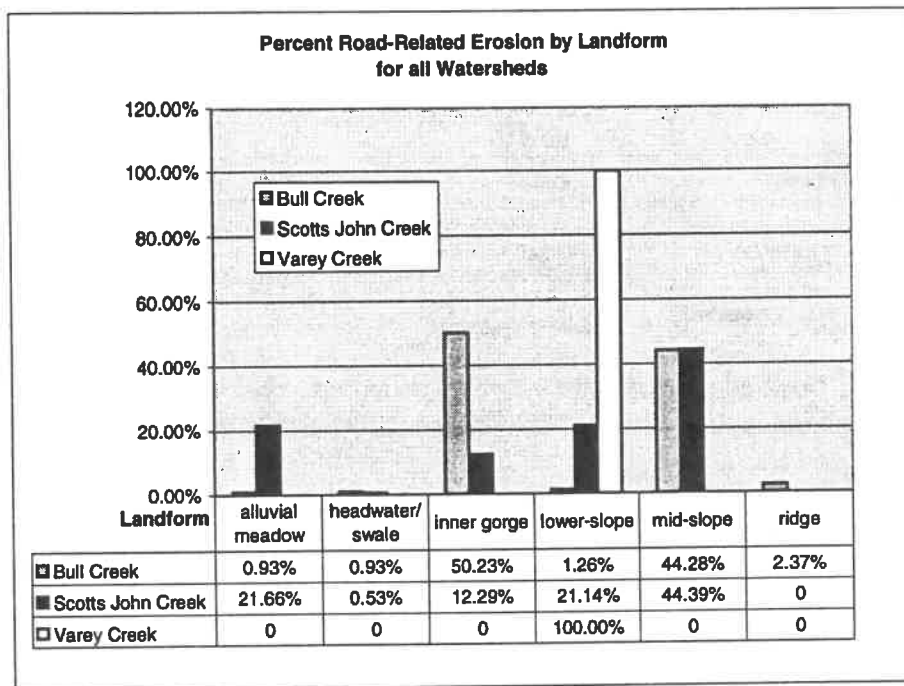
An analysis of erosion by landform for all three watersheds resulted in Figure 7. Trends within individual watersheds were quite strong relative to the representative landforms for which they were chosen. Consequently, data in Figure 7 was not lumped together on a study-wide average. In this way, trends within the three individual watersheds can still be seen, and any trends in landform variability will also be illustrated.

Figure 7: Percent of Road-Related Erosion by Landform for all Watersheds

In Bull Creek, 94.5% of the erosion in the watershed was found to be coming either from inner-gorge sites (50.2%) or mid-slope areas (44.3%). Again, these landforms coincide with the metamorphic geology and it is difficult to determine if it is the geology and stratigraphy that are responsible by way of determining the landform, or if it is landform independent of these two that may be a reasonable indicator for hazard.

Scotts John Creek has a considerable amount of erosion from mid-slope locations (44.28%), as well as alluvial/meadow areas (21.66%) and lower slopes (21.14%). Diverted stream crossings and new channel incision contributed to the amount of erosion on mid-slope roads.
