**A PRELIMINARY ASSESSMENT OF THE SALMON
HABITAT POTENTIAL OF BUTTE CREEK, A TRIBUTARY OF THE
SACRAMENTO RIVER, BETWEEN THE BUTTE HEAD DAM AND
CENTERVILLE DIVERSION DAM, BUTTE COUNTY, CALIFORNIA**

January, 1998

William M. Kier Associates
Sausalito, California

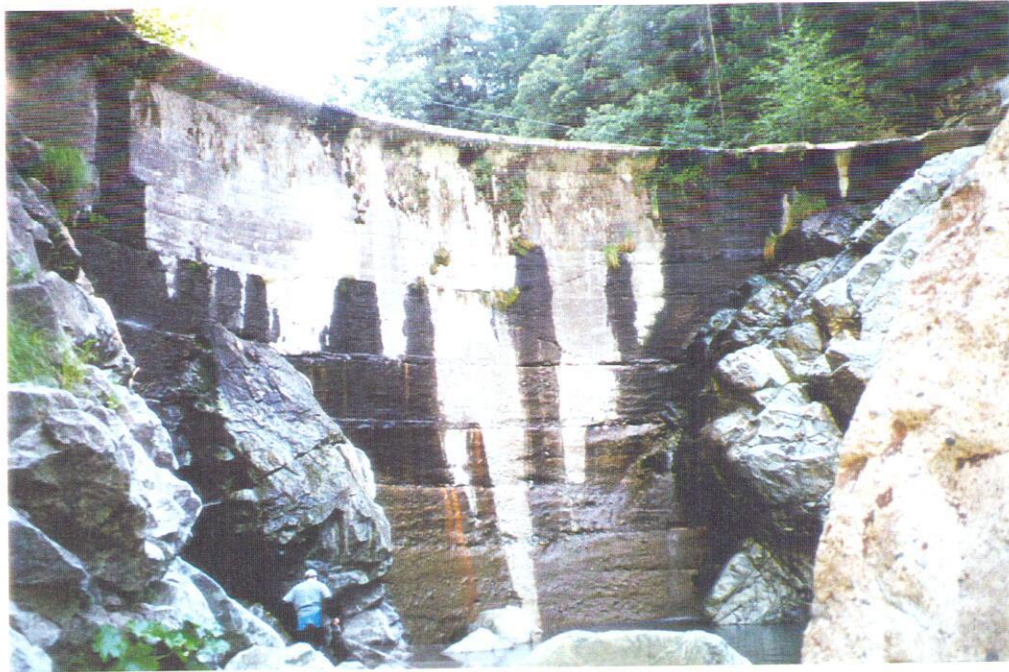
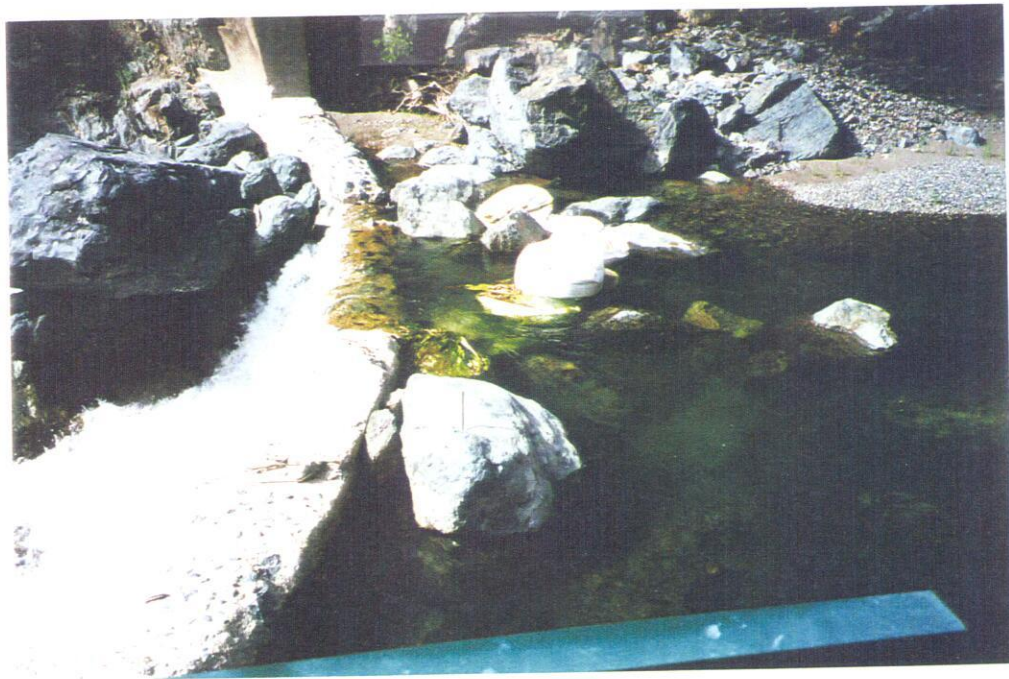
Photos 1 and 2. Looking up at the Butte Head Dam (upper photo) and down on the Centerville Diversion Dam. The dams, which are approximately 40 and 20 feet high, respectively, bracket the 11-mile canyon study reach

The eleven-mile stretch of Butte Creek between Pacific Gas and Electric Company's (PG&E) Butte Head Dam and the company's Centerville Diversion Dam (photos 1 and 2, map 1) was surveyed during the summer of 1997 to determine the stream's potential for supporting self-sustaining populations of salmon, particularly spring-run chinook salmon, *Oncorhynchus tshawytscha*. Spring-run salmon numbers have declined dramatically in the Sacramento River watershed during the past three or four decades.

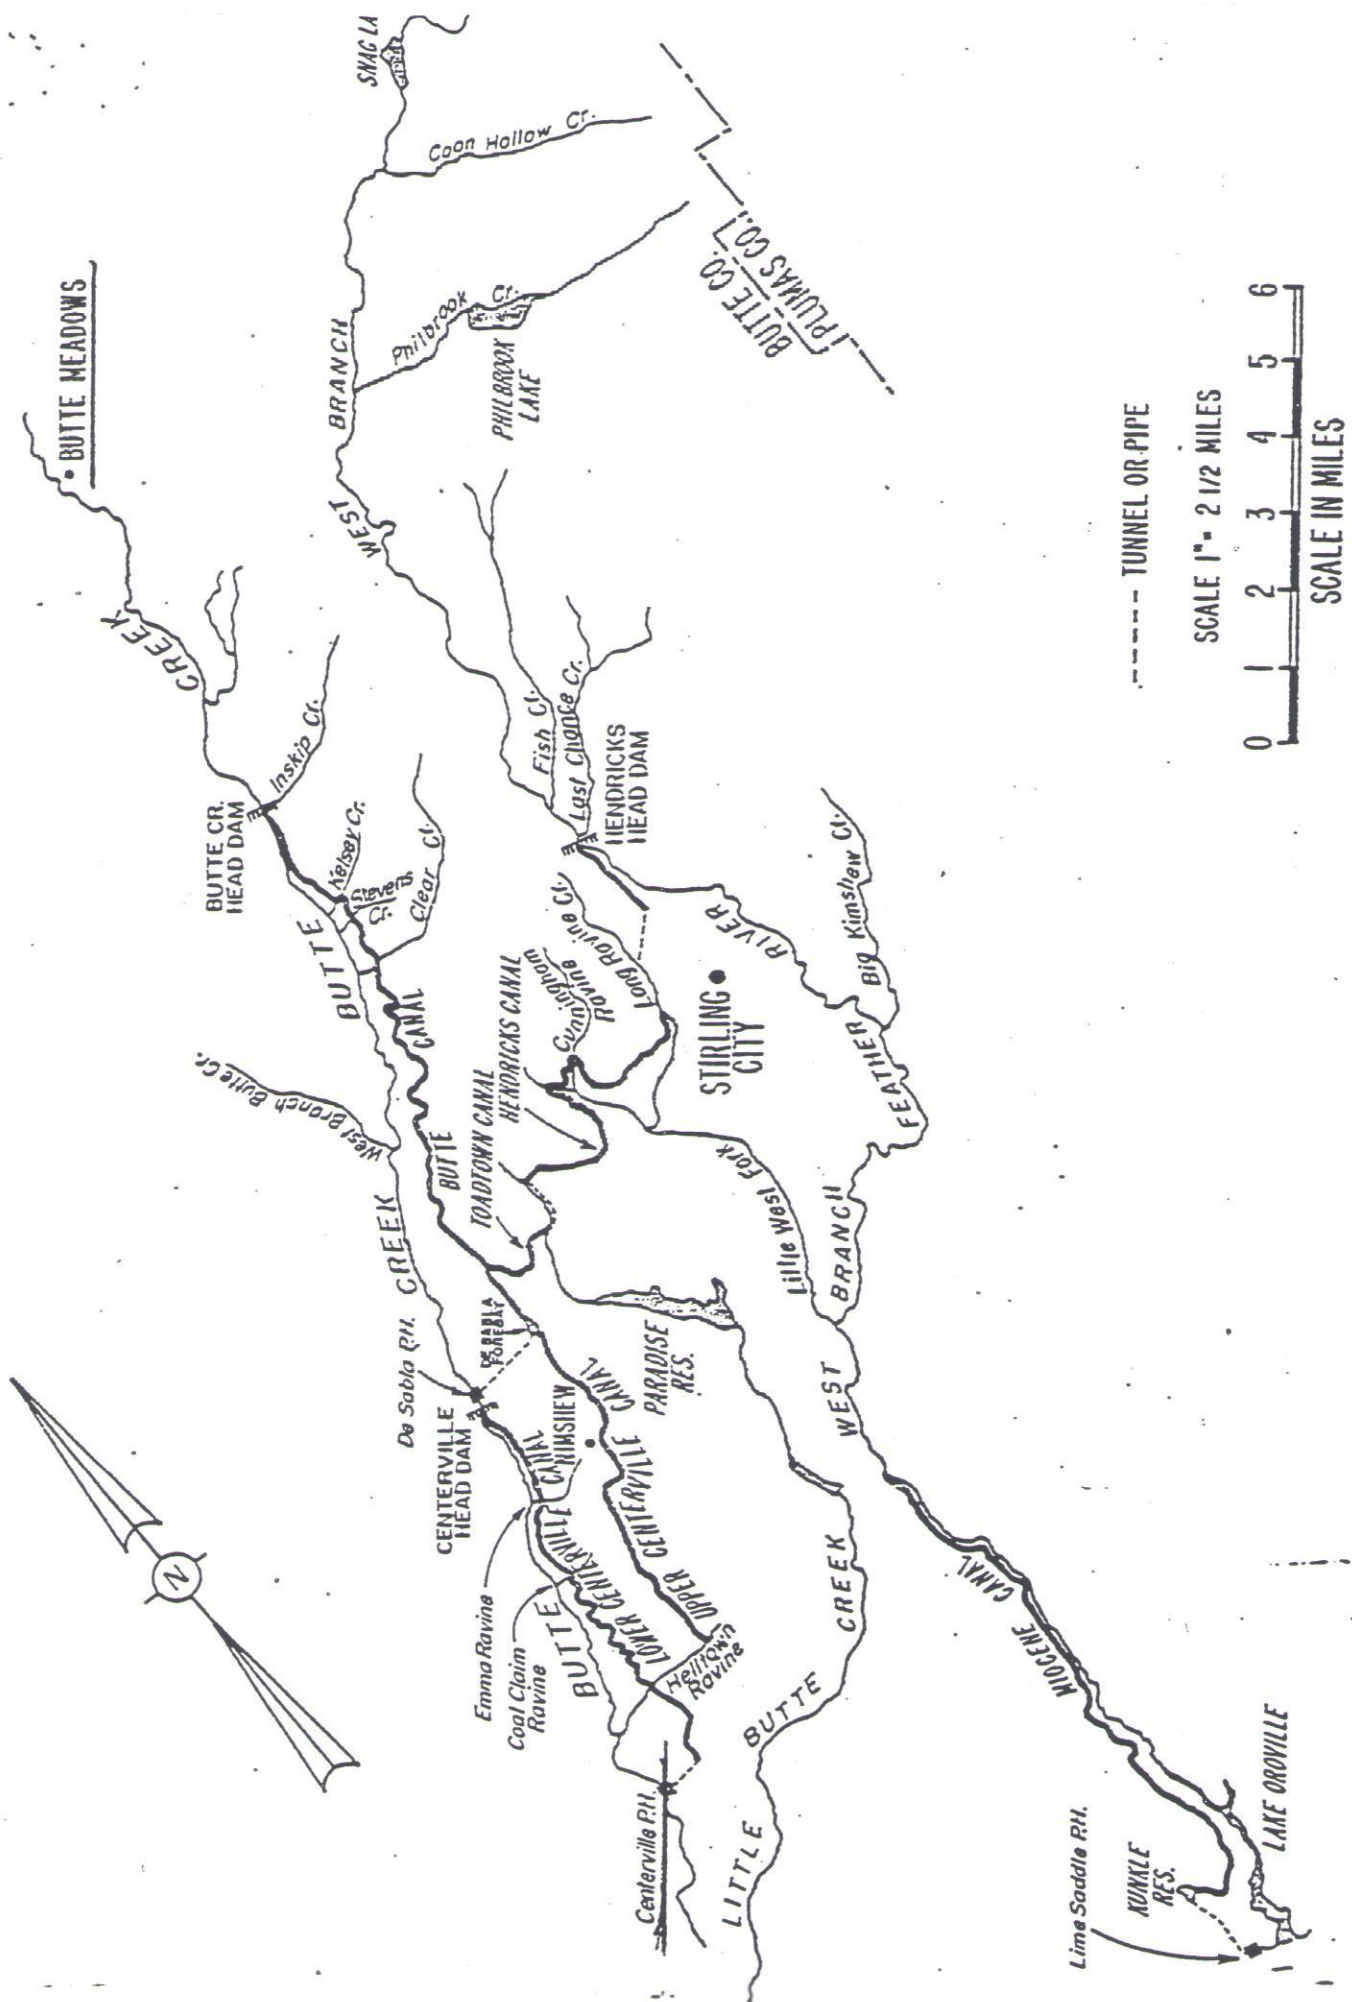
Map 1. Butte Creek canyon and environs, from Butte Meadows downstream to the Centerville Powerhouse

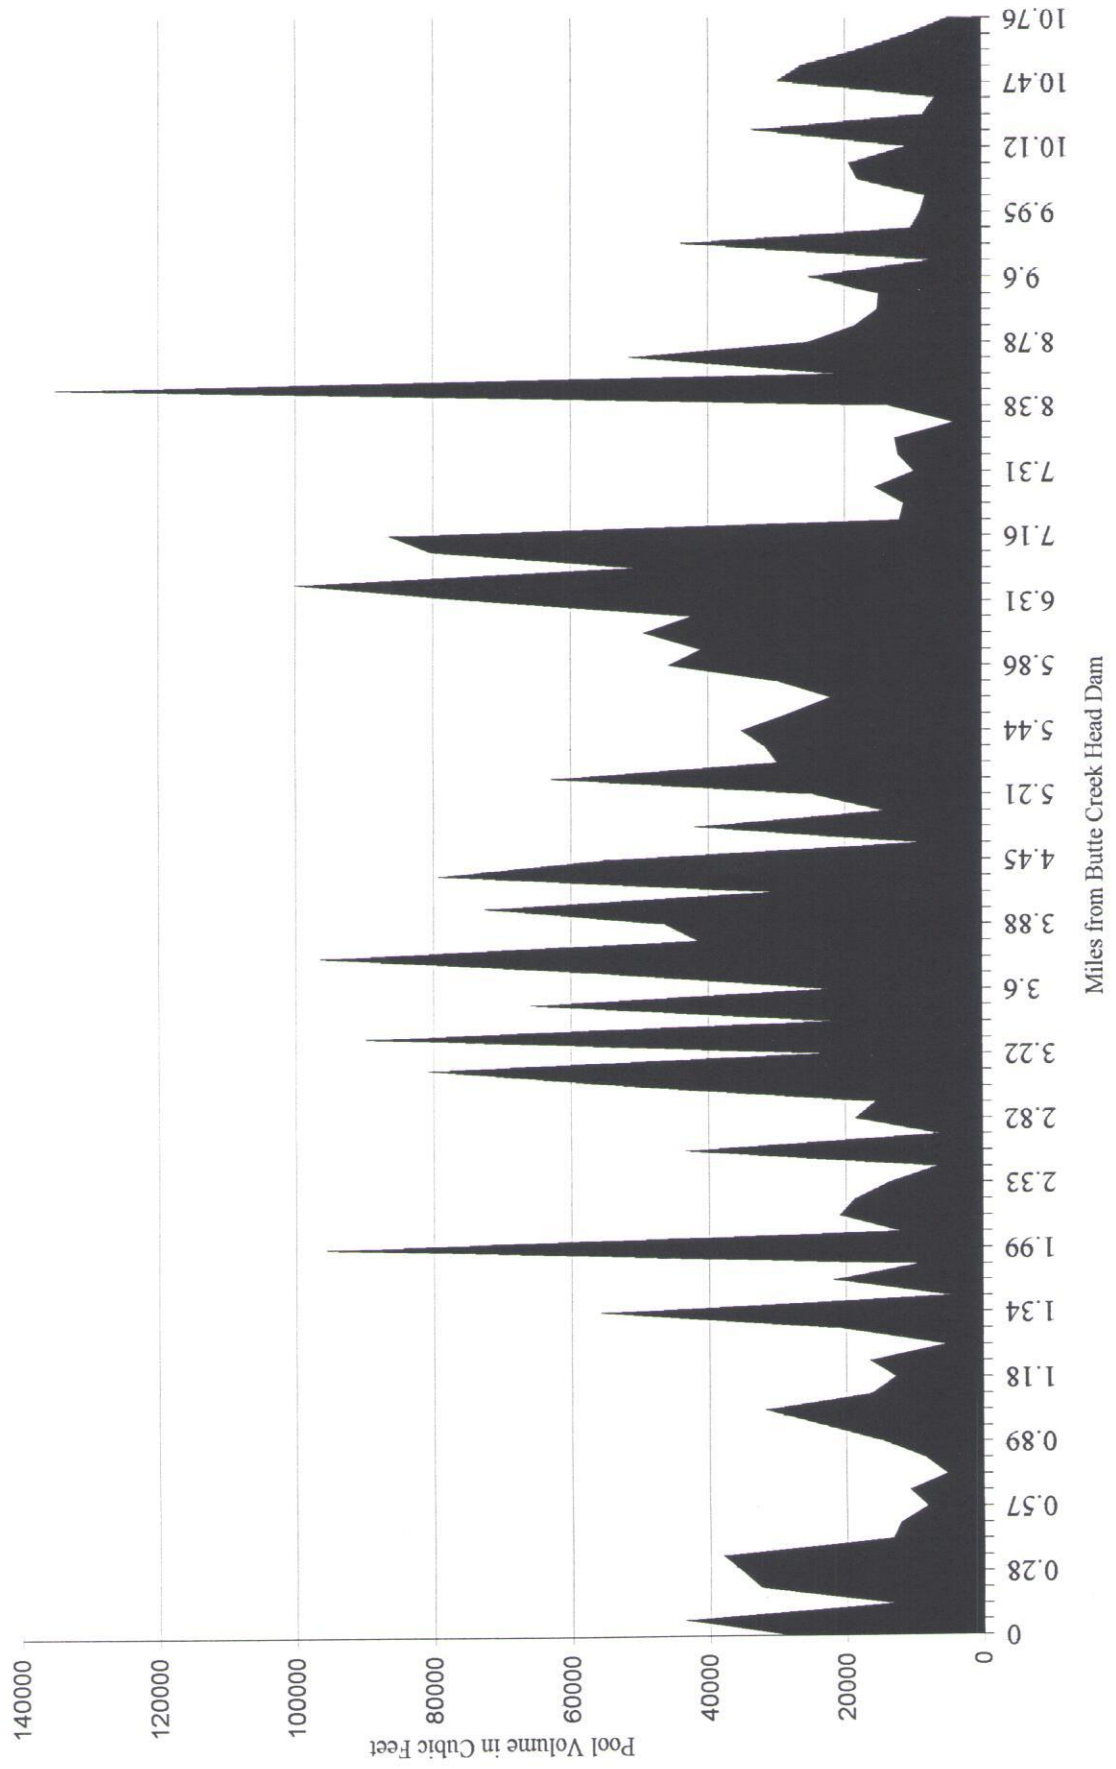
Figure 1. Volume and location of pools, Butte Creek canyon

The team identified 100 pools in the 11-mile reach ranging in maximum depth from 15.5 feet down to 5.0 feet. The pools are well distributed along the length of the reach, as indicated in Figure 1. Twenty-two of the pools had maximum depths of 10 feet or more. The 100 pools had a combined volume of more than three million cubic feet and a combined surface area of more than a half-million square feet. Roughly a third of the total pool volume enjoyed an instream cover rating greater than 100. These higher instream cover ratings were typically the result of many large boulders in the pools, extensive bubble curtains, or both, as shown in photograph 3.

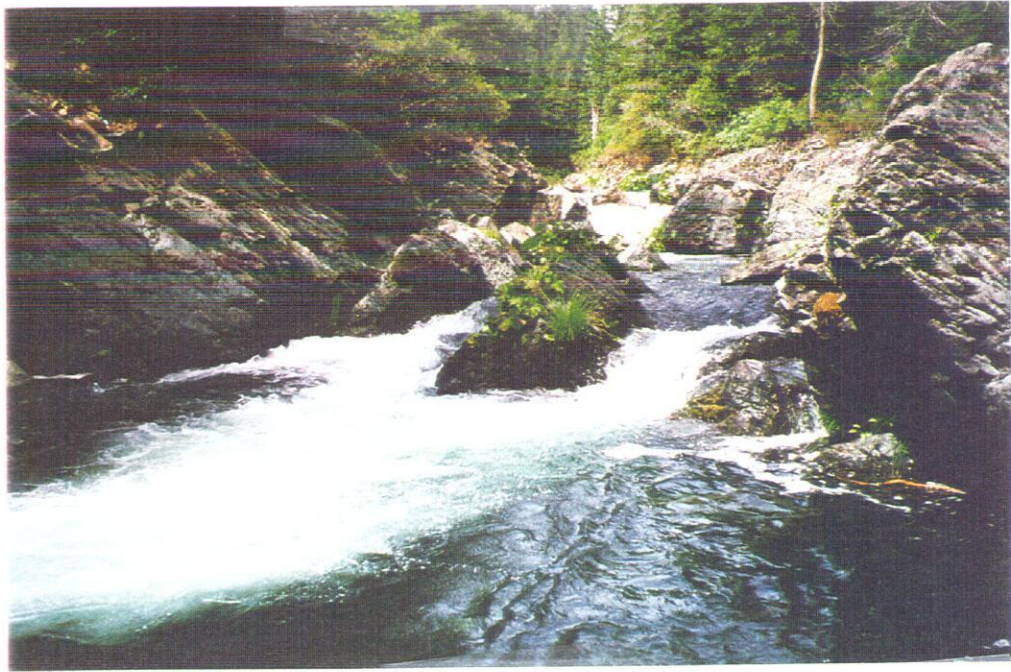
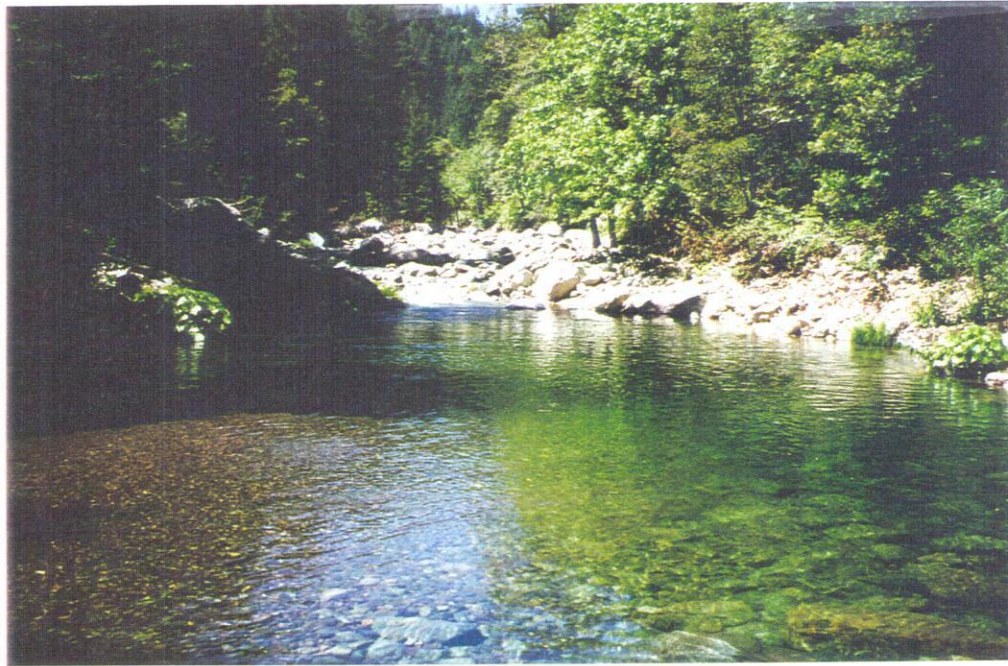
Photos 3 and 4. Eight-foot-deep pool (upper photo) with extensive bubble curtain, resulting in high cover rating. Pool tail-out (lower photo) below Garland Road bridge, showing gravel highly suitable for salmon spawning.

spawning, similar to that shown in photograph 4, are reached within four miles of the Centerville Diversion Dam.

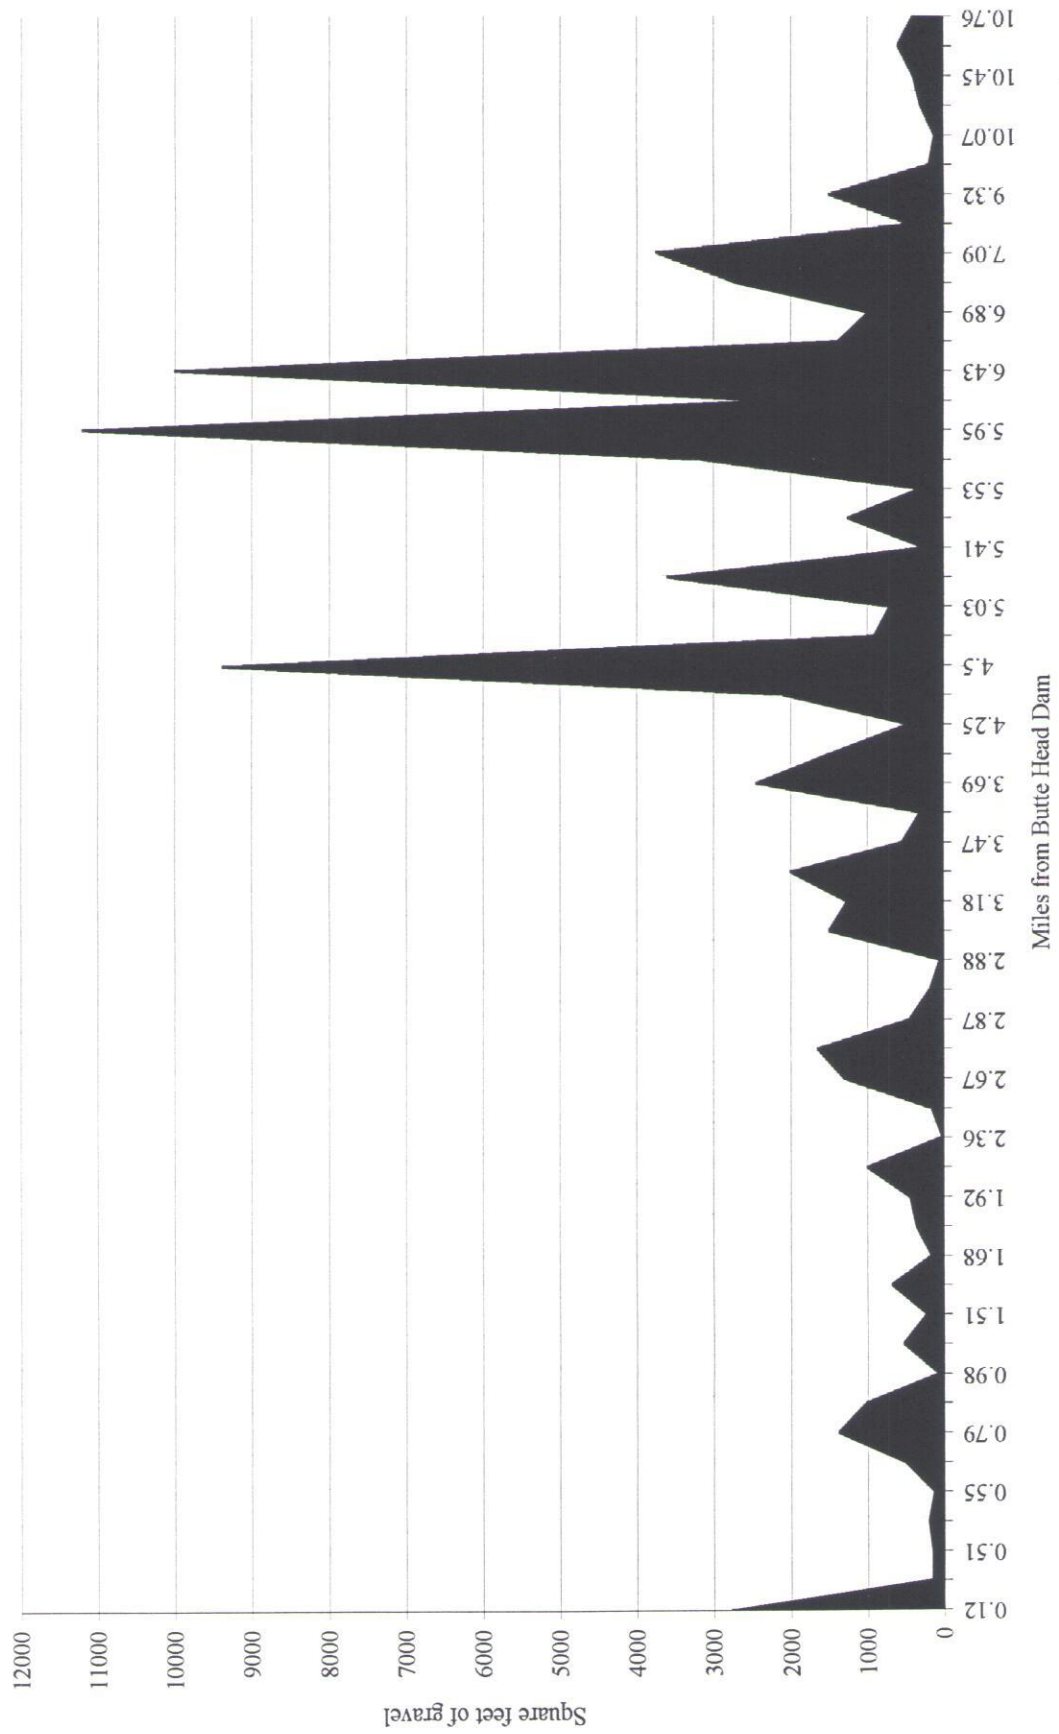
Figure 2. Extent and location of significant spawning gravel

Figure 2 shows the extent and location of significant gravel areas. Figure 3 shows where relatively silt-free gravel of the most suitable size for salmon spawning is located. Taken together, the two figures show that significant amounts of clean gravel of suitable size for

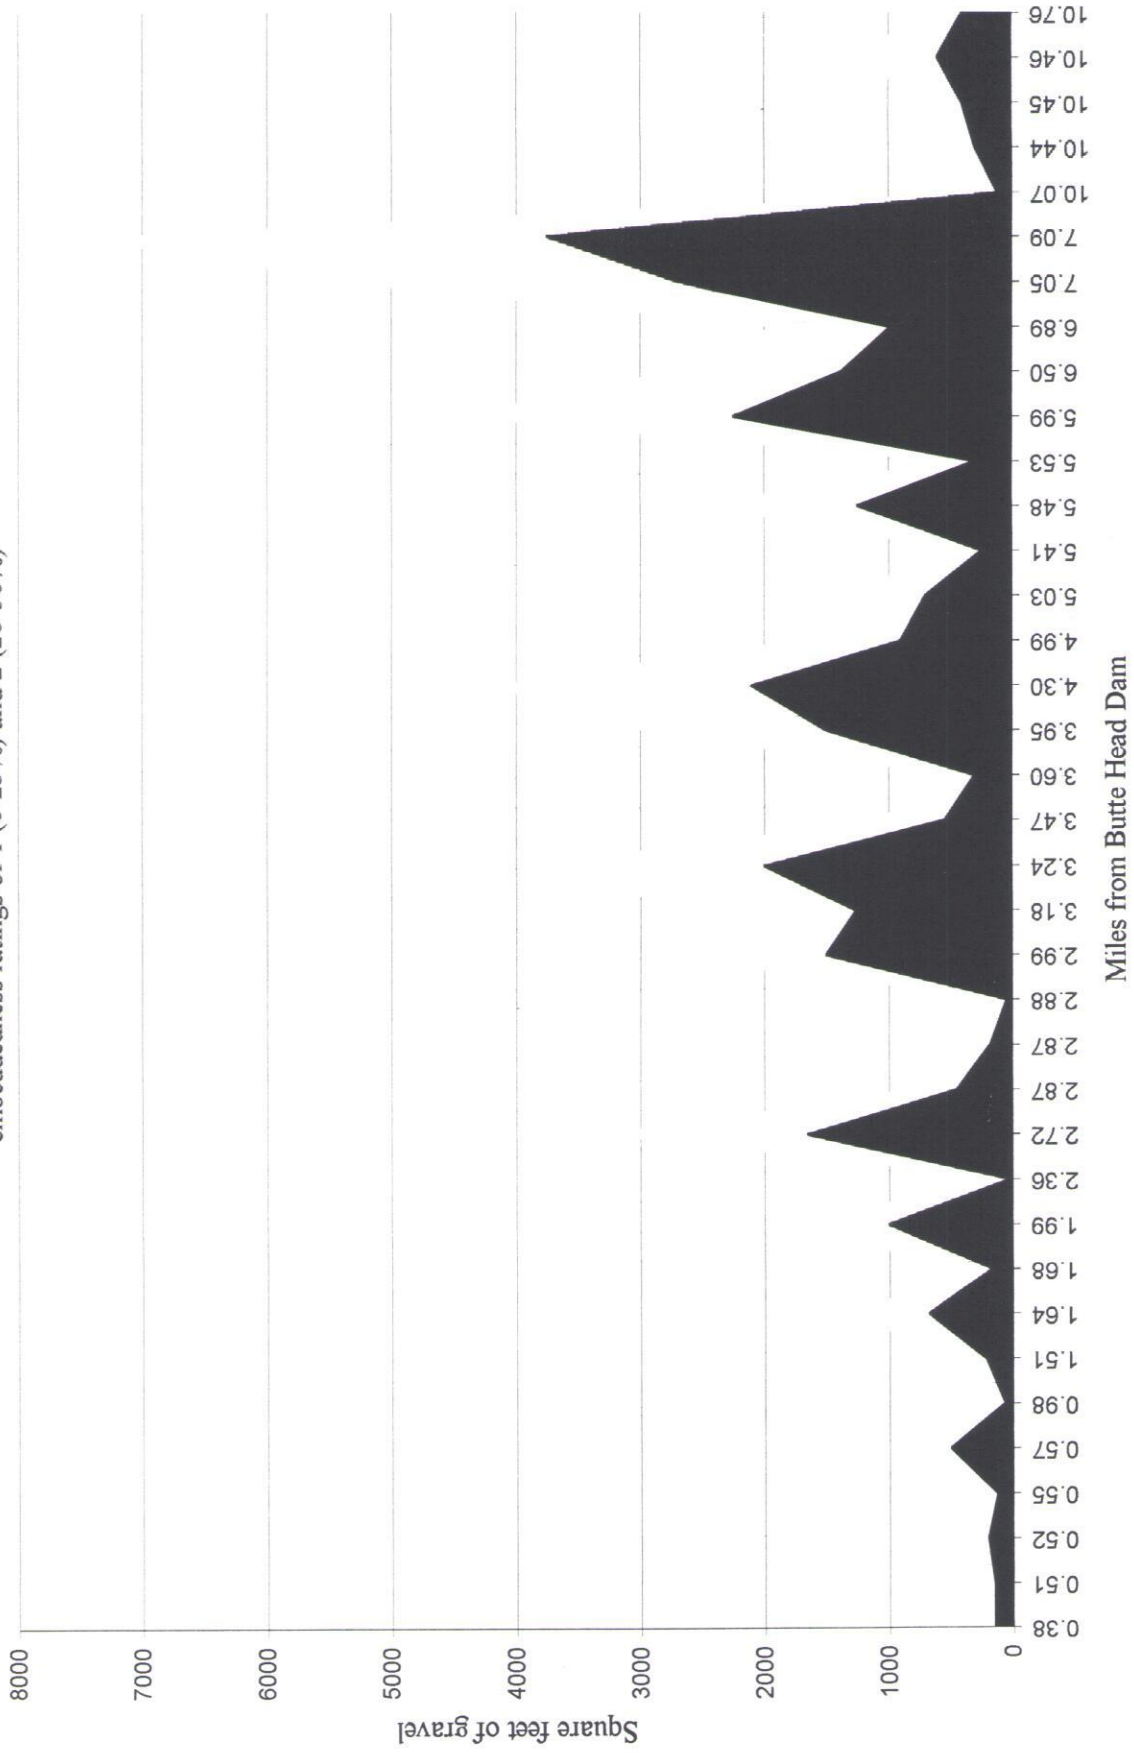
Figure 3. Butte Creek canyon areas with dominant gravel substrates (particle size .08-2.5") and small cobble (2.5-5") with embeddedness ratings of 1 (0-25%) and 2 (26-50%)

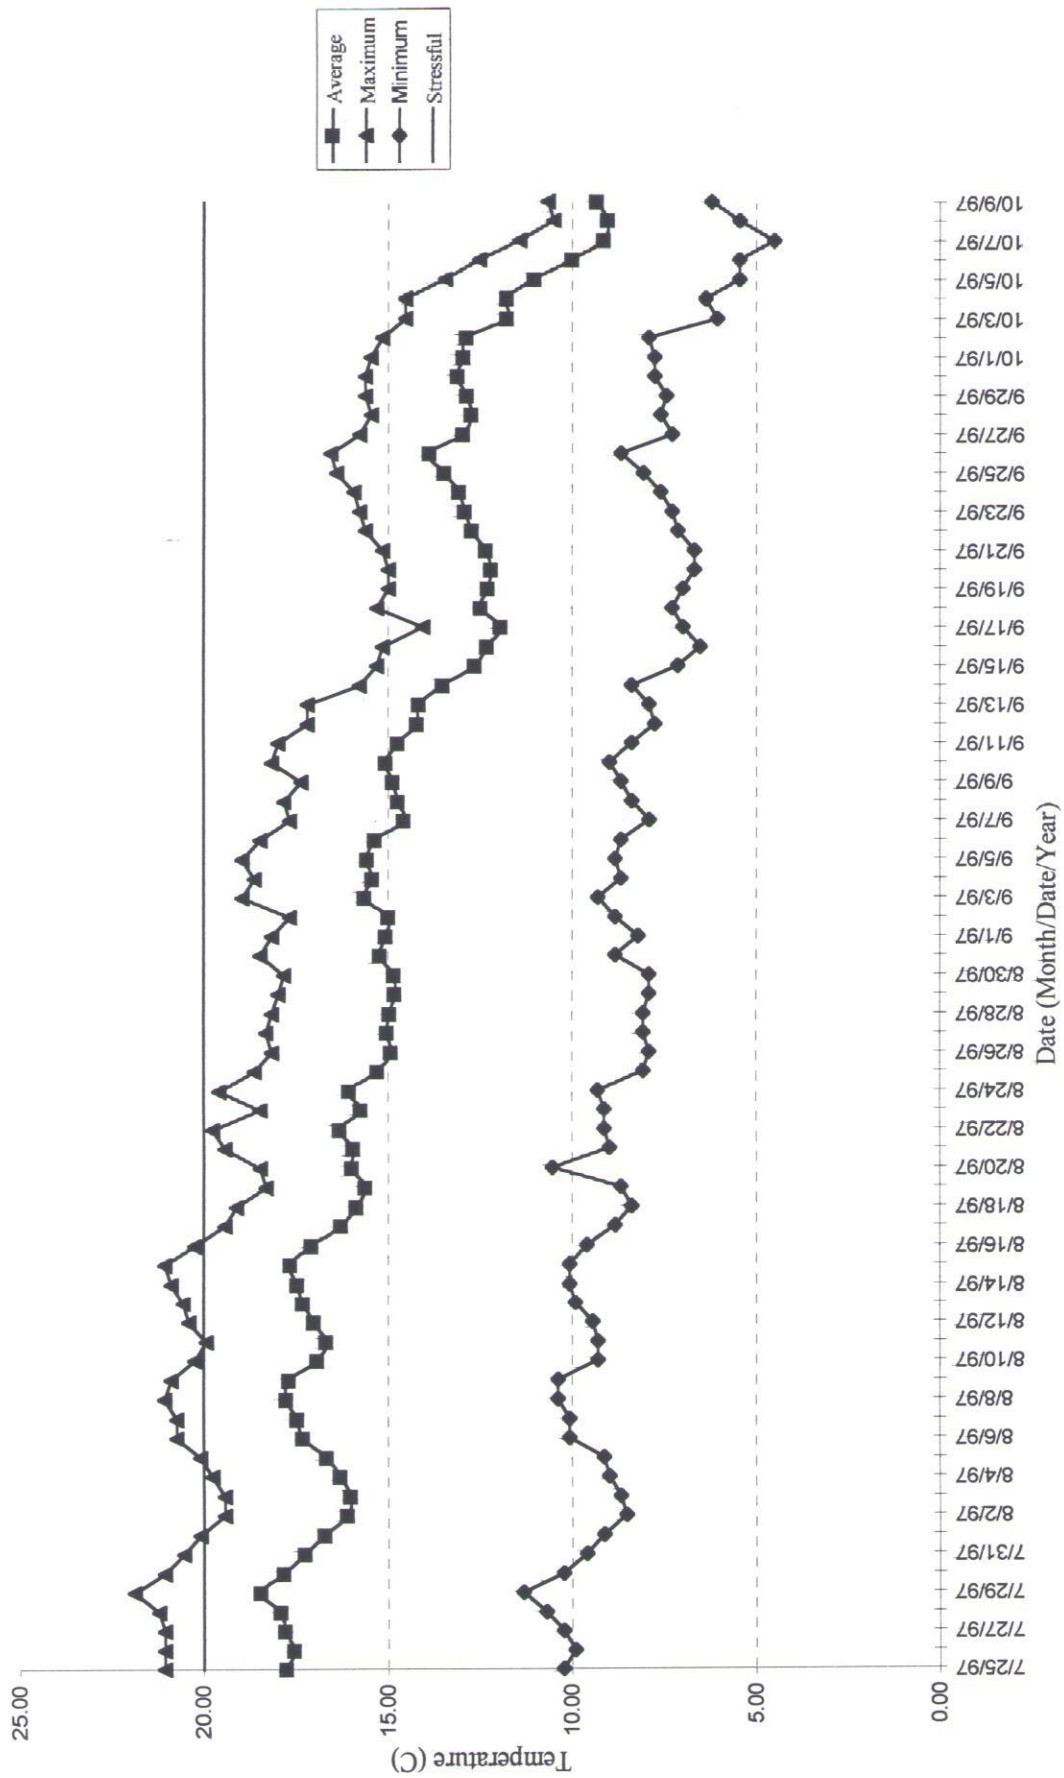
Figure 4. Daily maximum, average, and minimum
Butte Creek pool temperatures

Figure 4 shows the daily maximum, average and minimum temperatures recorded by the monitors in the four Butte Creek canyon pools. The location of and record for each of the pools is found in Appendix 3.

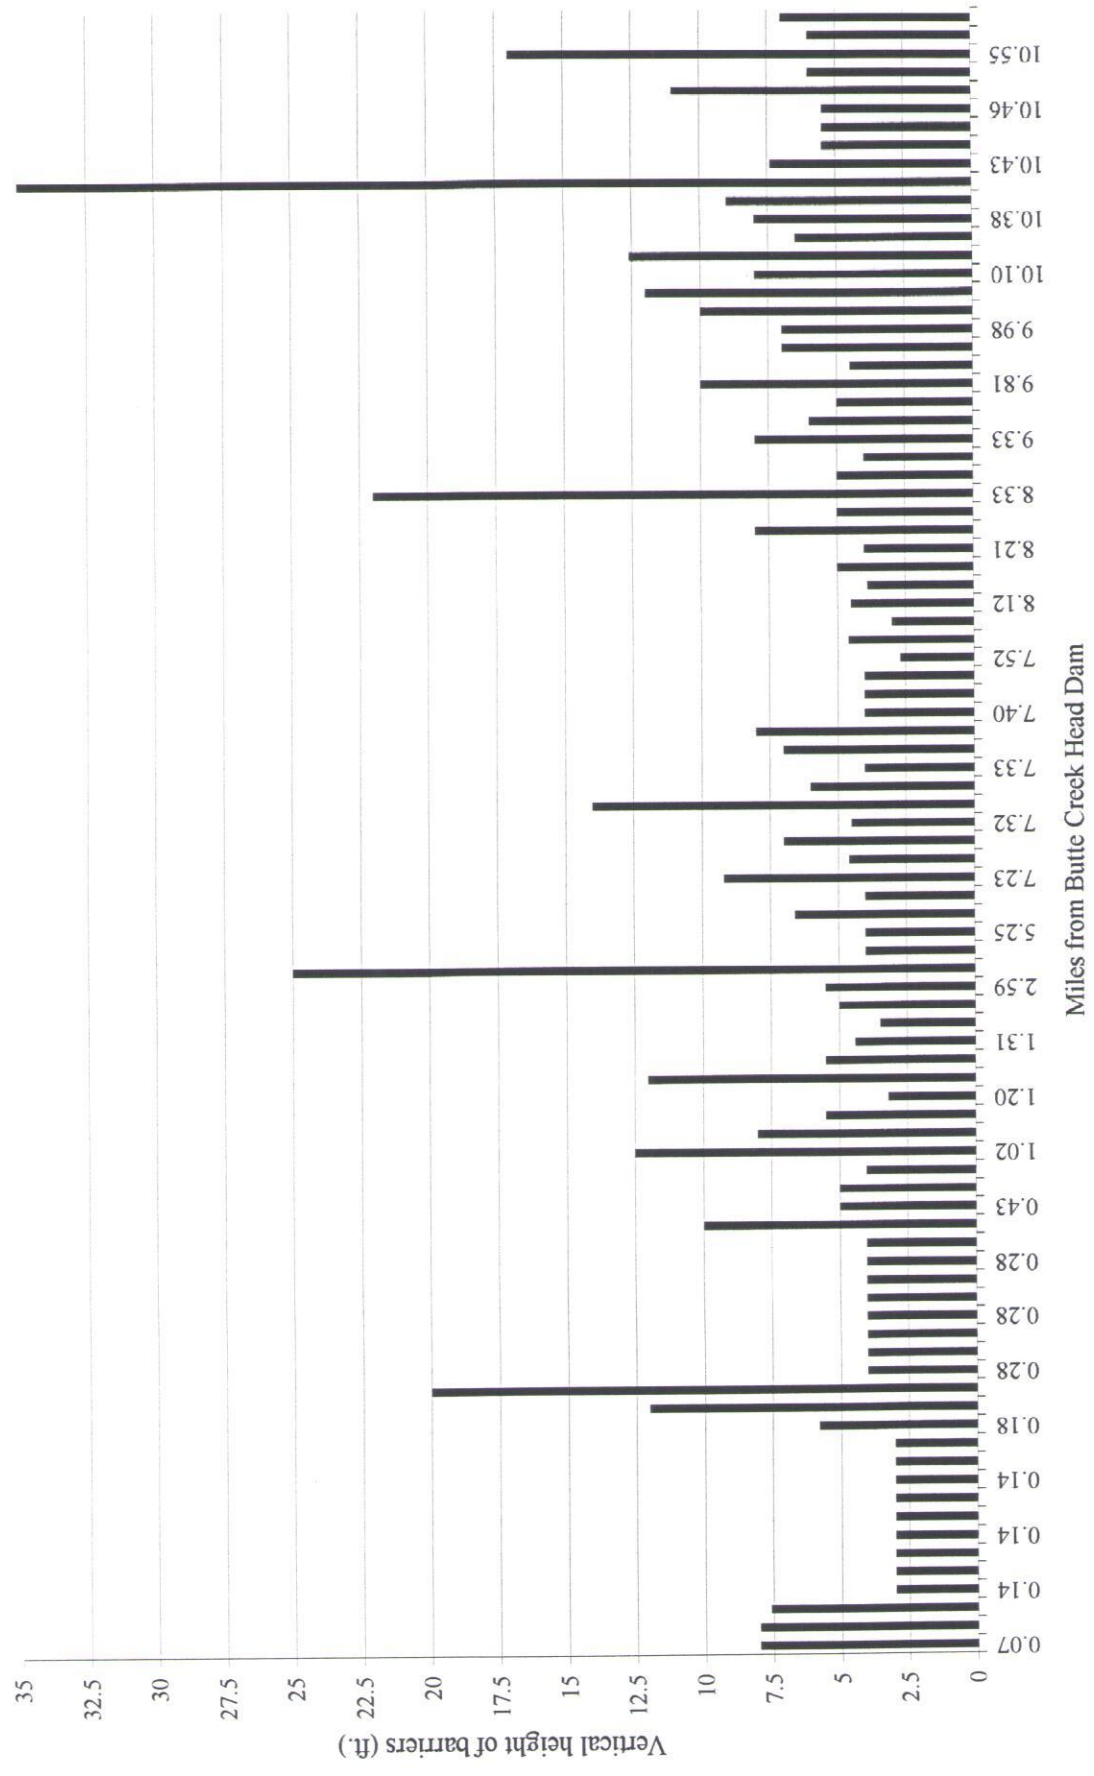
Figure 5. Size and location of barriers, Butte Creek canyon

The survey team encountered 77 apparent barriers to the upstream migration of adult salmon in the 11 mile reach - 80 counting the Centerville Diversion, Forks of the Butte Dam and Butte Head Dam (Figure 5). There were 57 single waterfalls, eight chutes and eleven cascades - and, at approximately seven miles below the Butte Head Dam, the unladdered, ten-foot-high Forks of the Butte hydroelectric diversion dam.

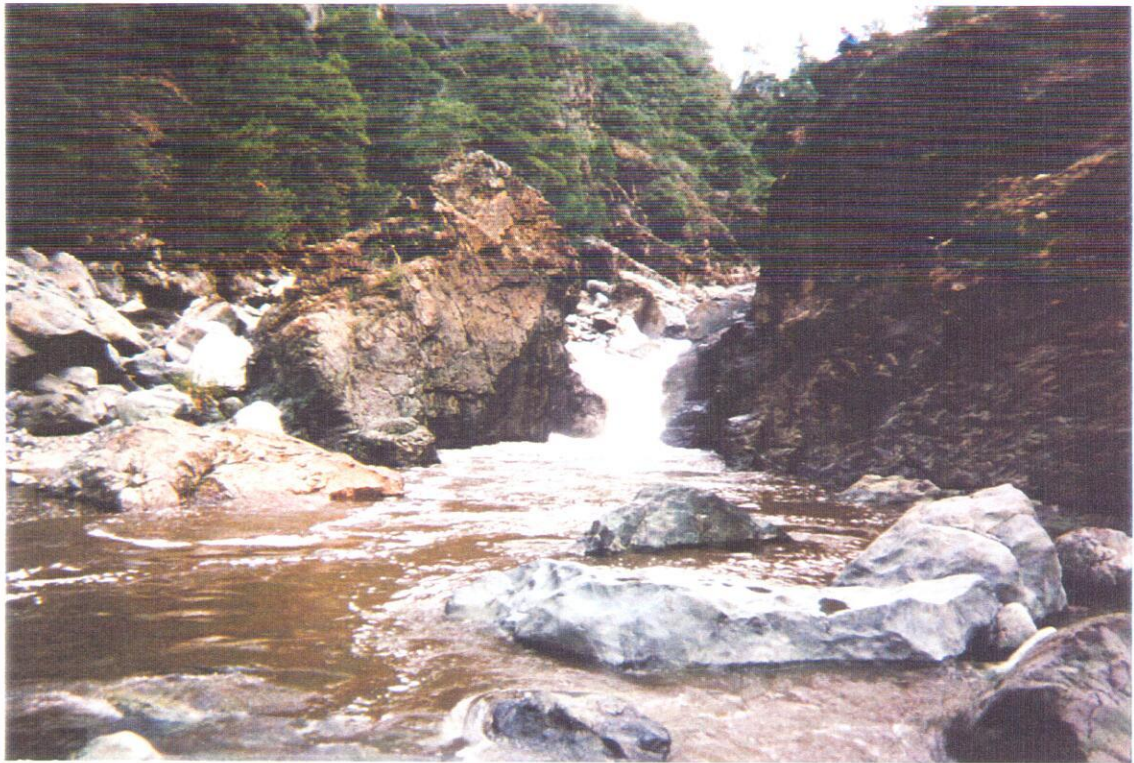
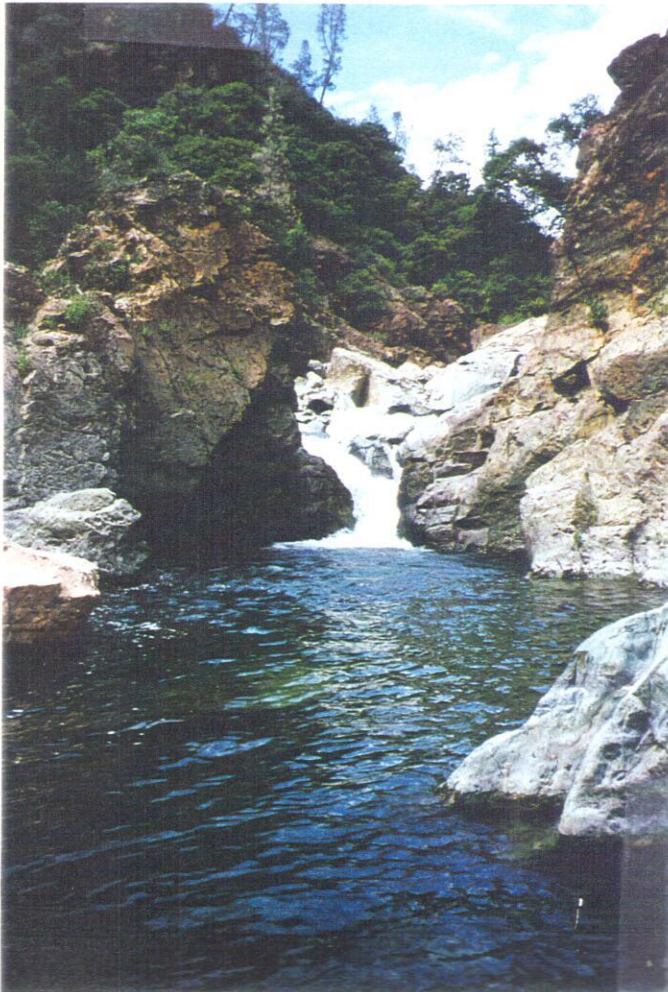
Photos 7 and 8. Twelve-foot waterfall salmon barrier above PG&E's De Sabla Powerhouse, at flows of approximately 25 c.f.s (left) and 50 c.f.s. (above), showing increase in plunge pool depth and decrease in vertical waterfall height at the higher flow.

Photographs 5 and 6 show how the relatively modest flow increase that resulted from the first fall, 1997 rainstorm appears to have opened up a riffle area to adult salmon migration - were the canyon reach open to salmon migration at all. Photographs 7 and 8 show how significantly the modest fall flow increase modified a 12-foot waterfall above the De Sabla Powerhouse.

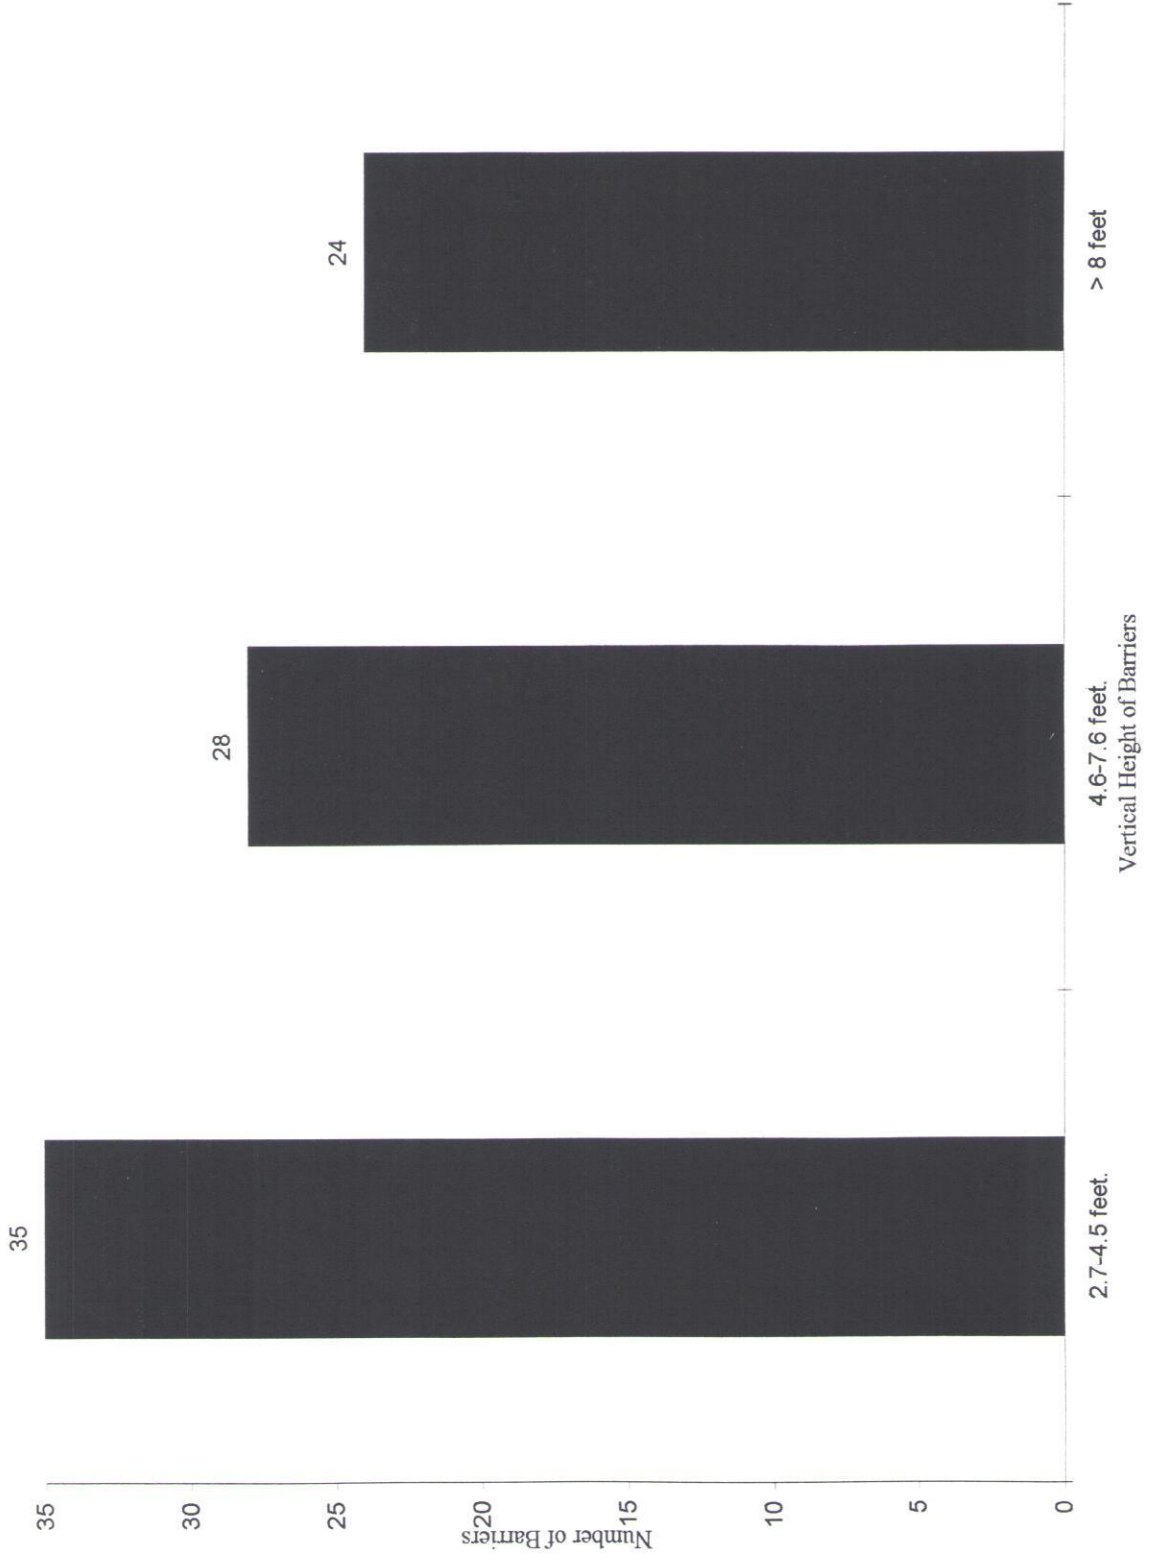
Figure 7. Size classes of barriers between Butte Creek Head Dam and Centerville Head Dam

Figure 7 classifies the barriers in the canyon reach on the basis of their height from plunge pool surface to waterfall crest *at the low, late-summer flow available at the time of the survey.*

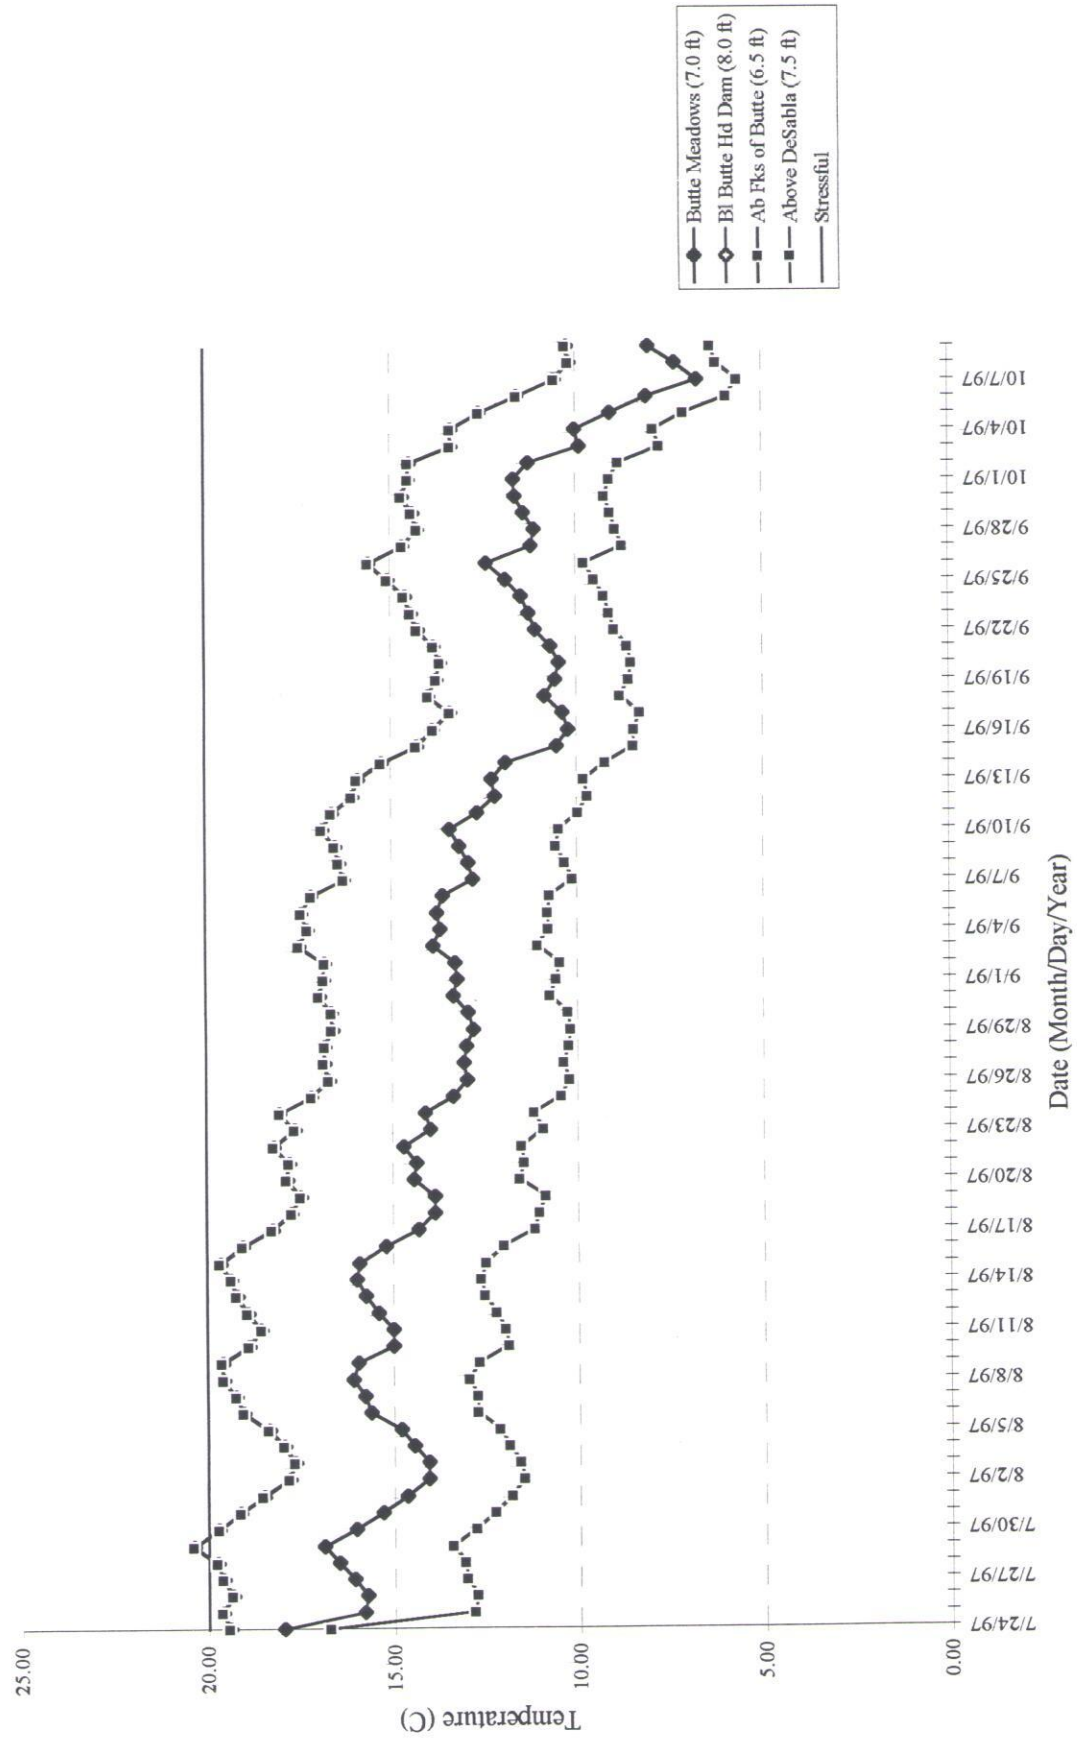
Figure 6. Average Butte Creek pool temperatures at four locations

Figure 6 shows that average water temperatures in the four pools from which recorders were recovered rarely rose to levels regarded as stressful for adult chinook salmon. There are a couple of things about the pool temperatures worth noting, however. First, the average temperatures just below the Butte Head Dam and just above the Forks of the Butte diversion are virtually identical - the two graph lines are literally on top of one another in Figure 6 - while the temperature just above De Sabla Powerhouse is significantly cooler. The surveyors believe this is the effect of the hydroelectric diversions. Several small, cool tributary streams enter Butte Creek between Forks of Butte Dam and the De Sabla Powerhouse, allowing Butte Creek to gain some flow and lose some heat. This gaining section of Butte Creek, it should be noted, is even cooler than Butte Creek at a much higher elevation just below Butte Meadows.
