**A PRELIMINARY ASSESSMENT OF THE SALMON
HABITAT POTENTIAL OF BUTTE CREEK, A TRIBUTARY OF THE
SACRAMENTO RIVER, BETWEEN THE BUTTE HEAD DAM AND
CENTERVILLE DIVERSION DAM, BUTTE COUNTY, CALIFORNIA**

January, 1998

William M. Kier Associates
Sausalito, California

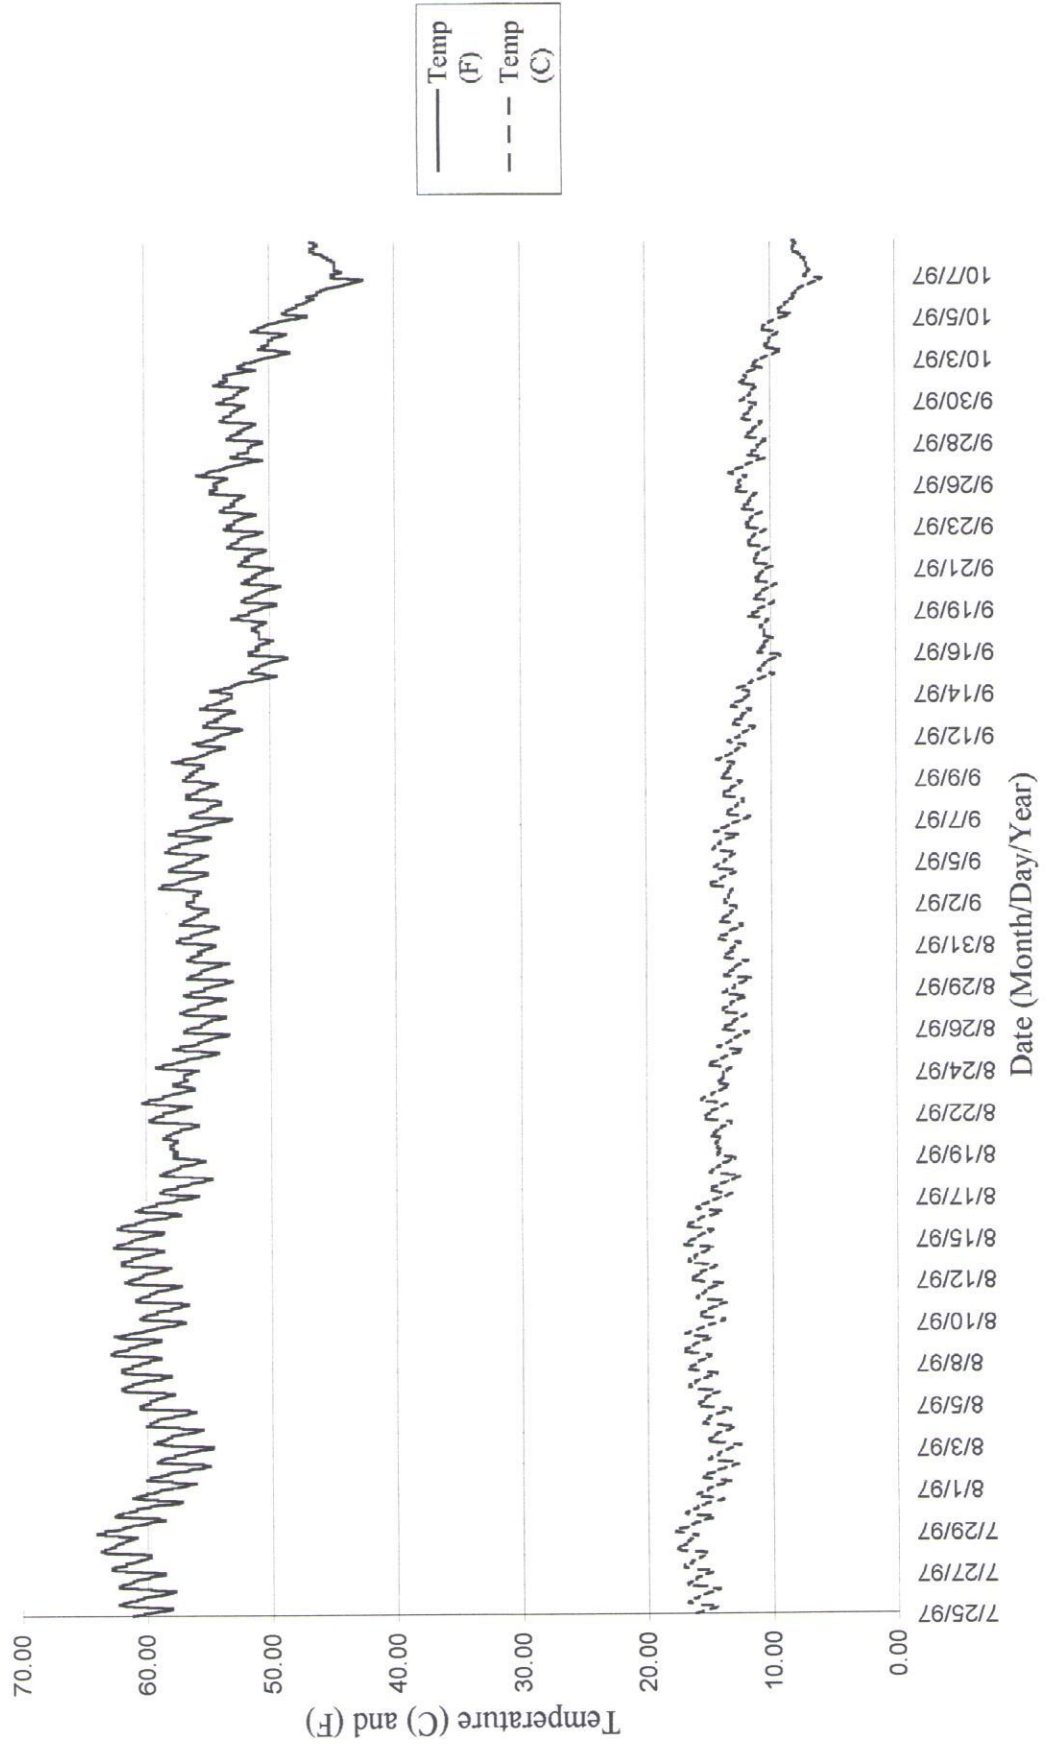
Appendix 3
 Hourly temperatures, Butte Creek downstream of the Butte
 Meadows Campground at 7.0 feet depth

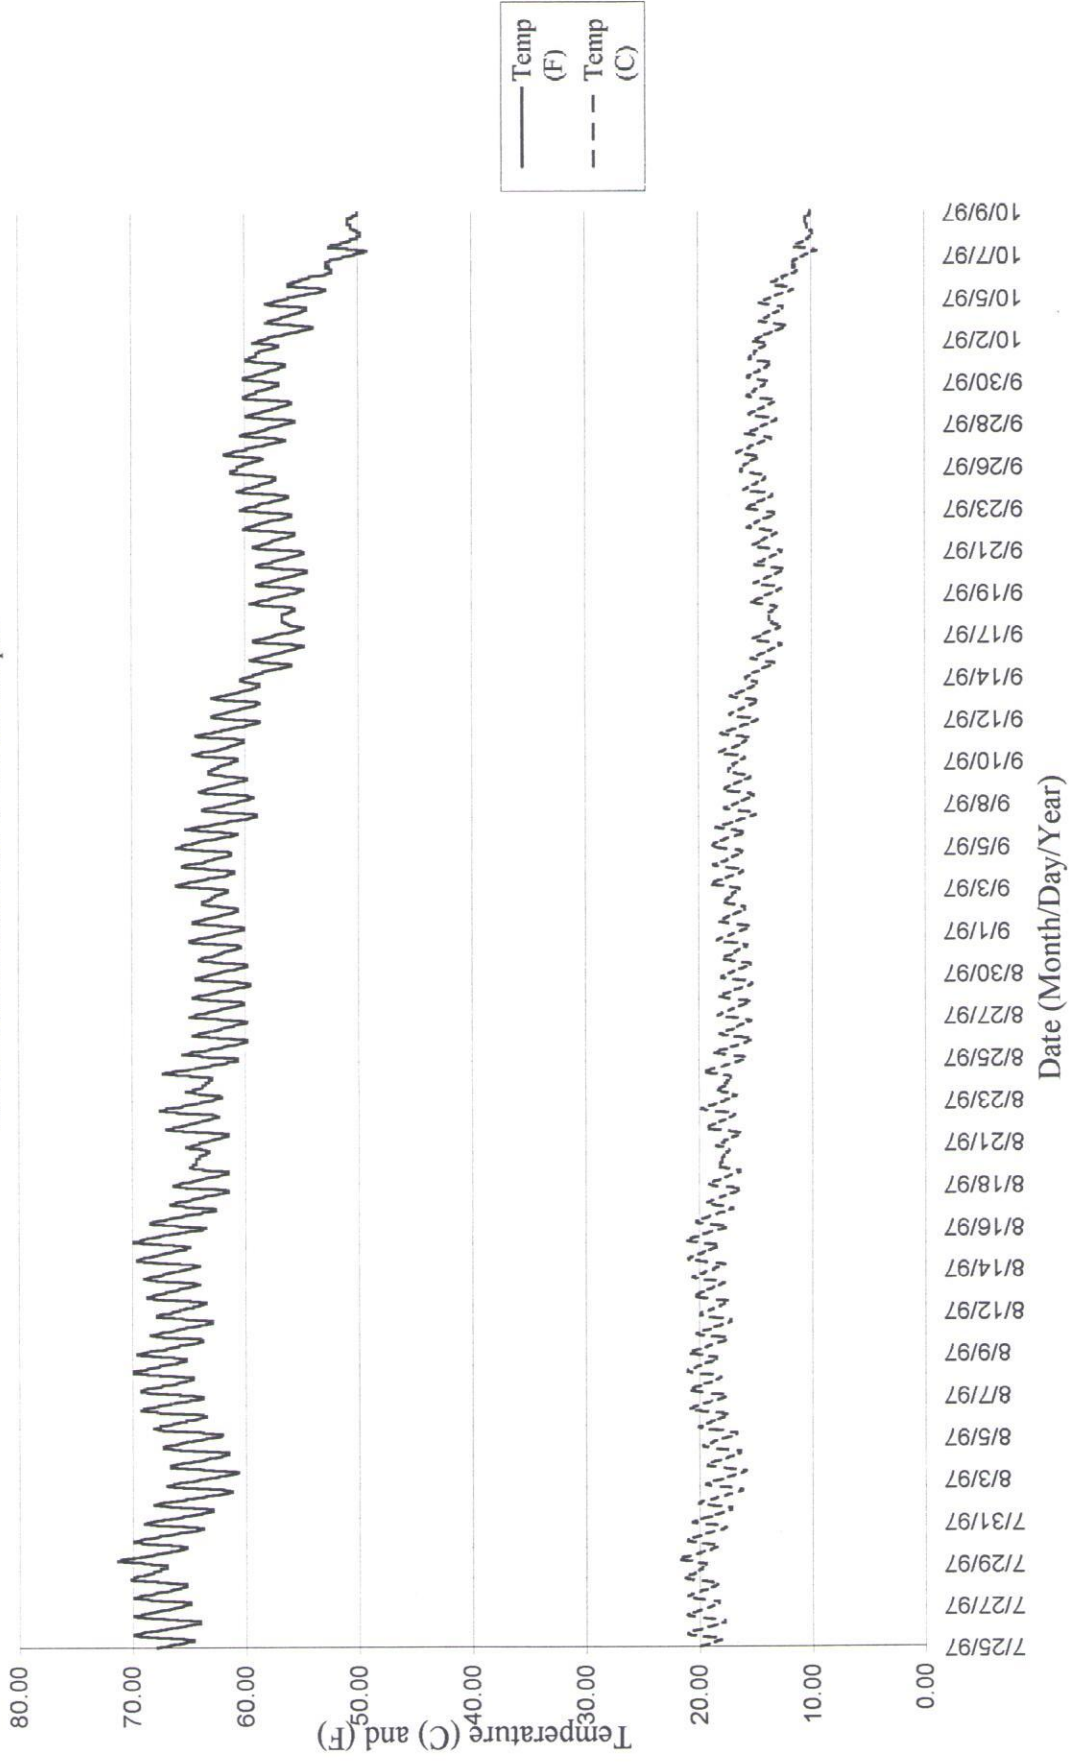
Hourly temperatures, Butte Creek approximately 0.25 miles below Butte Head Dam at 8.0 feet depth

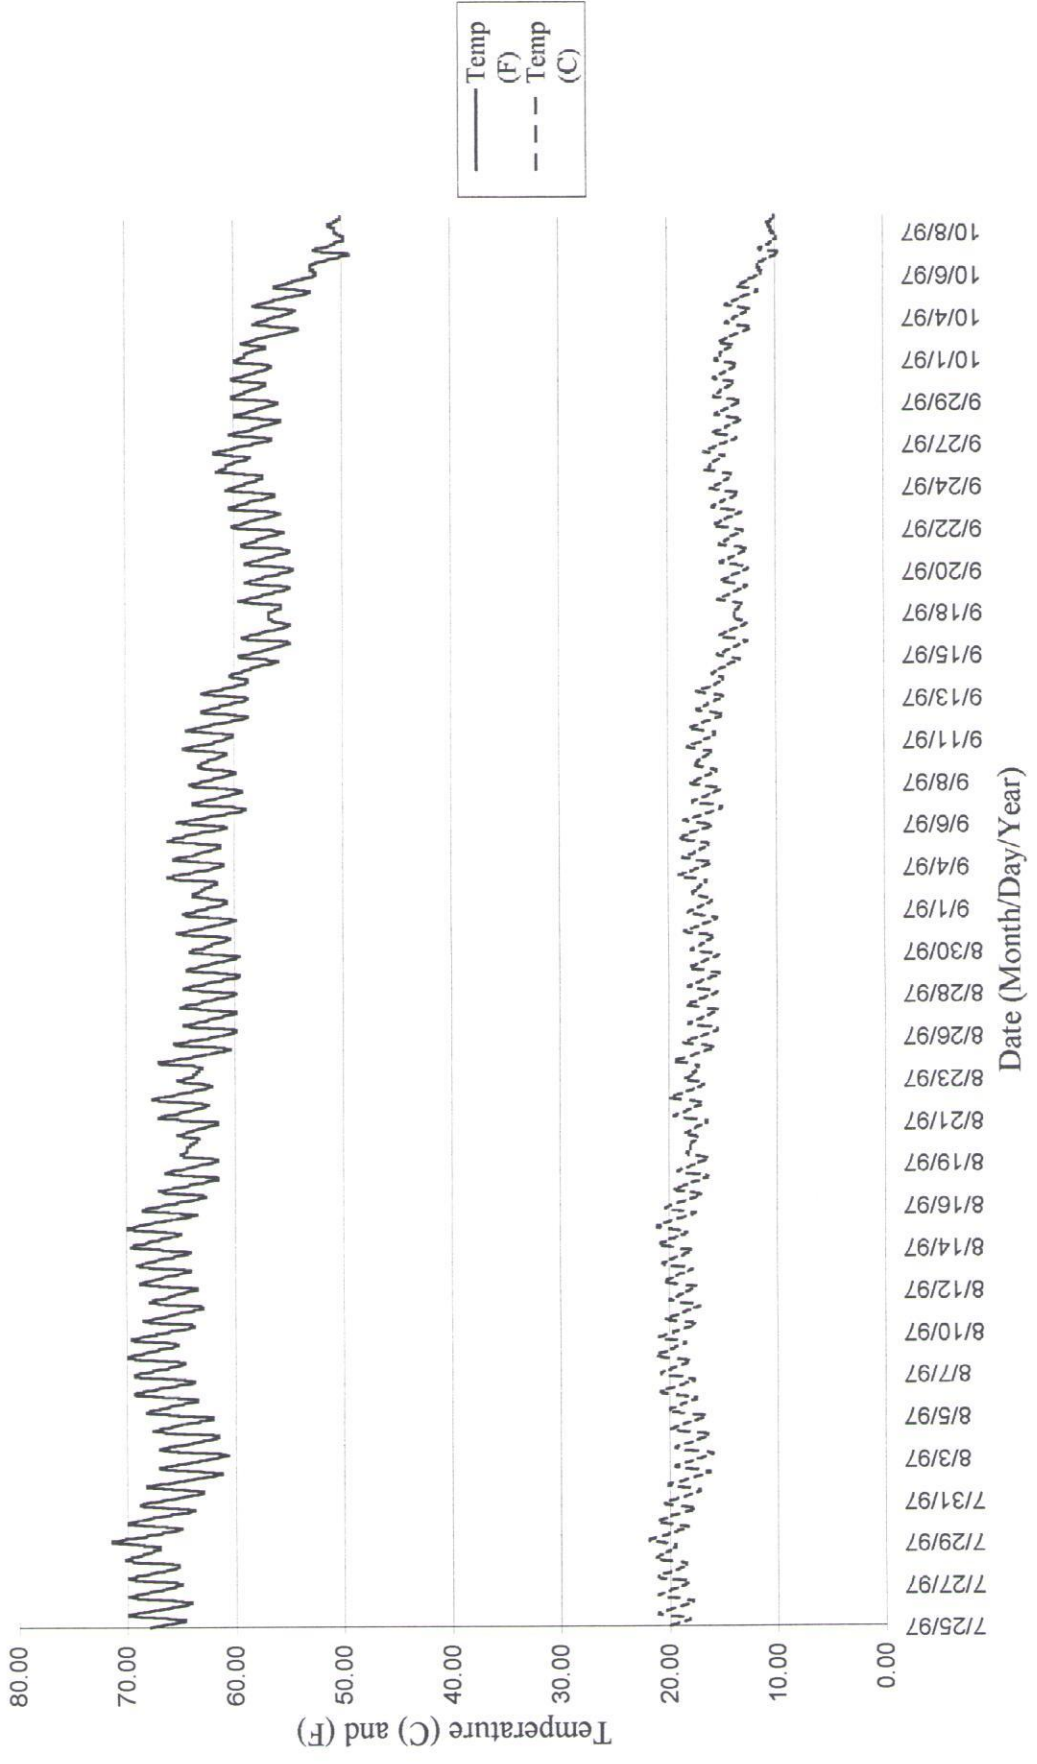
Hourly temperatures, Butte Creek approximately 0.25 miles above
Forks of Butte Diversion Dam at 6.5 feet depth

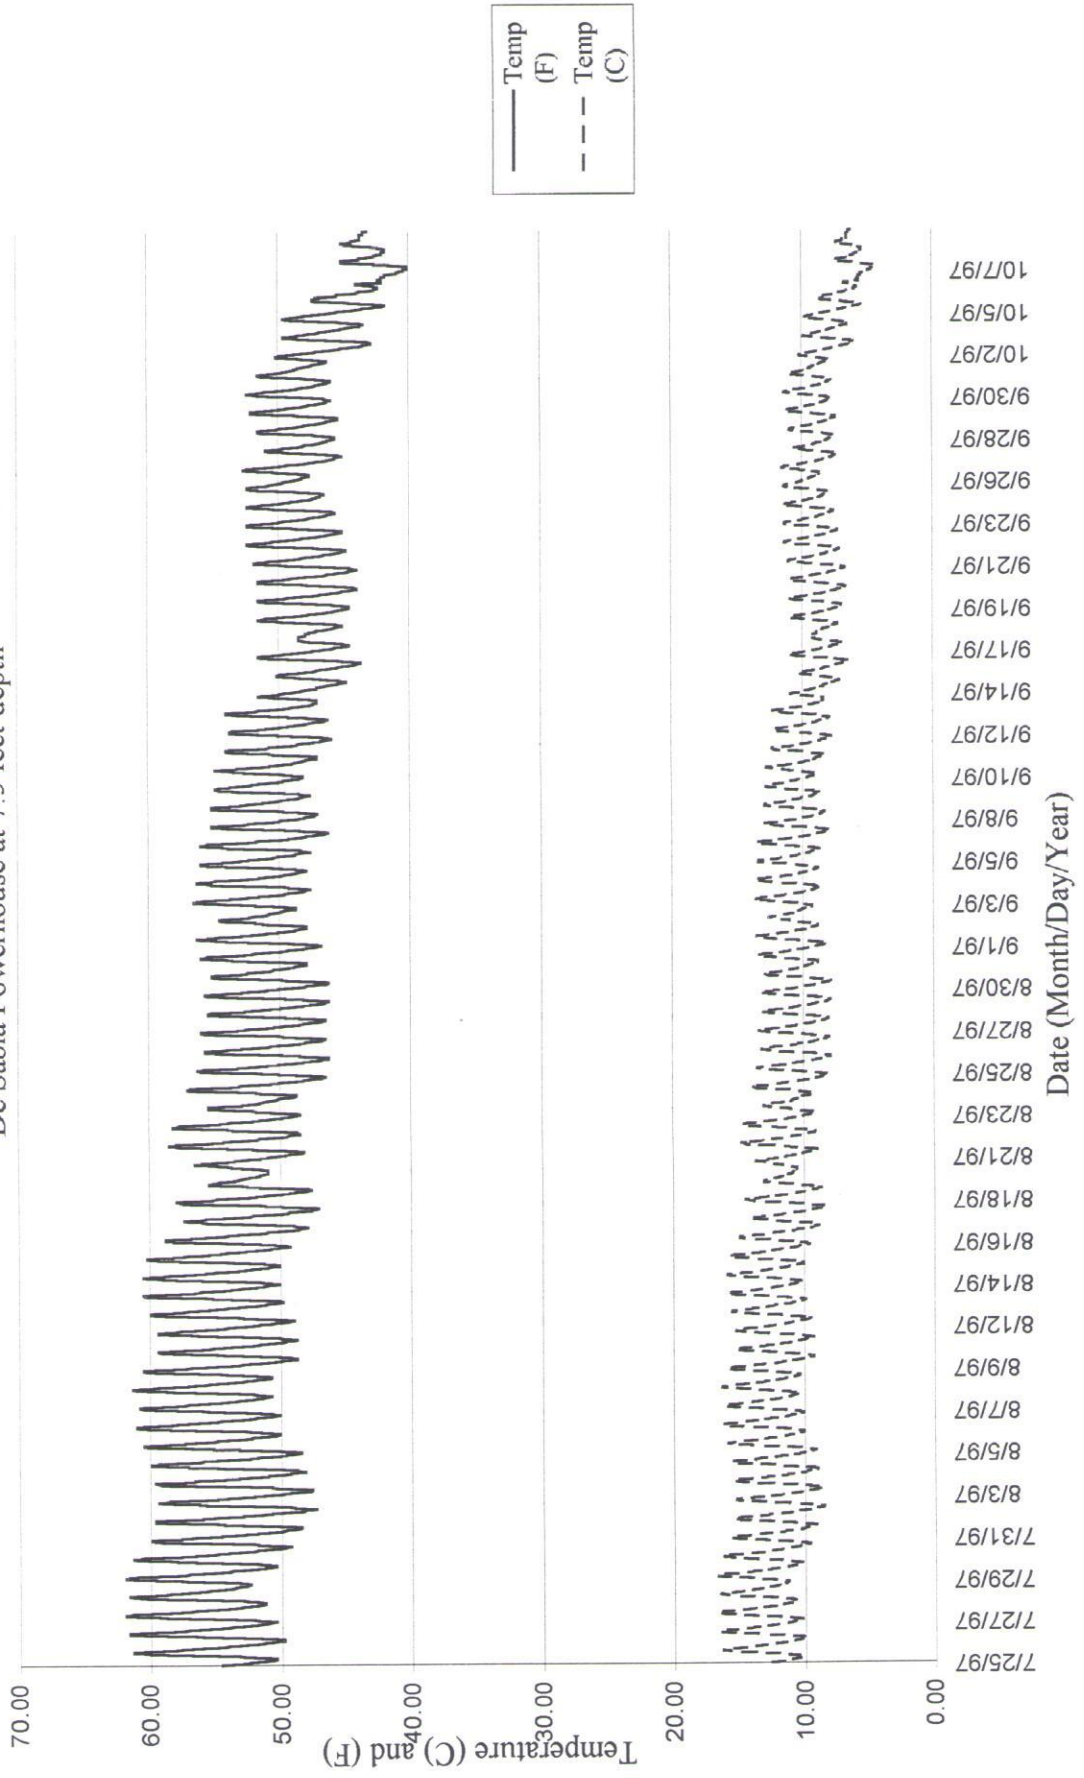
Hourly temperatures, Butte Creek approximately 0.5 miles above
De Sabla Powerhouse at 7.5 feet depth
