Project Incident
Project No. 803-CA, DeSabra-Centerville Project
Unplanned Non-Injury Service Interruption

On March 20, 2011, 1:58 pm PST, Pacific Gas & Electric CO (PG&E) submitted an e-mail notification of a project incident at the DeSabra-Centerville Project, FERC Project No. 803-CA.

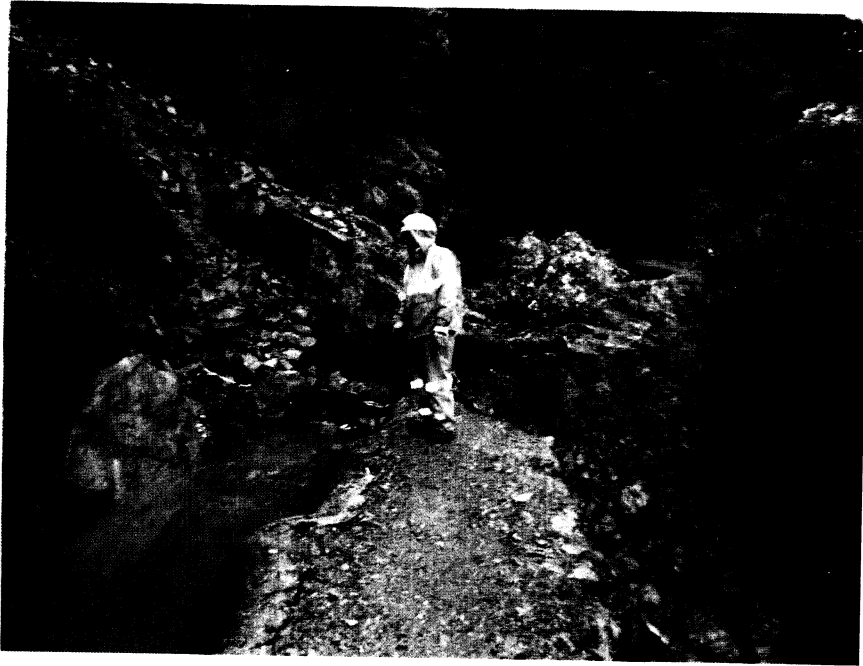
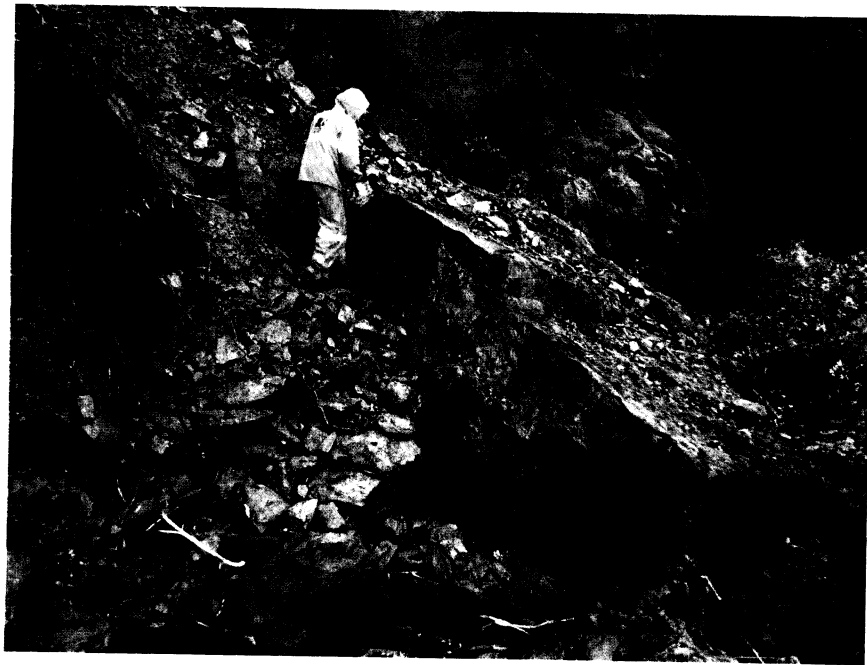
As a result of the ongoing storm, a large rock slide occurred blocking the lower Centerville Canal on March 19, 2011, 7:05 pm PST. The slide is one mile downstream of the Lower Centerville (Diversion) Dam. The slide closed the canal and also removed a portion of the downslope side-wall of the canal. At the time 25 cfs was flowing in the canal. PG&E has isolated water from the canal. The head gate at the intake to the canal is now closed and the spill gate at the dam has been opened.

PG&E has sent their engineering team to evaluate and assess the canal.

PG&E will provide a status after completing the engineering assessment. Follow-up action will be developed upon completion of the assessment.
